2015 FACILITY CONDITION SURVEY

SOUTHWESTERN COLLEGE

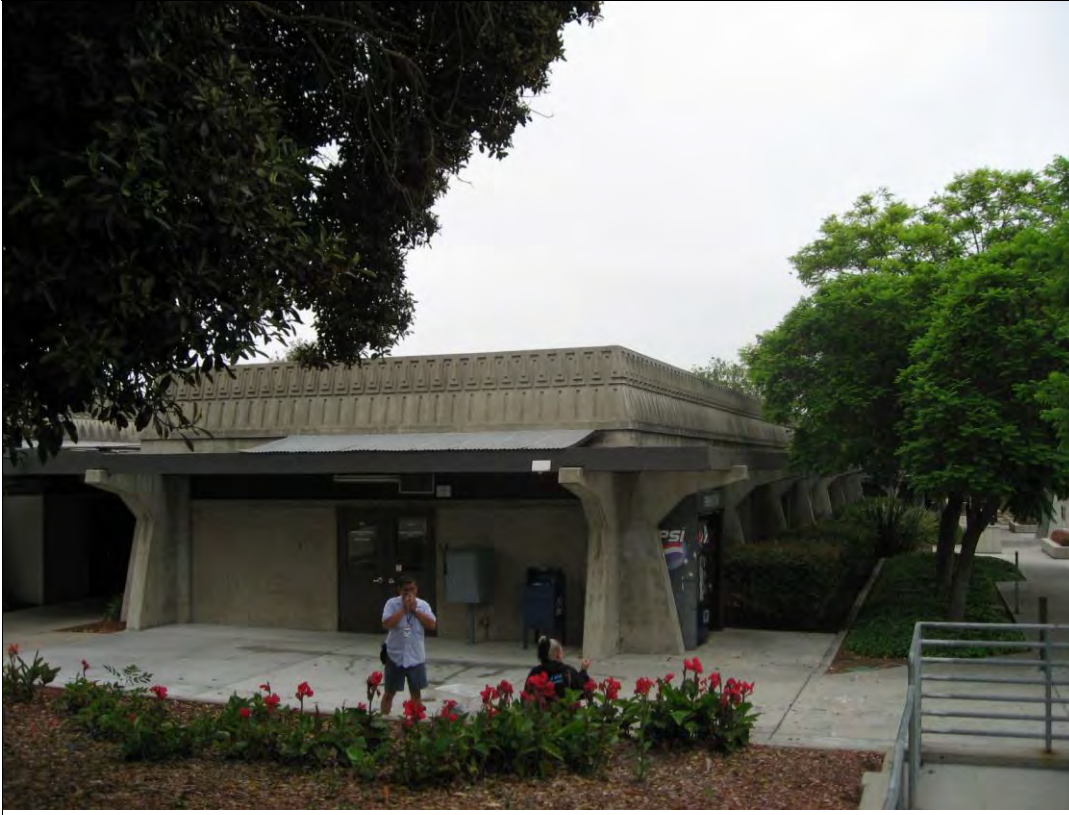
PRIMARY USE: Administration

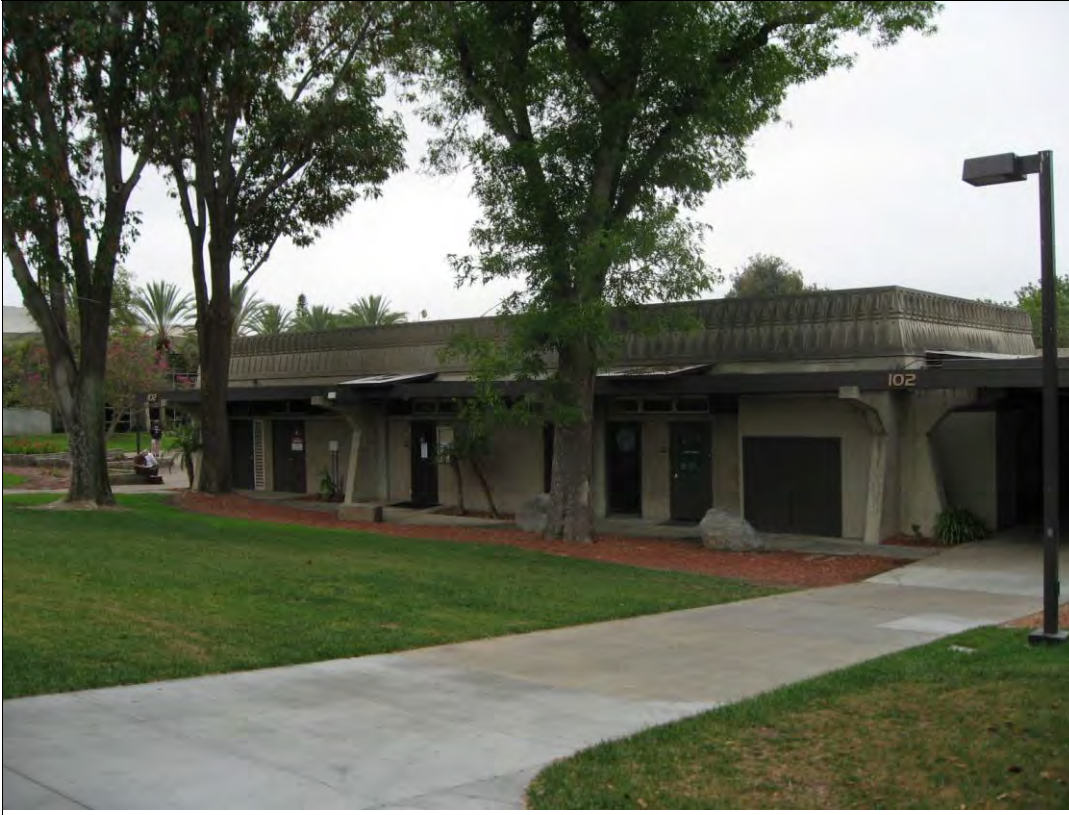
PRIMARY USE: Staff Support

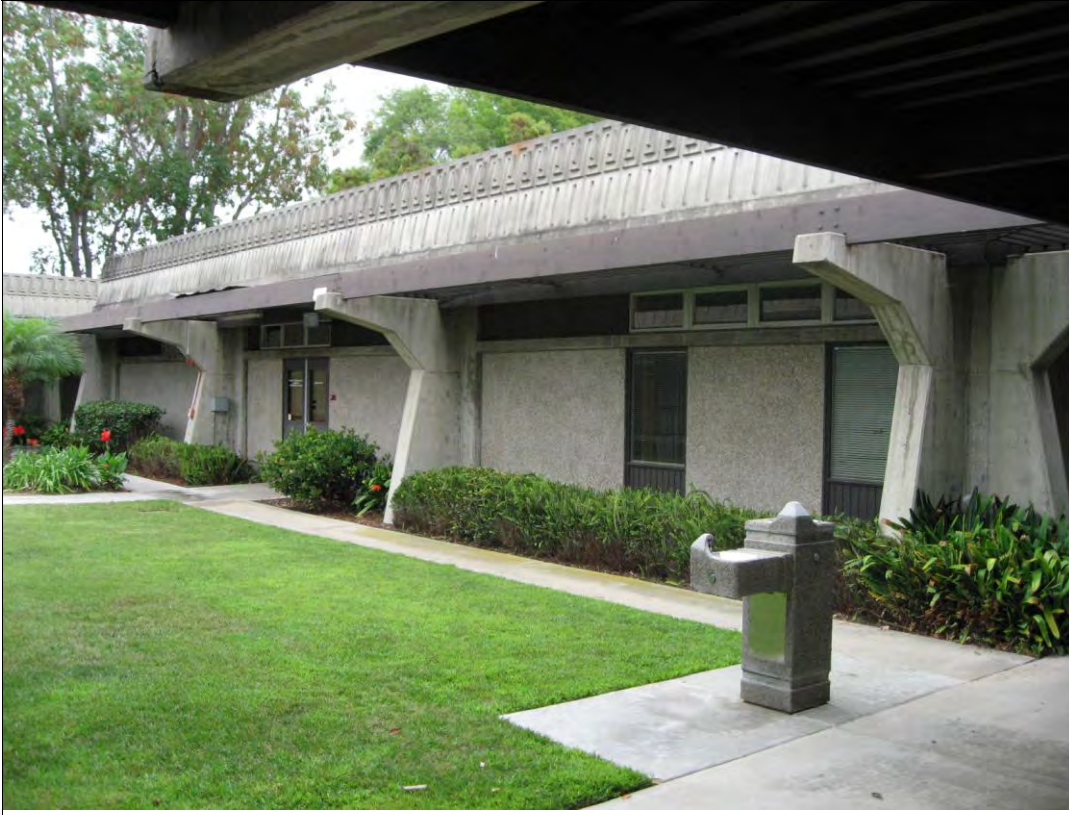
PRIMARY USE: Classroom/Office

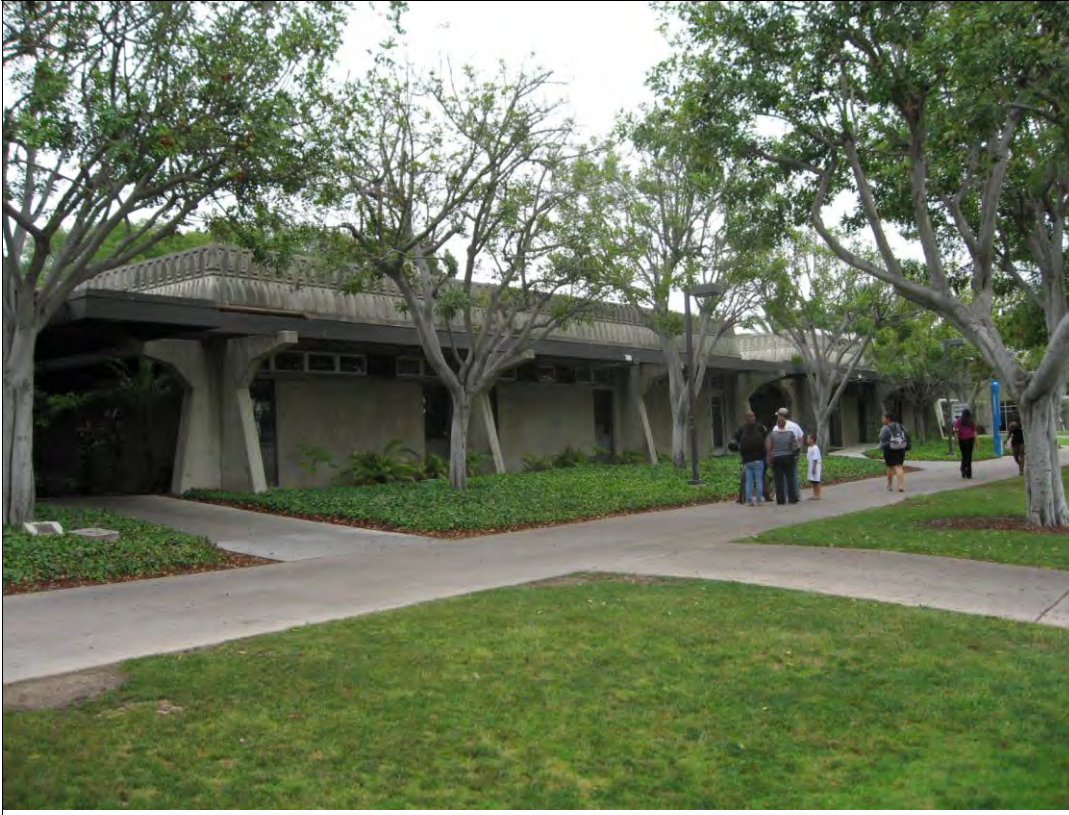
PRIMARY USE: Conference

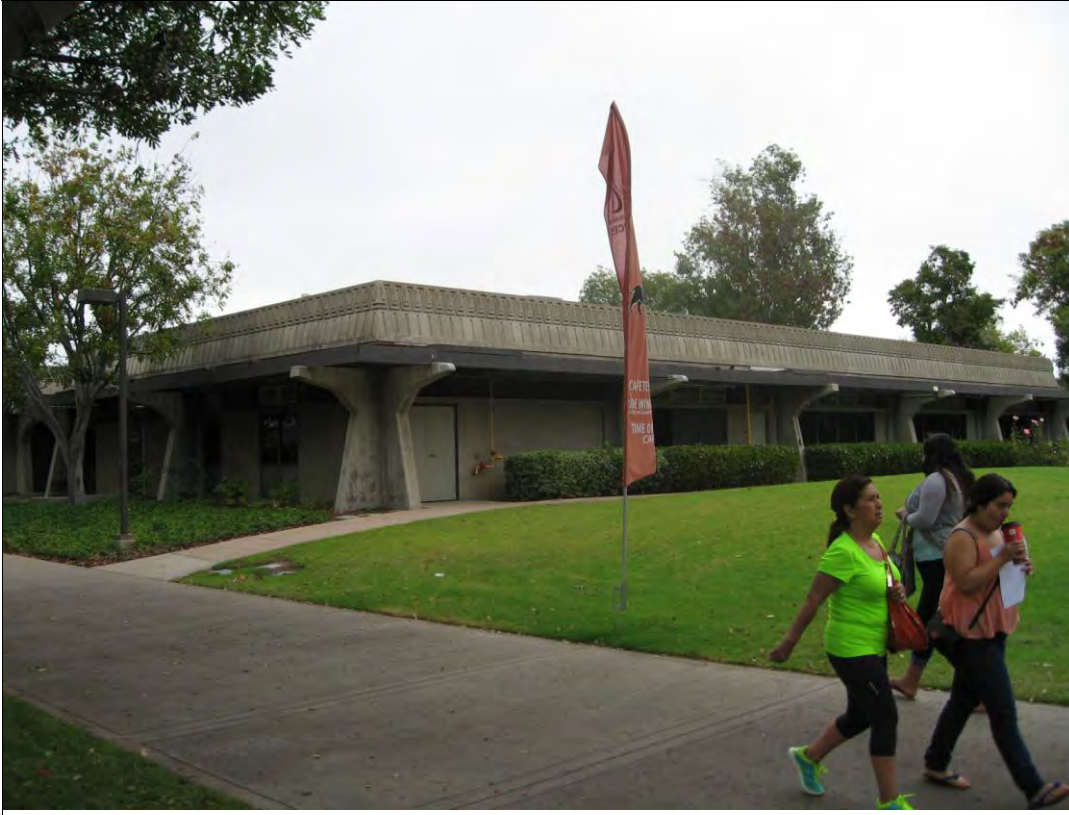
PRIMARY USE: Campus Police

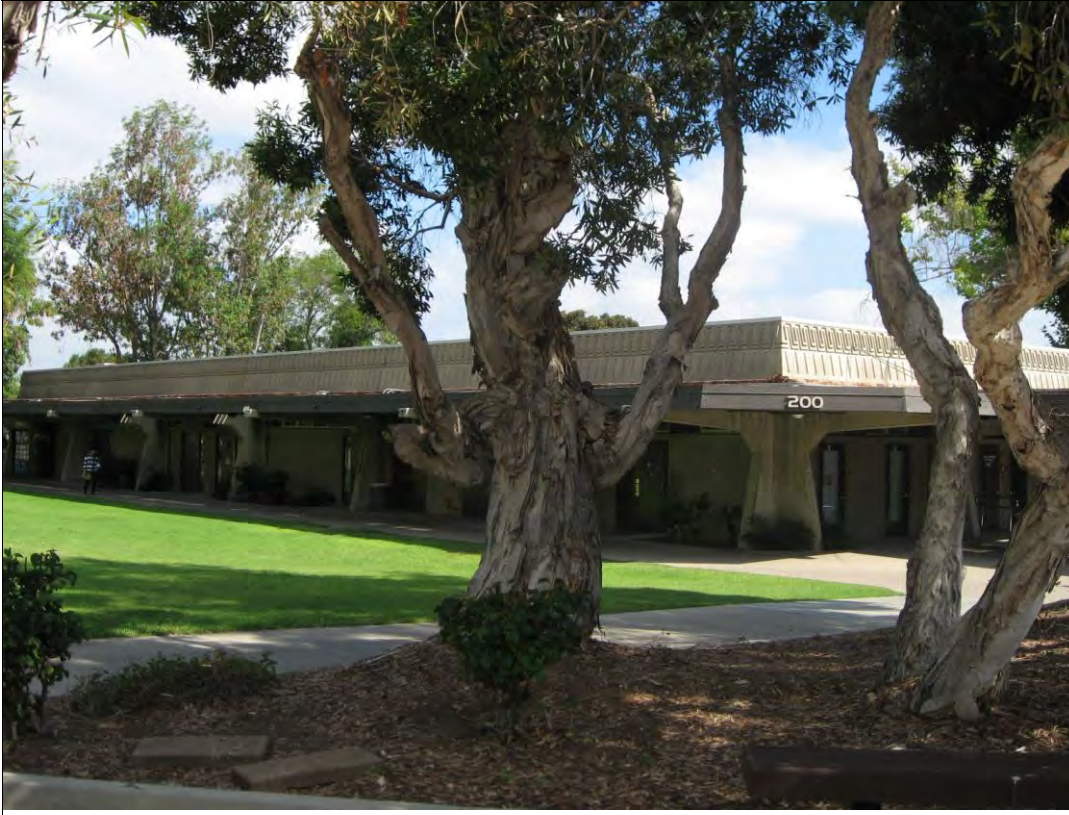
PRIMARY USE: Classroom

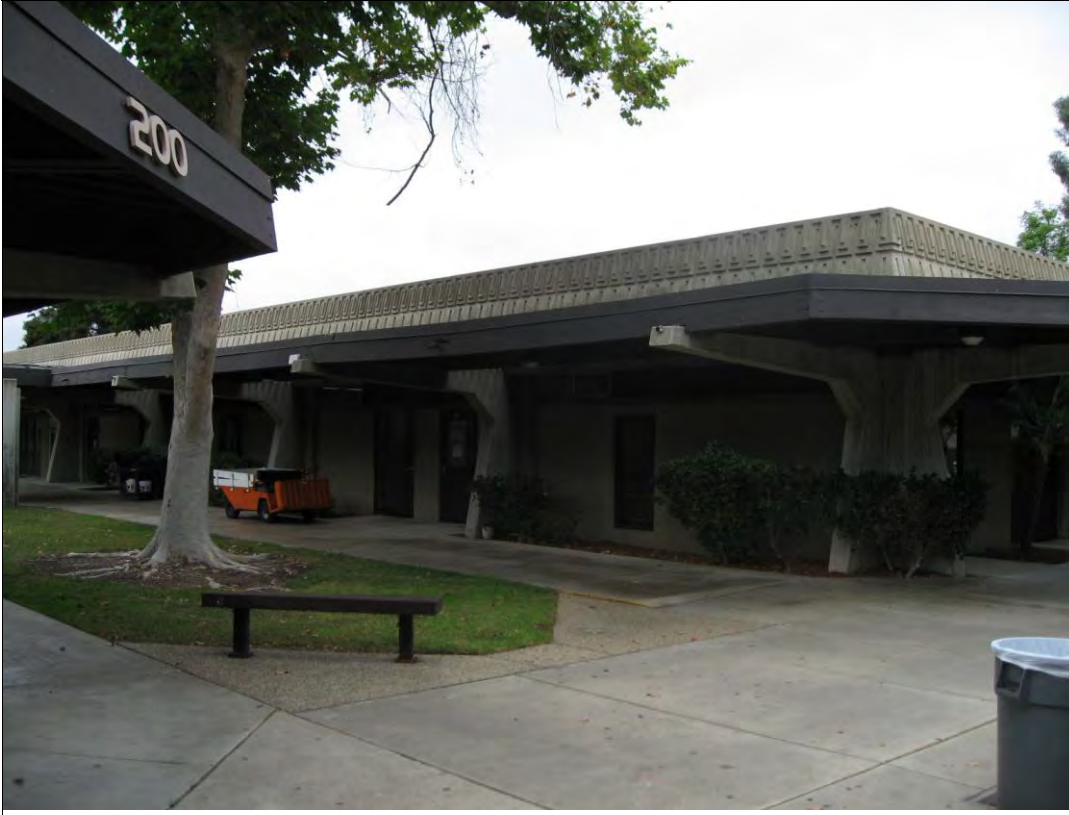
PRIMARY USE: Administration

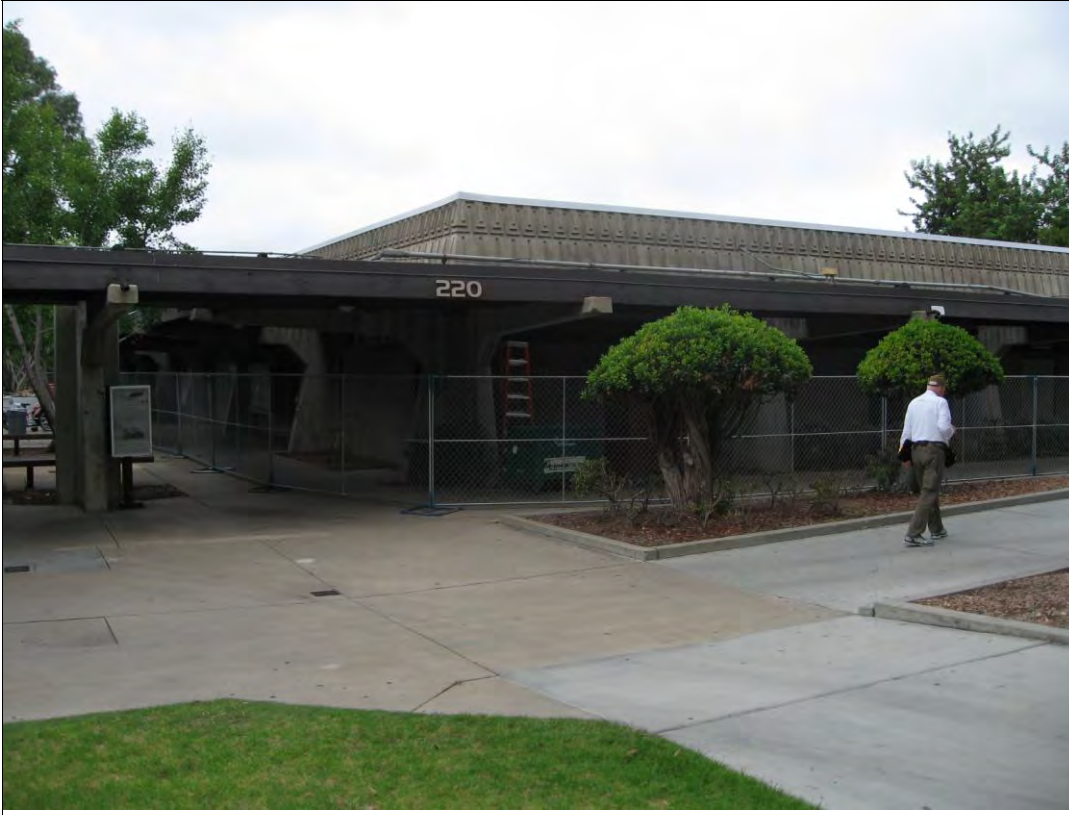
PRIMARY USE: Classroom

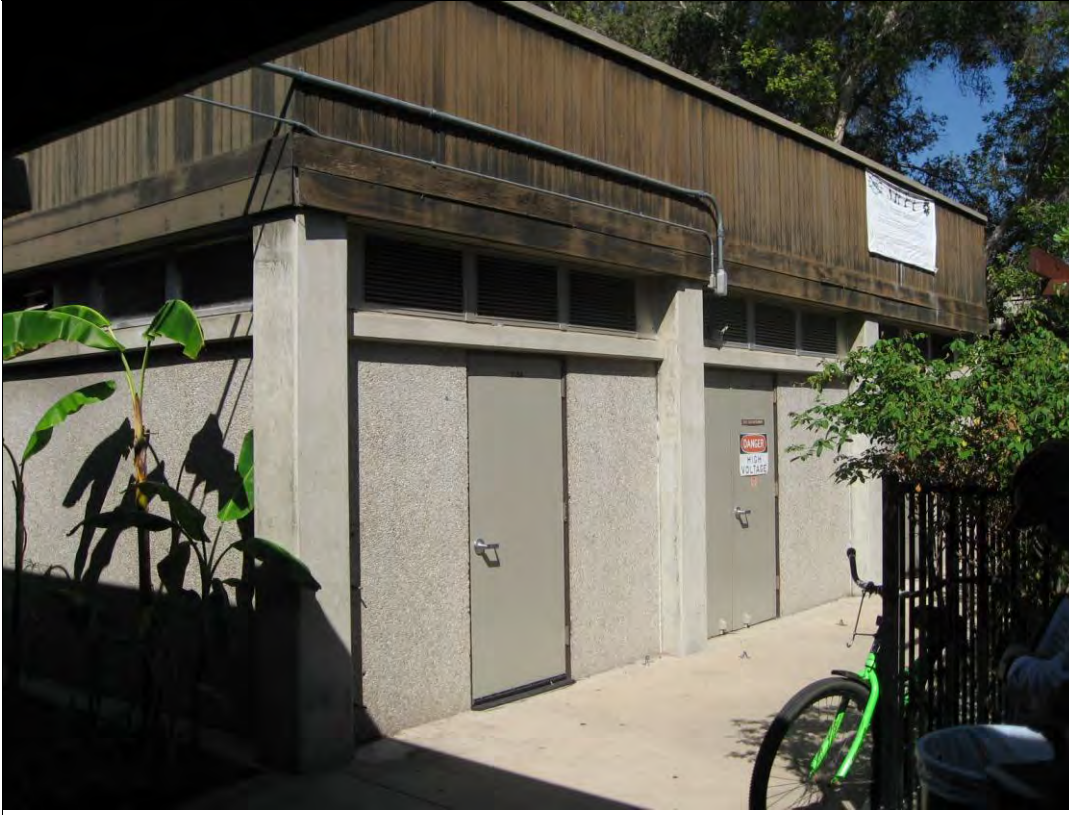
PRIMARY USE: Storage

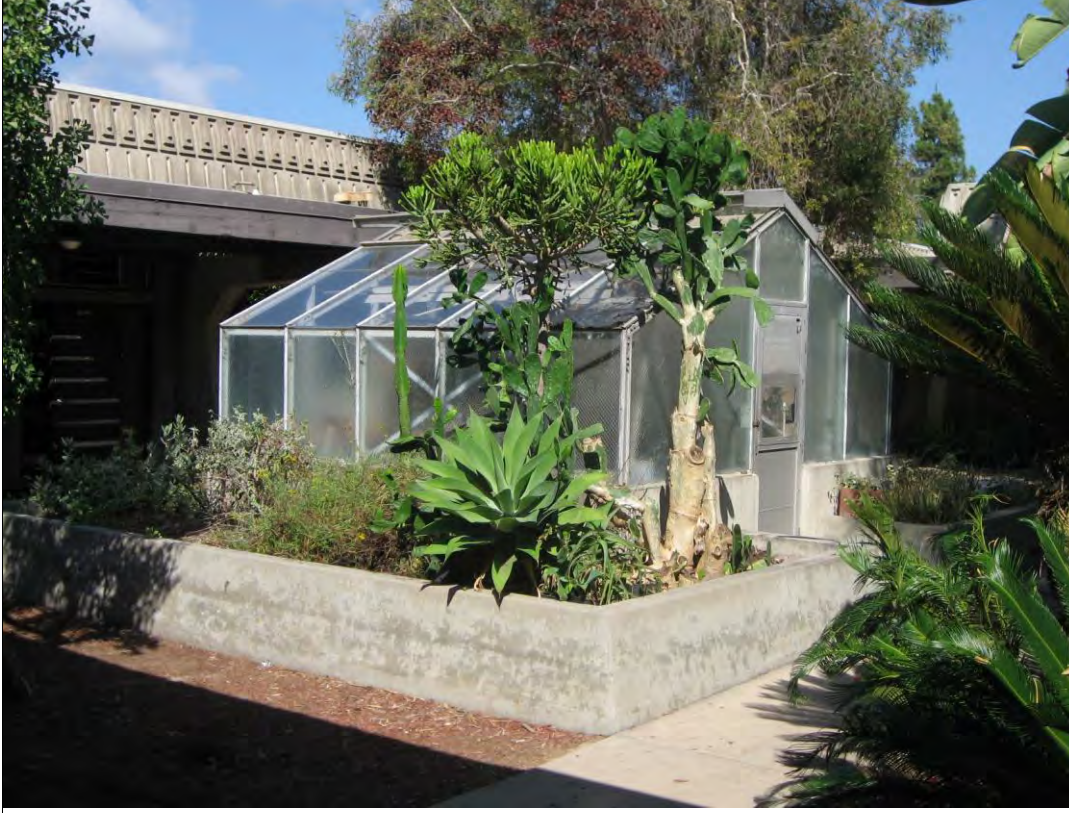
PRIMARY USE: Horticulture

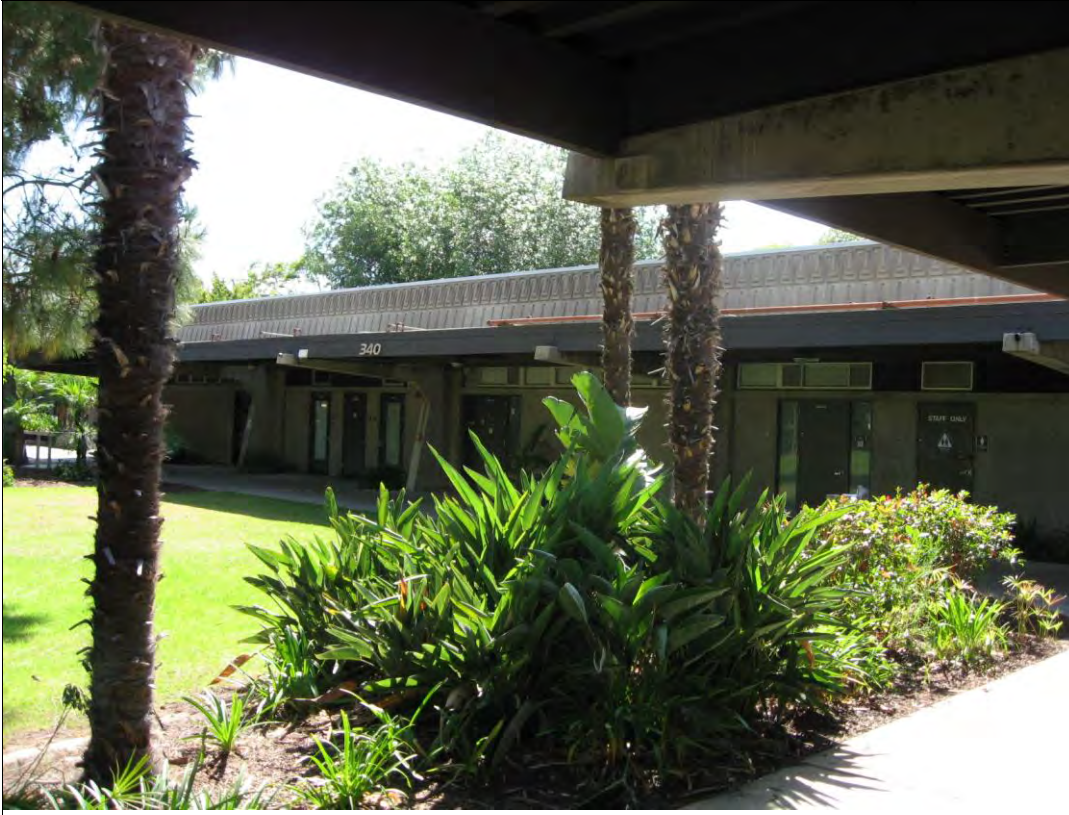
PRIMARY USE: Classroom/Lab

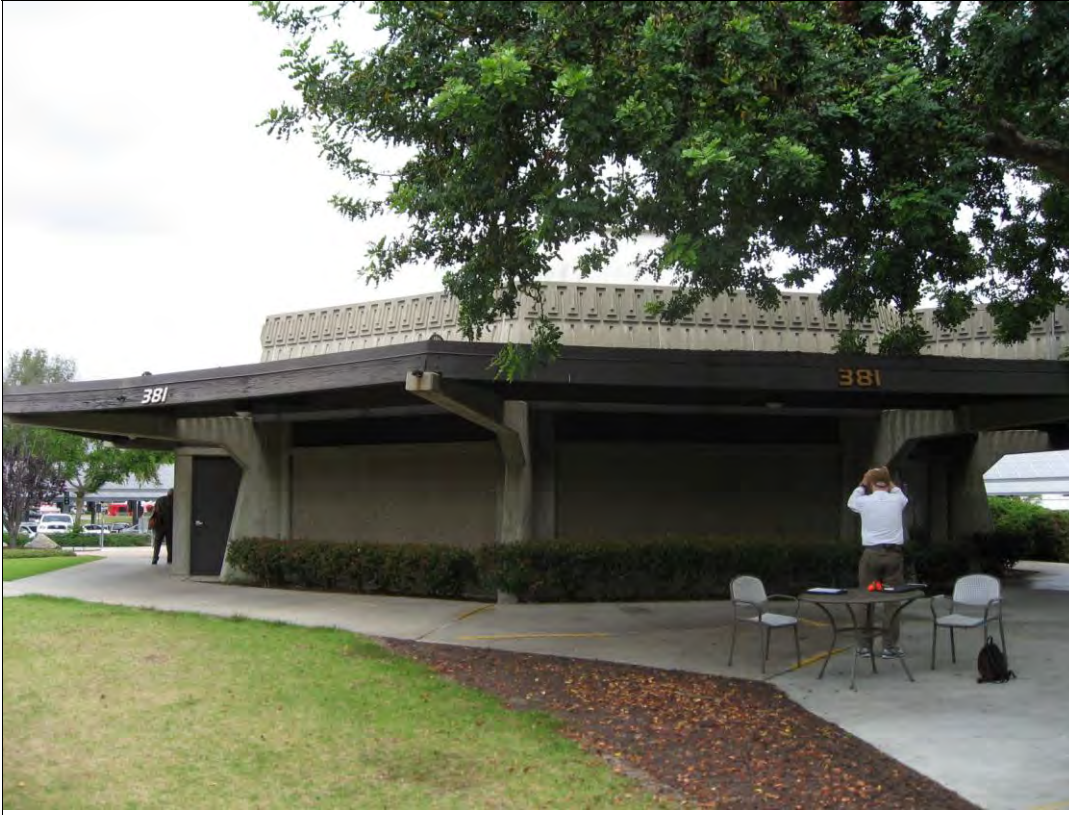
PRIMARY USE: Exhibits

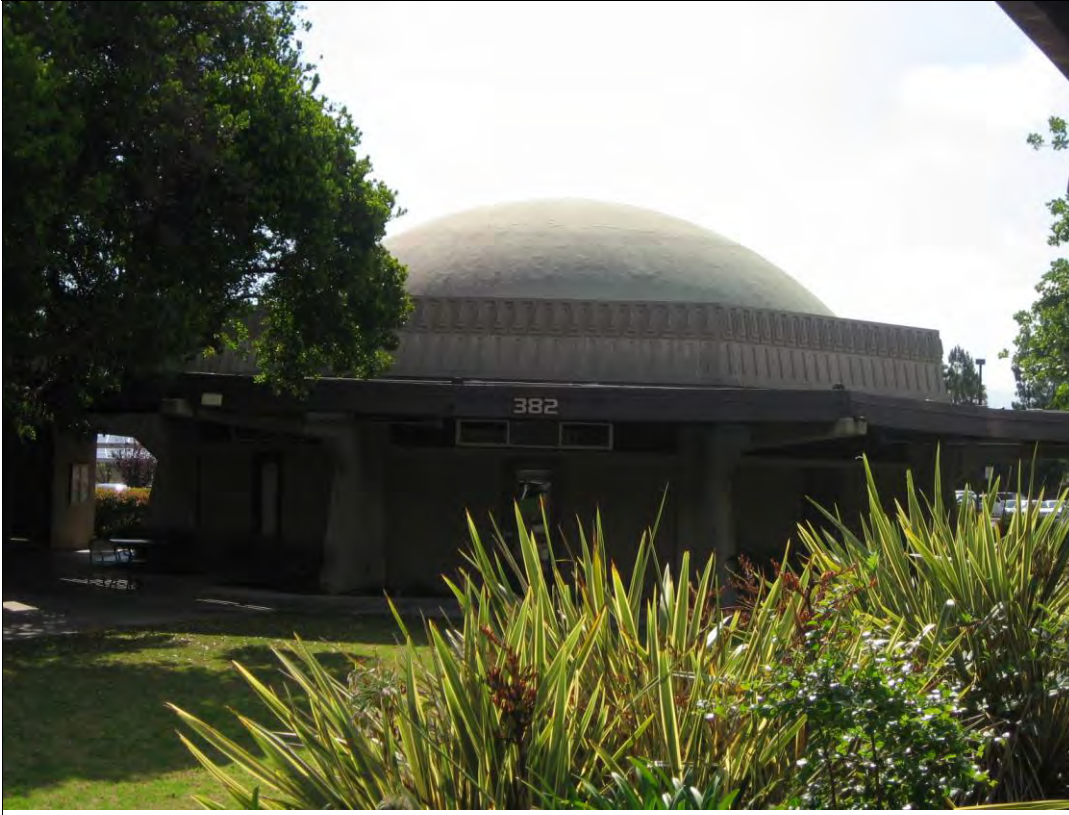
PRIMARY USE: Planetarium/Classroom

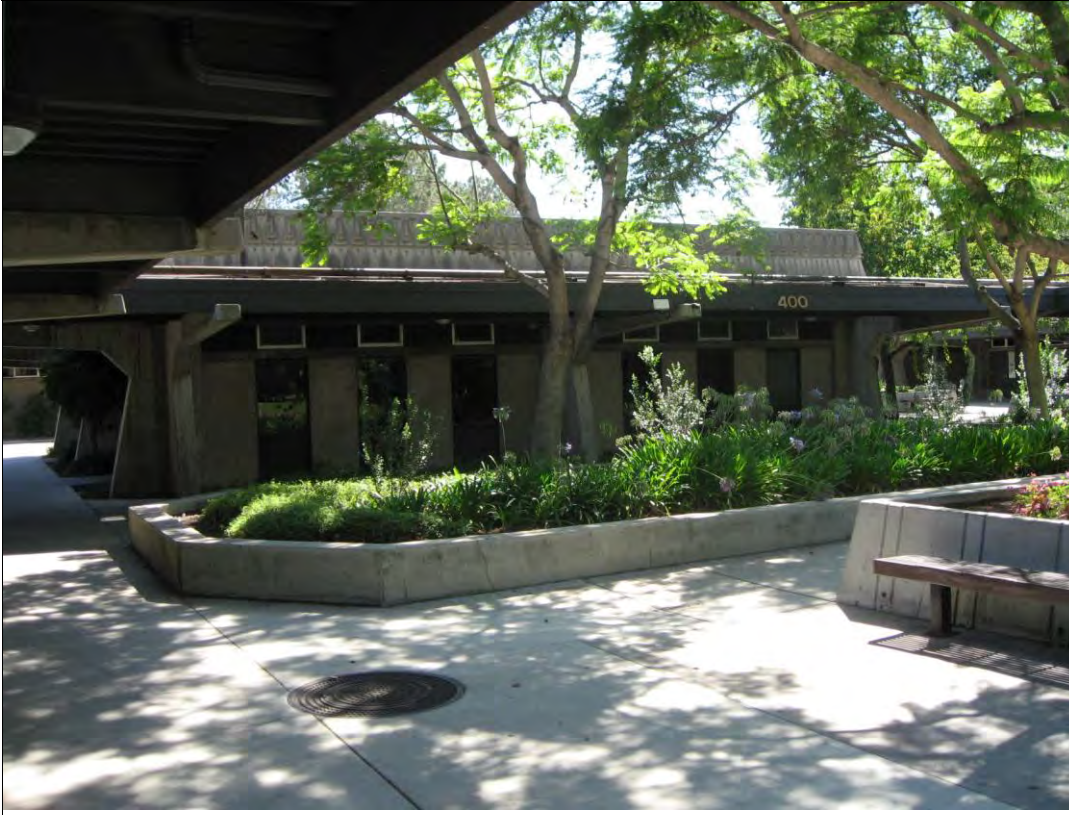
PRIMARY USE: Faculty Offices

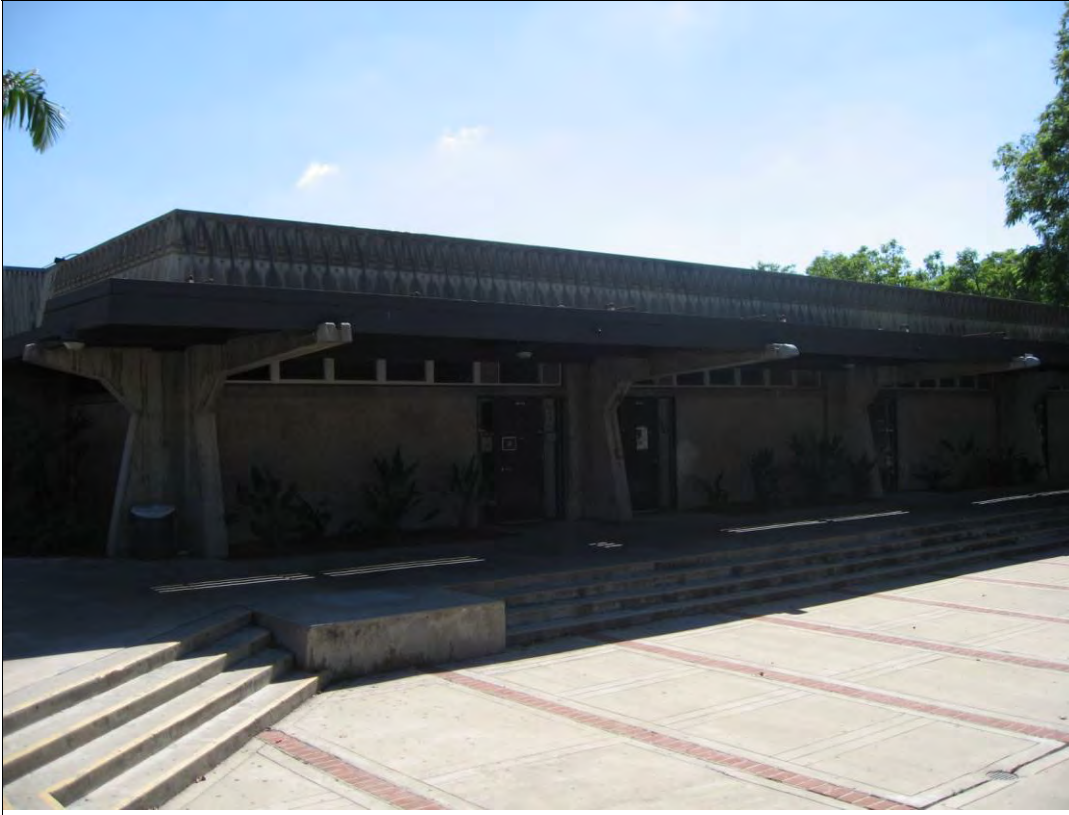
PRIMARY USE: Classroom

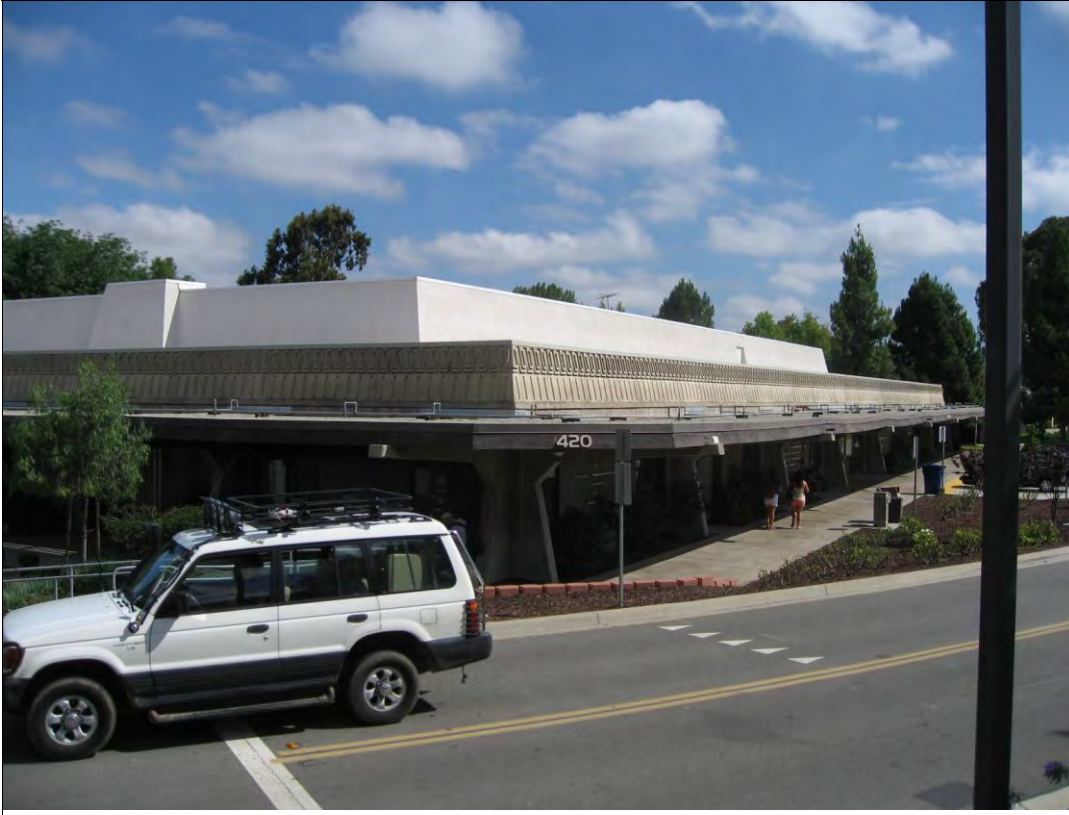
PRIMARY USE: Student Support

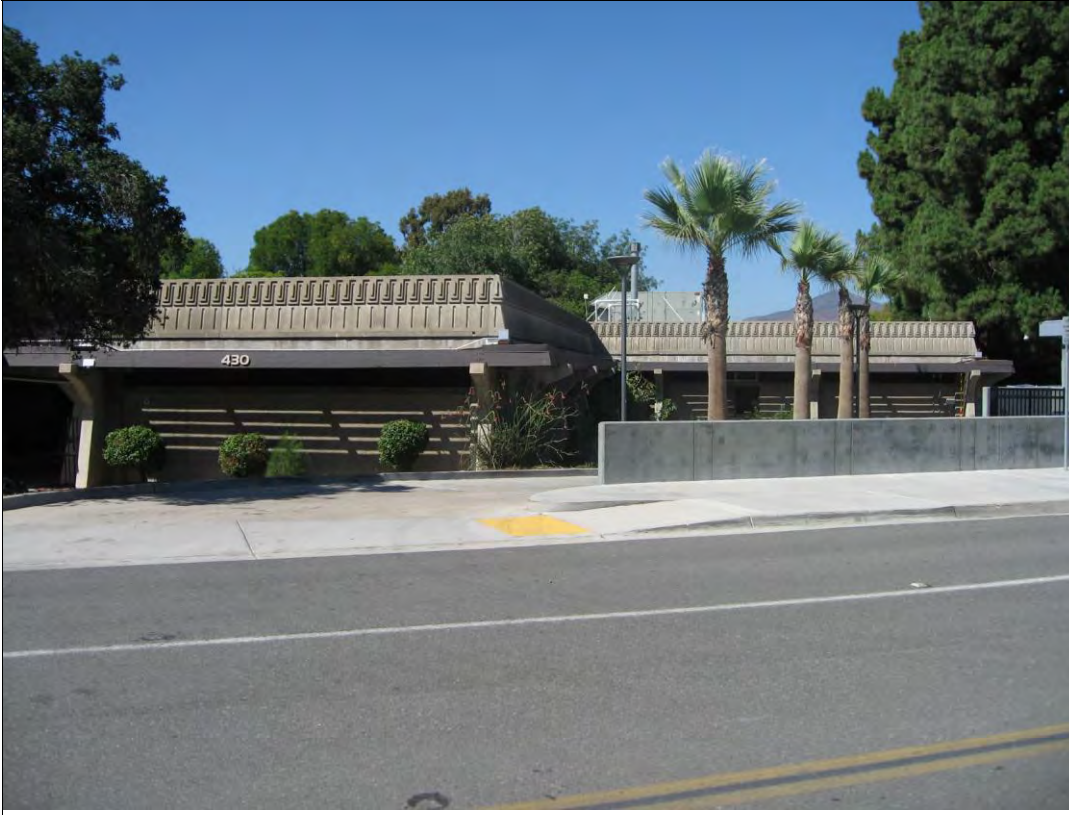
PRIMARY USE: Classroom

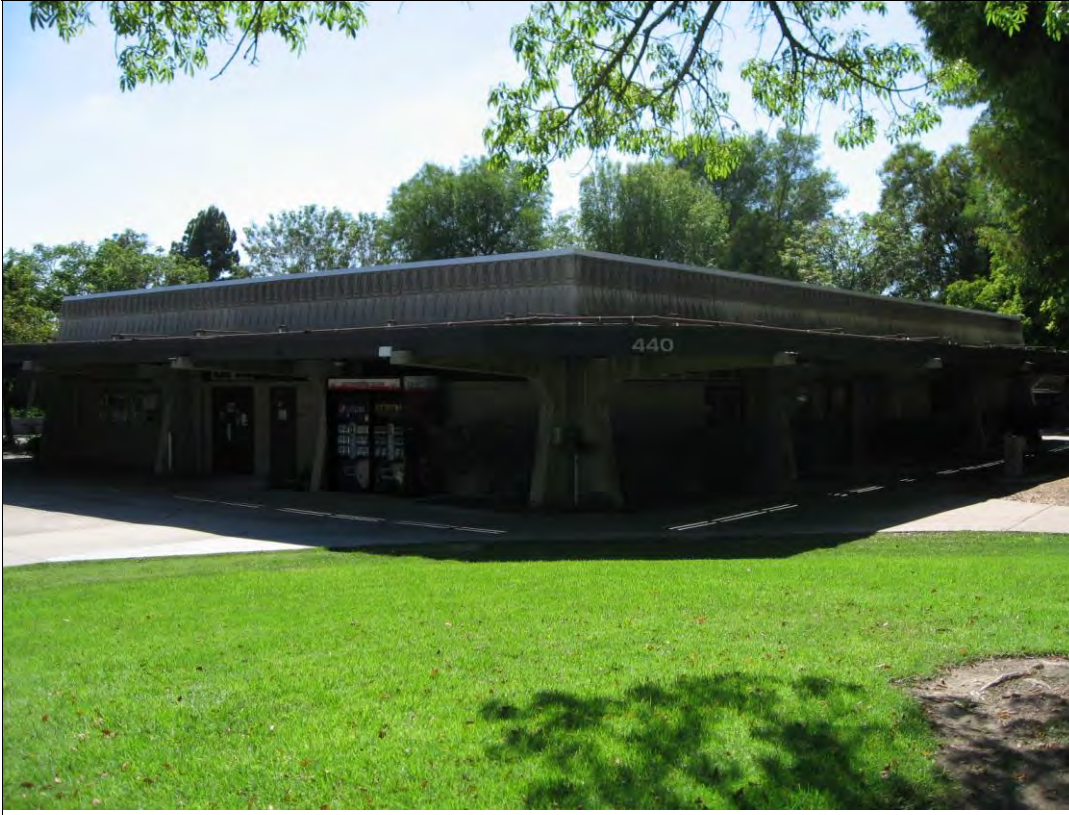
PRIMARY USE: Classroom

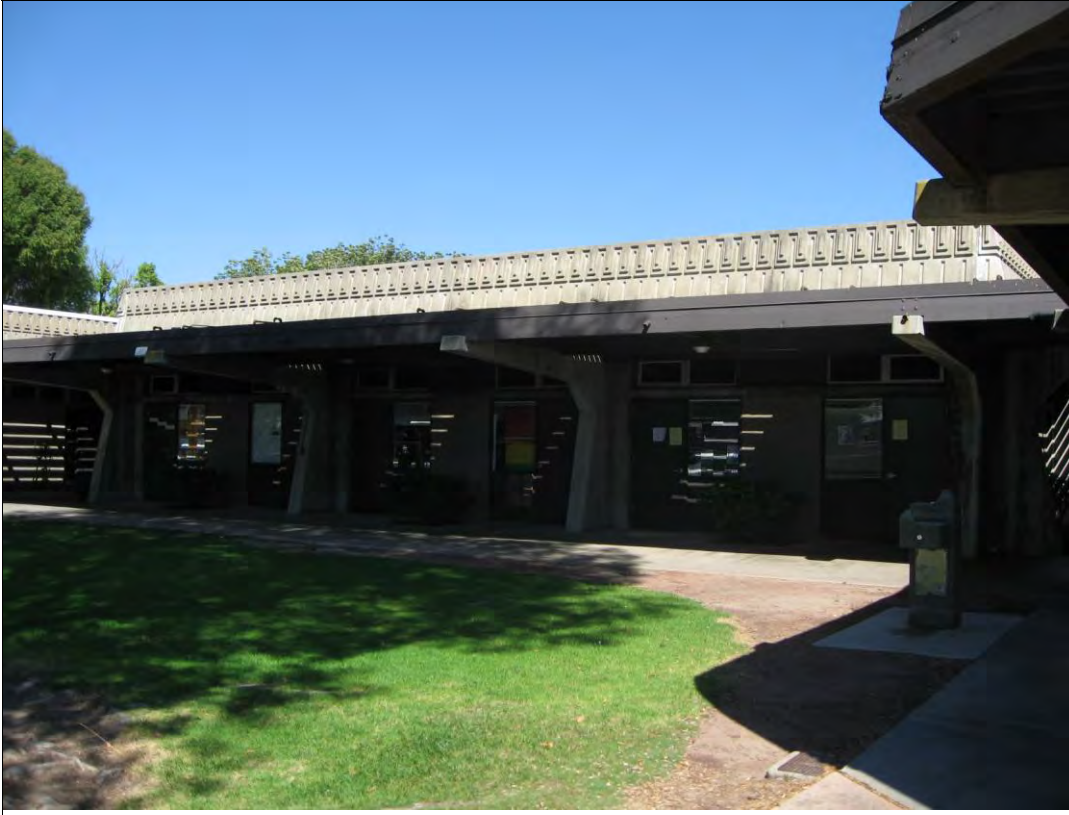
PRIMARY USE: Administration

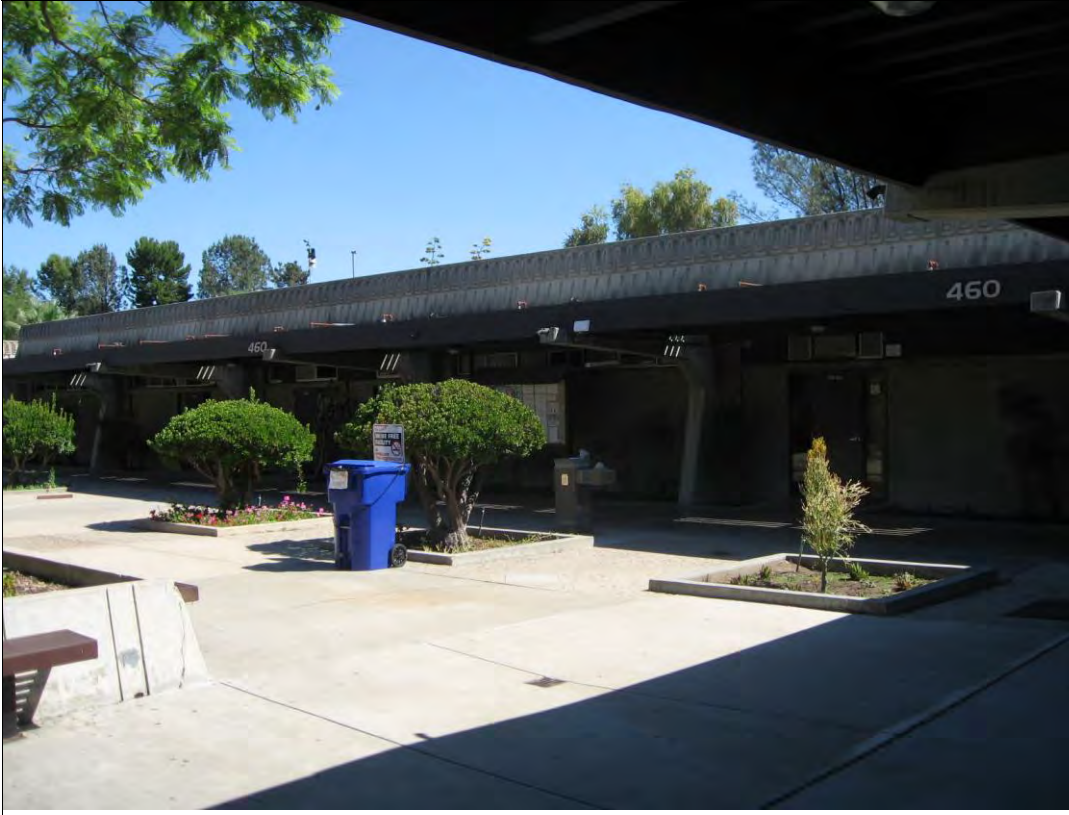
PRIMARY USE: Classroom

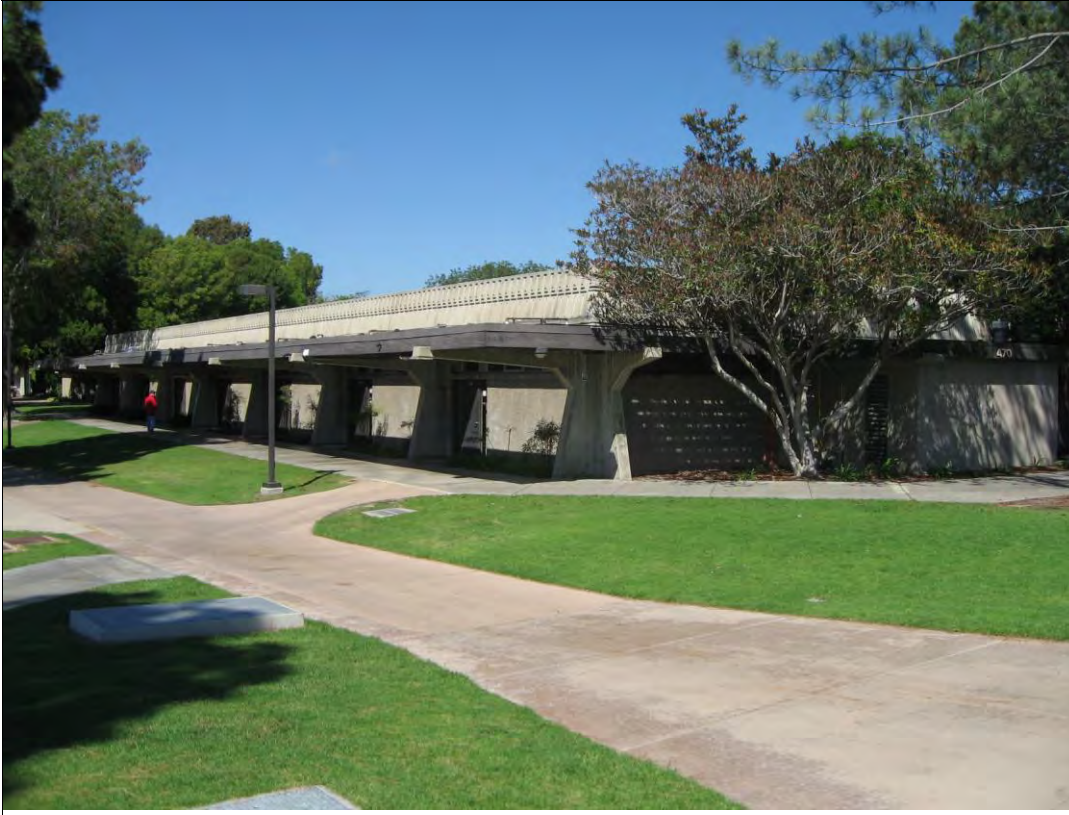
PRIMARY USE: Classroom

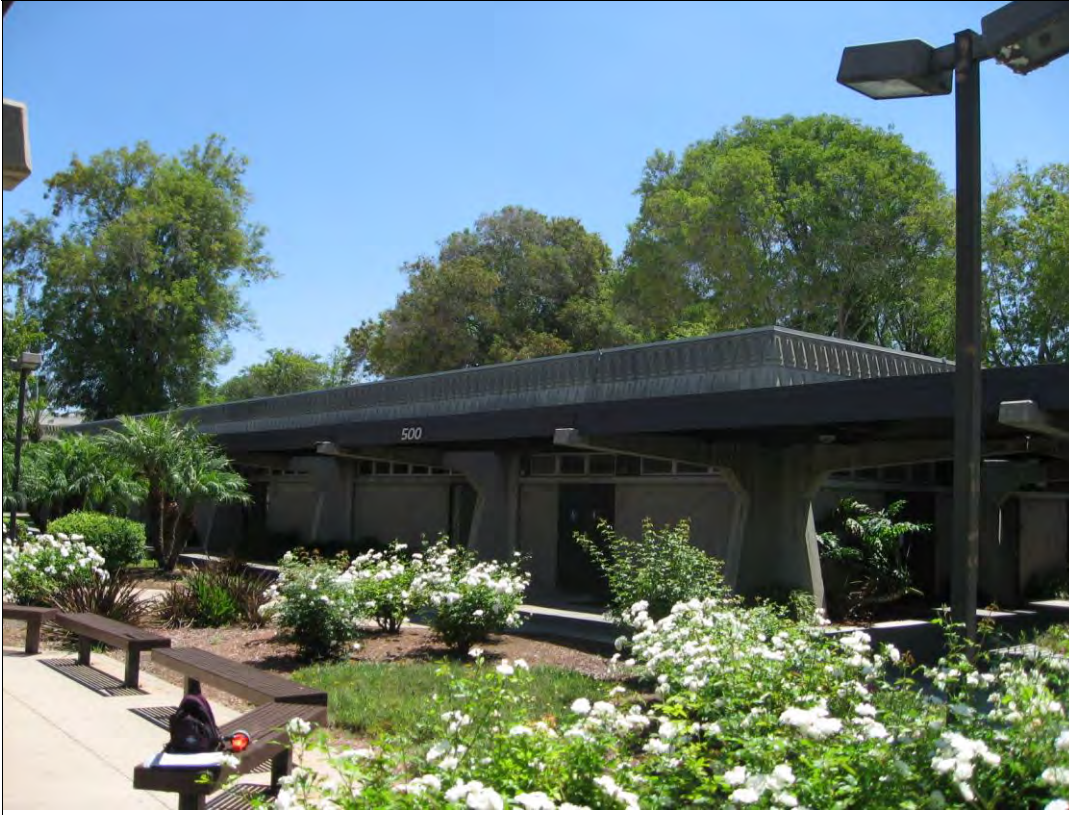
PRIMARY USE: Classroom/Lab

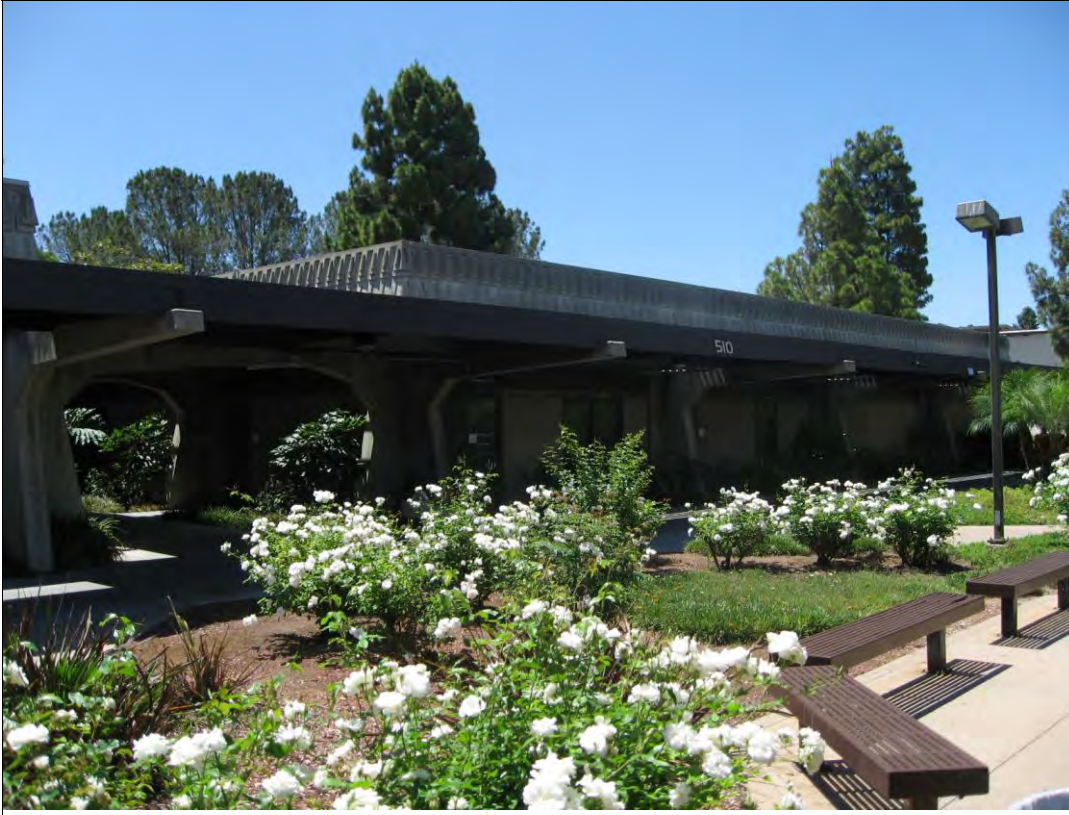
PRIMARY USE: Classroom

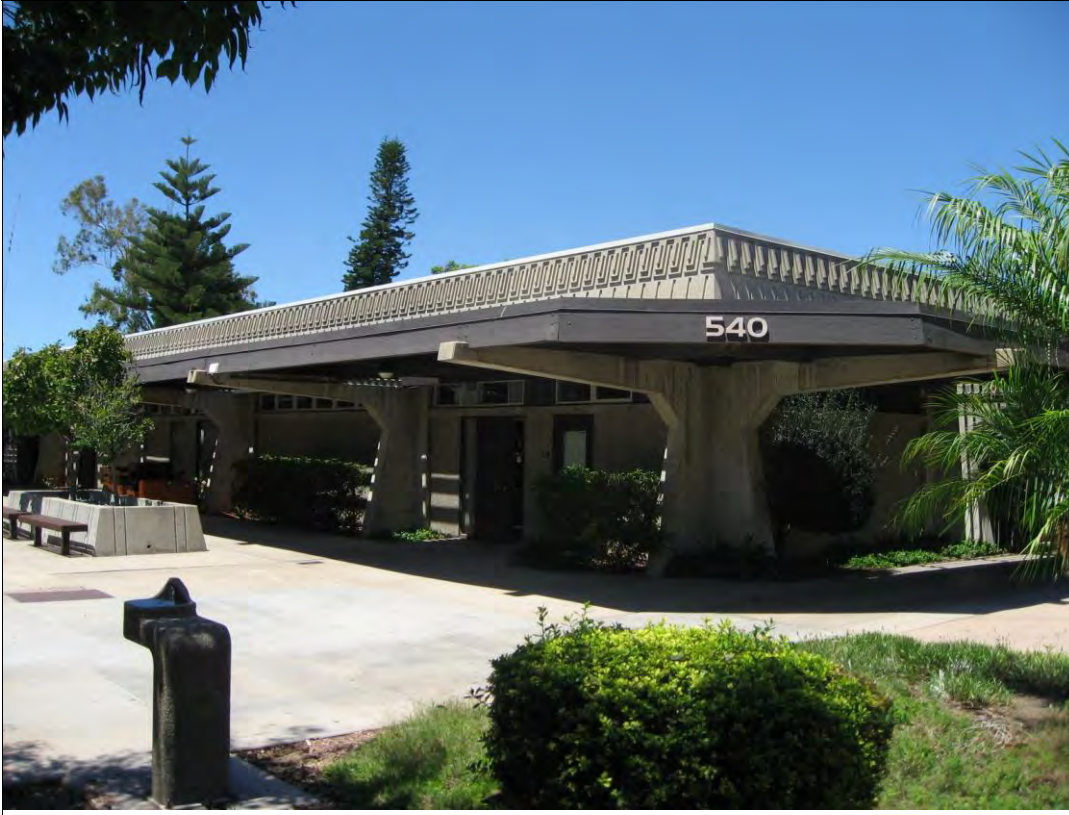
PRIMARY USE: Classroom/Lab

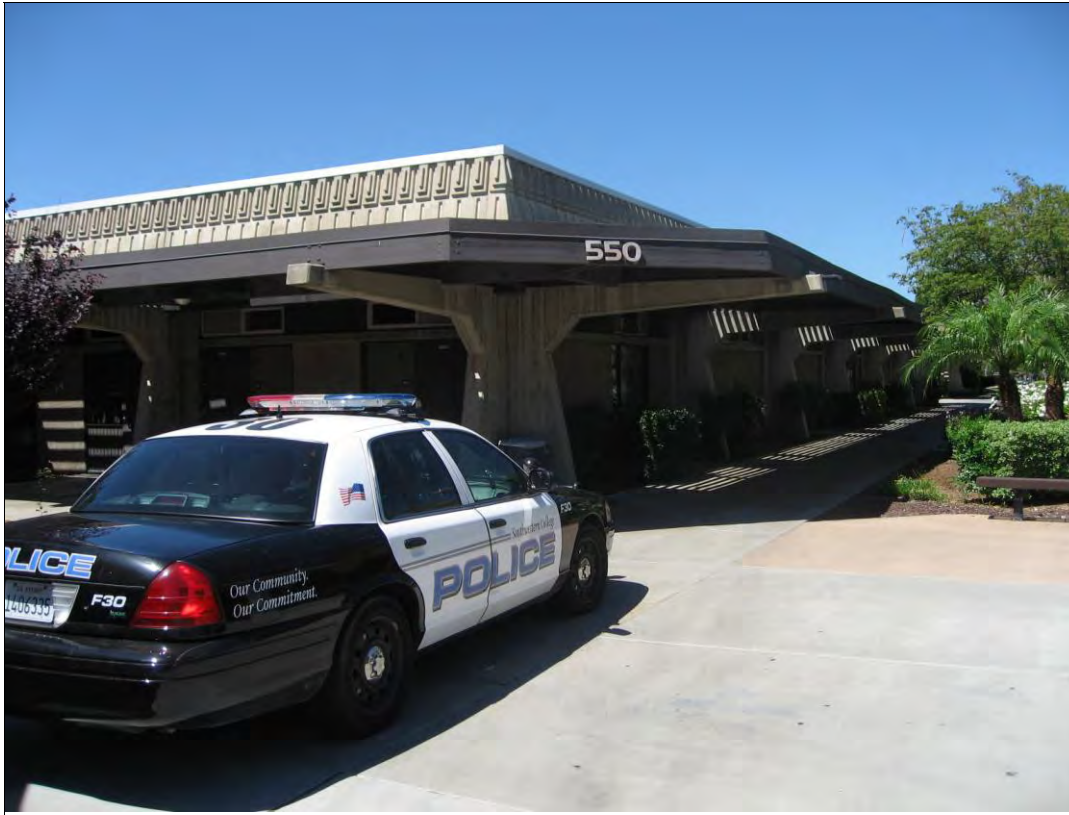
PRIMARY USE: Classroom

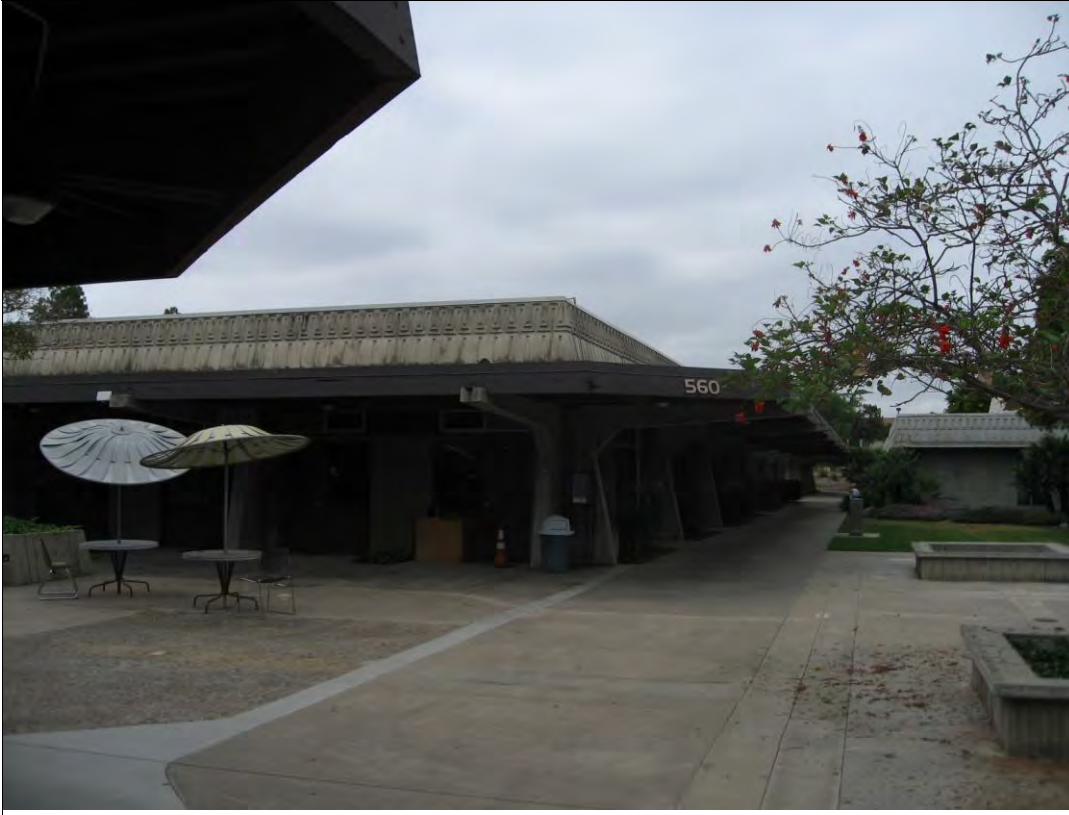
PRIMARY USE: Classroom
