2015 FACILITY CONDITION SURVEY

SOUTHWESTERN COLLEGE

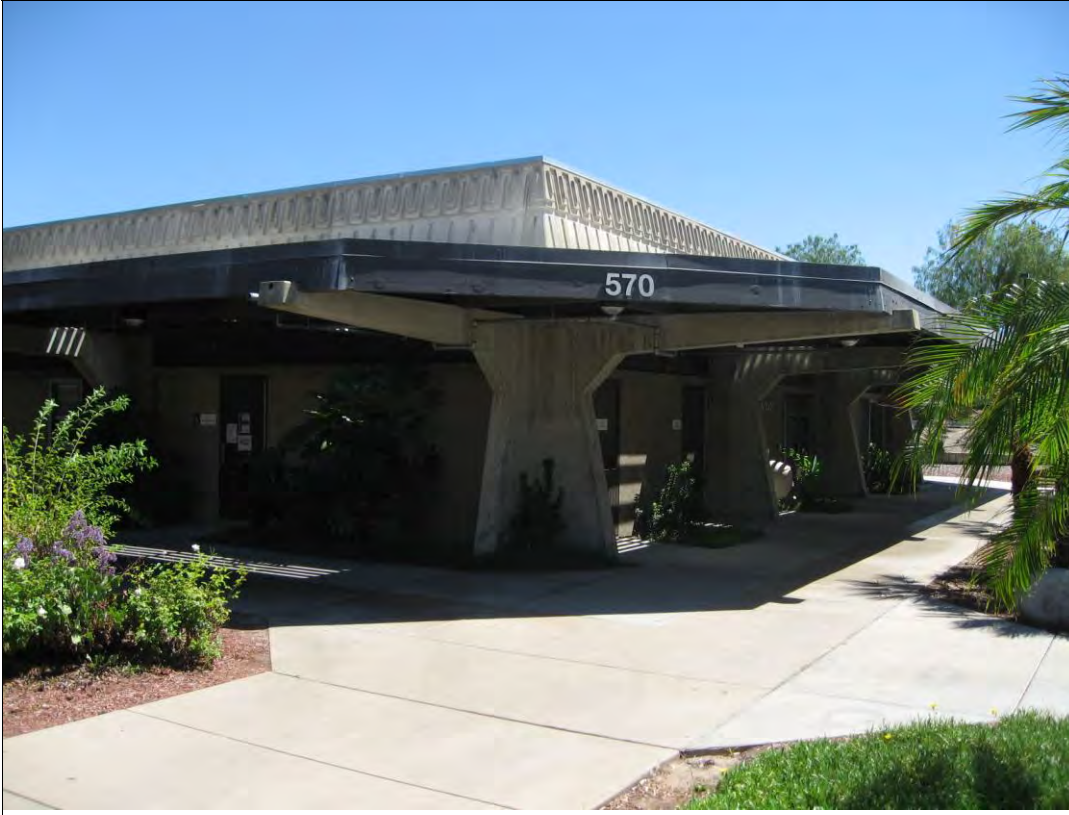
PRIMARY USE: Classroom/Lab

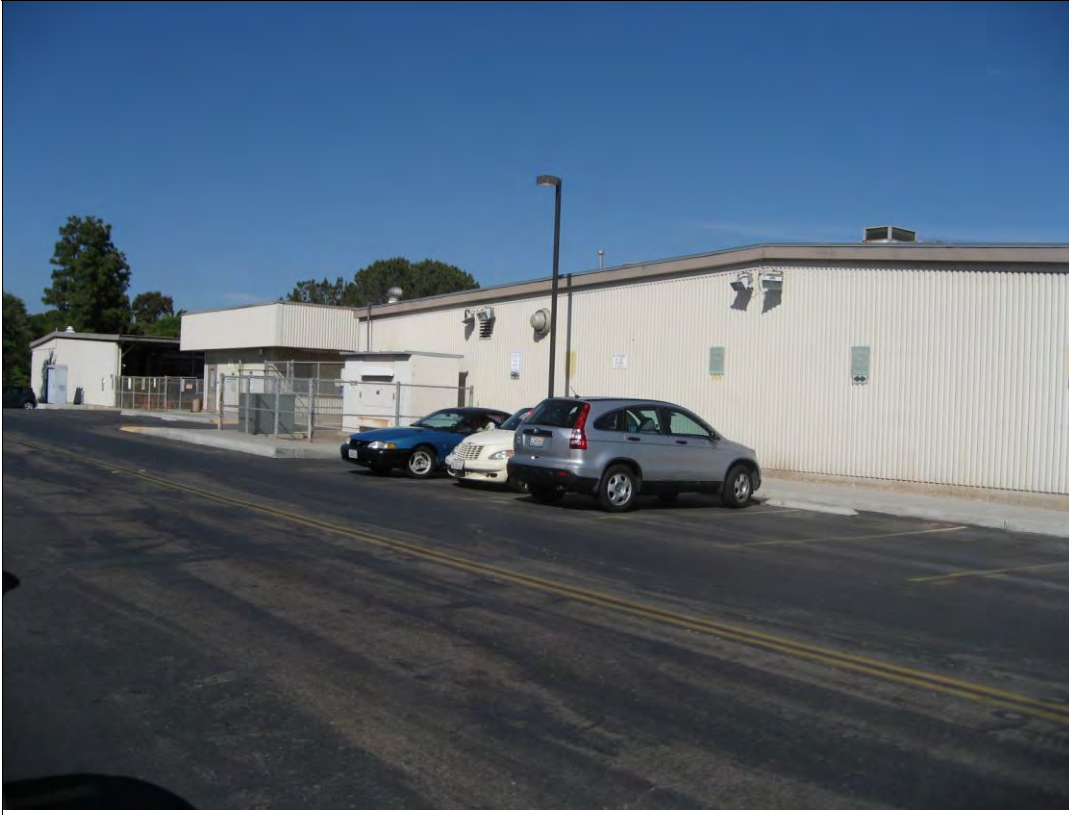
PRIMARY USE: Classroom/Lab

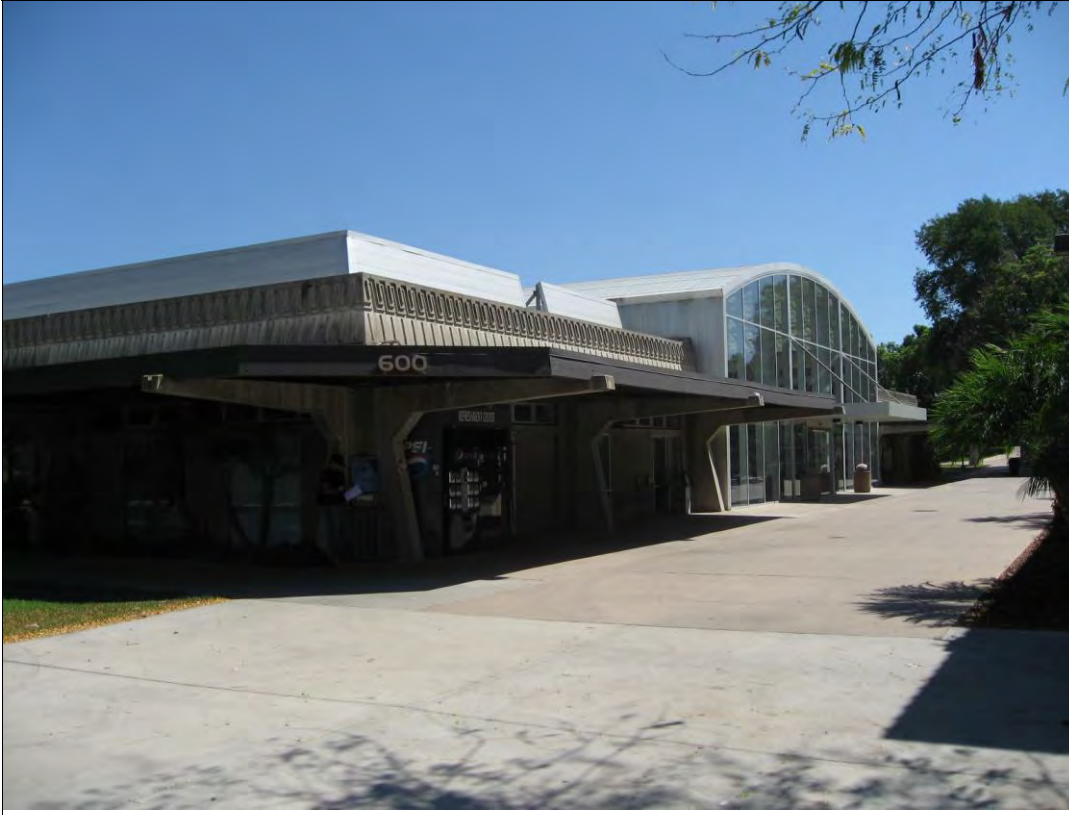
PRIMARY USE: Student Union

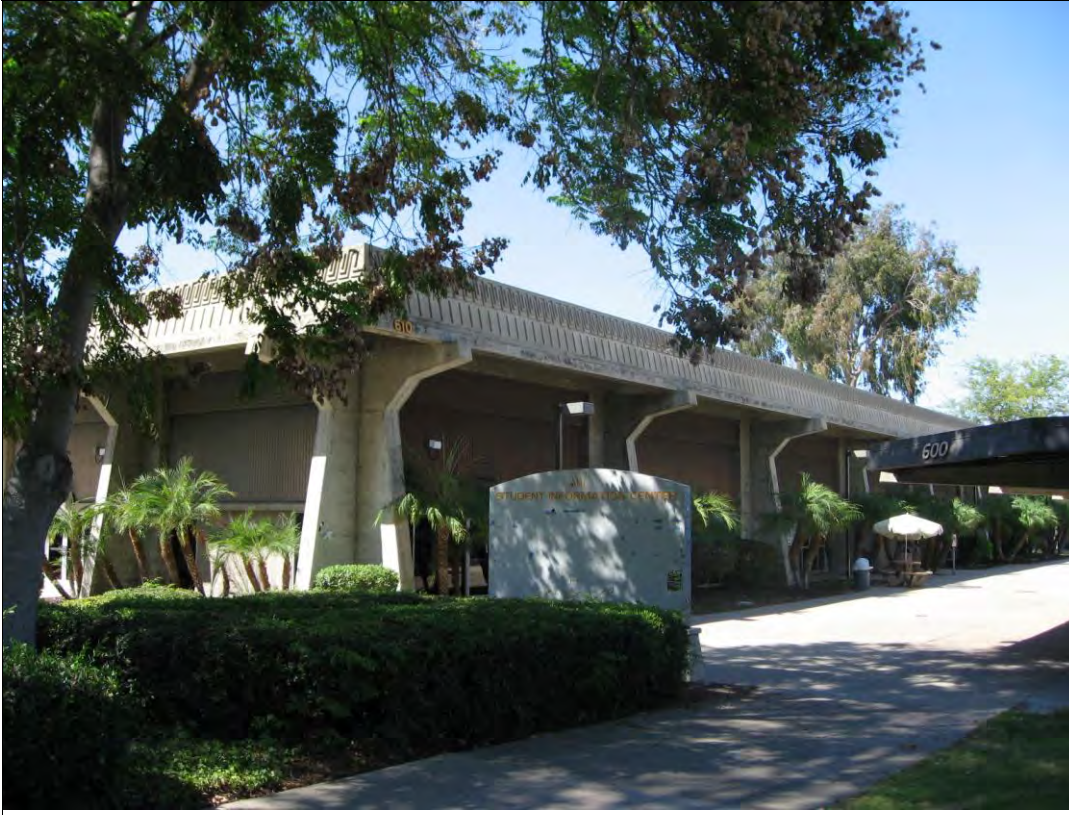
PRIMARY USE: Cafeteria/Dining

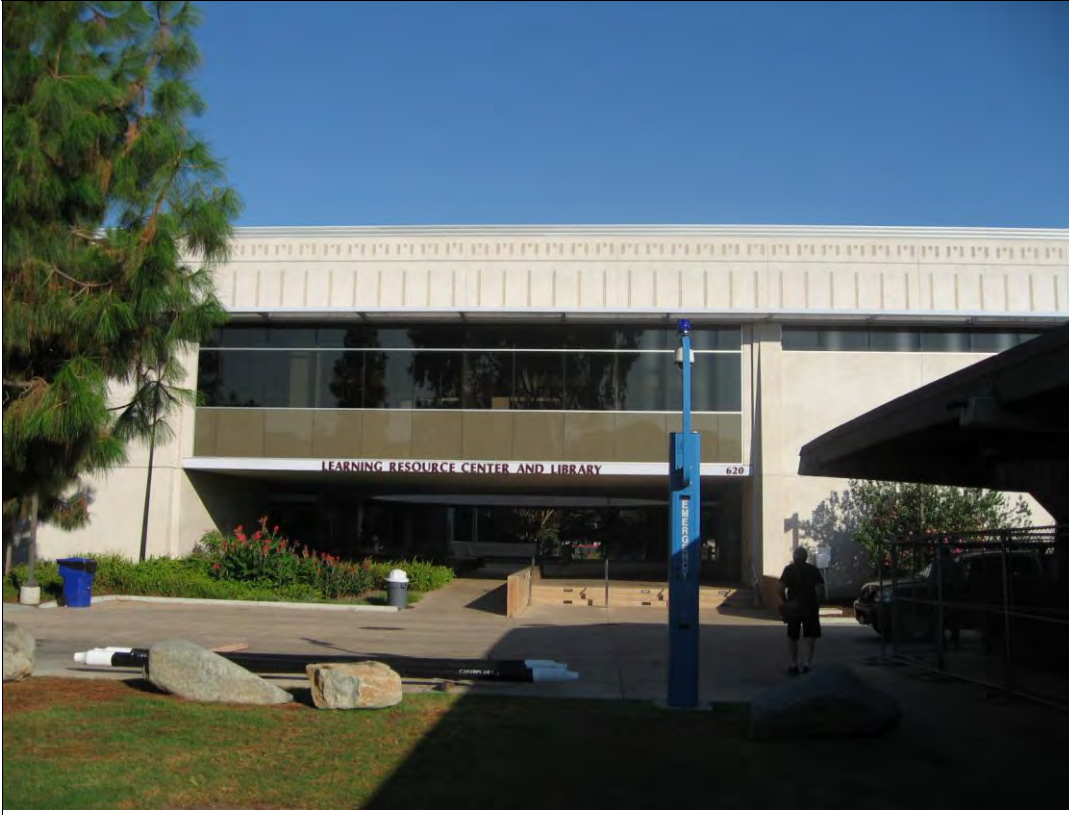
PRIMARY USE: Library

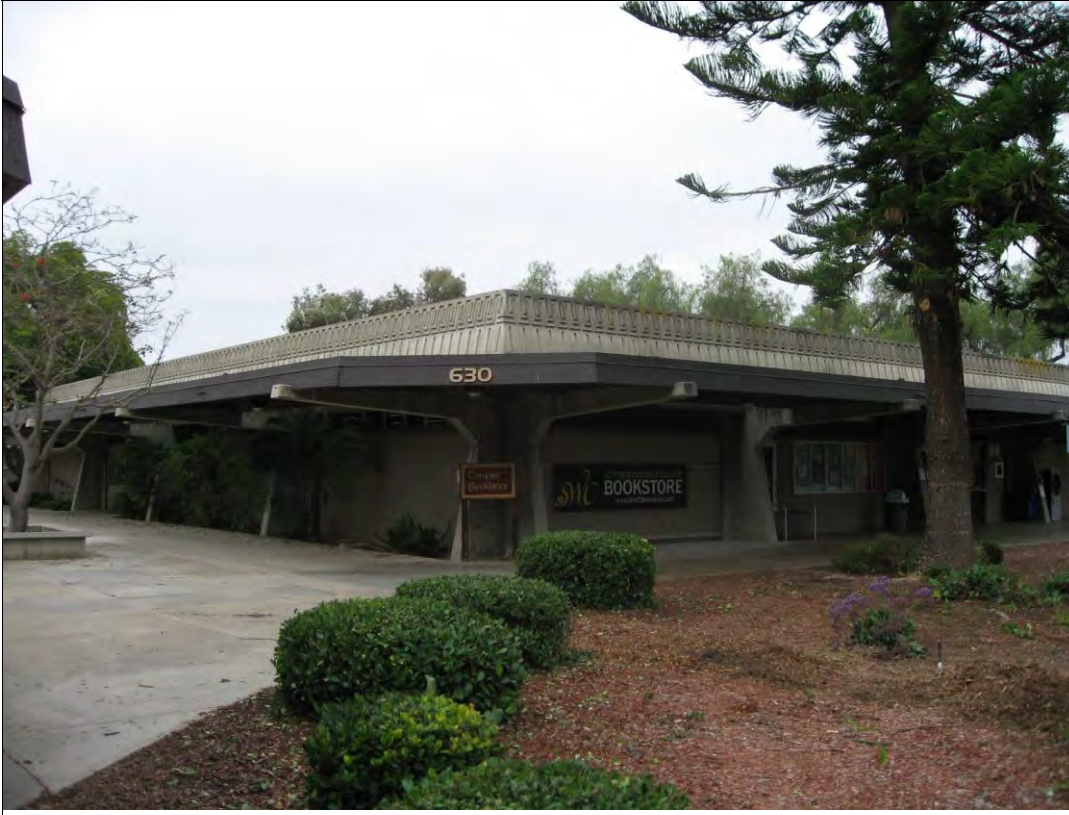
PRIMARY USE: Bookstore

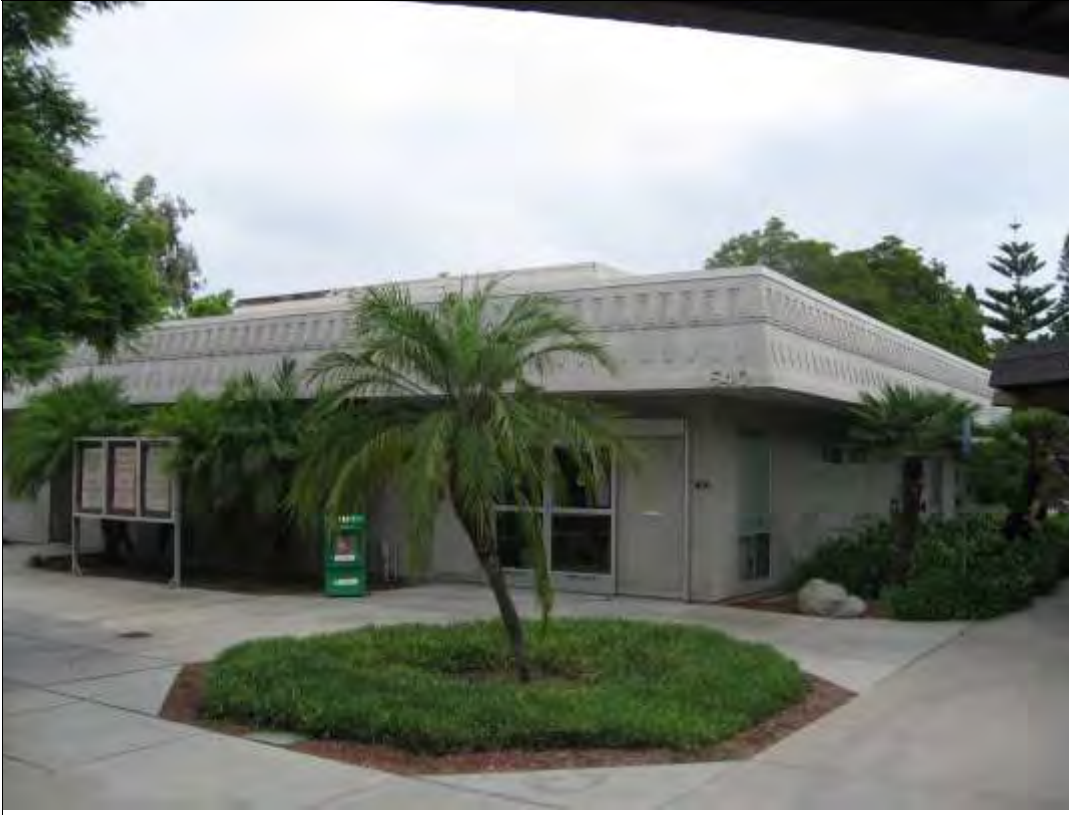
PRIMARY USE: Classroom/Office

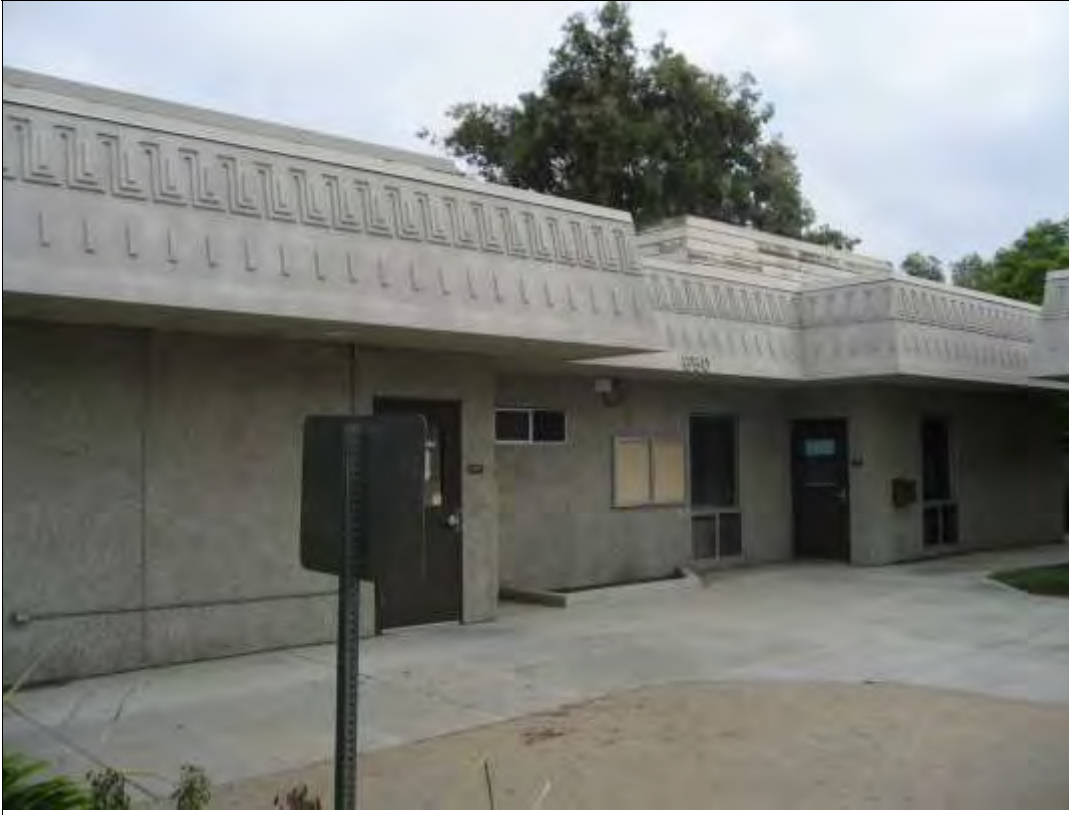
PRIMARY USE: Student Support

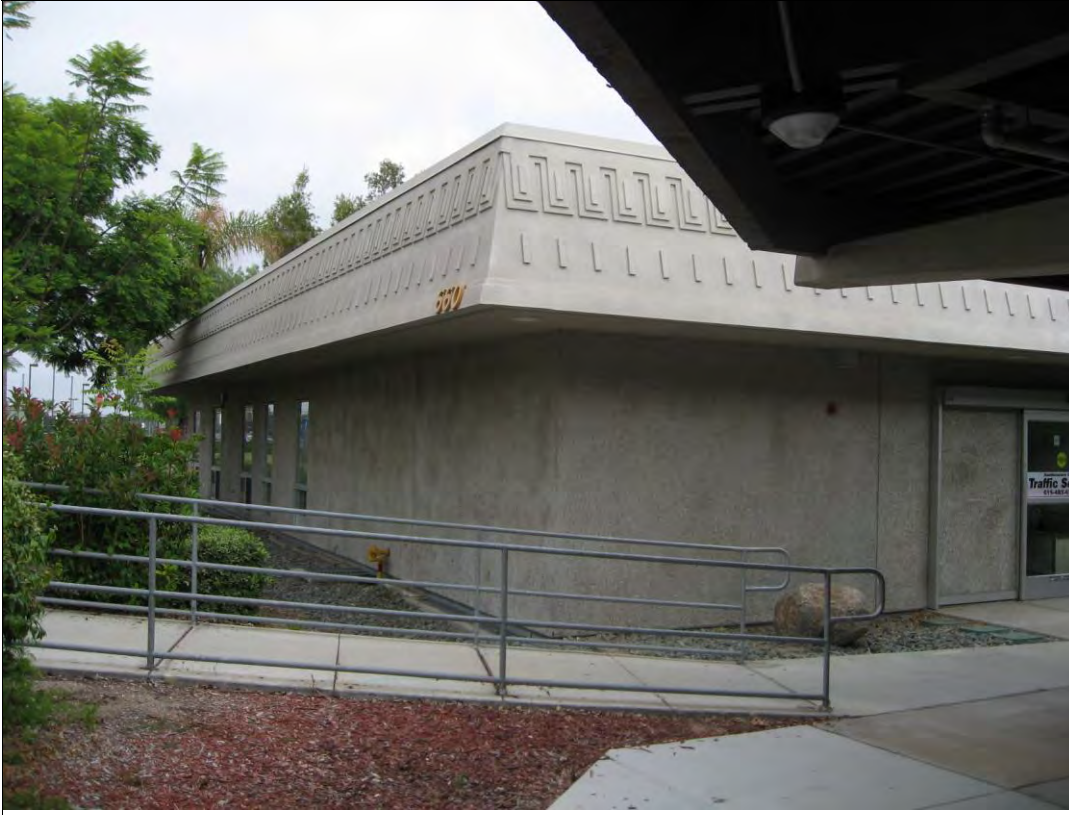
PRIMARY USE: Continuing Education

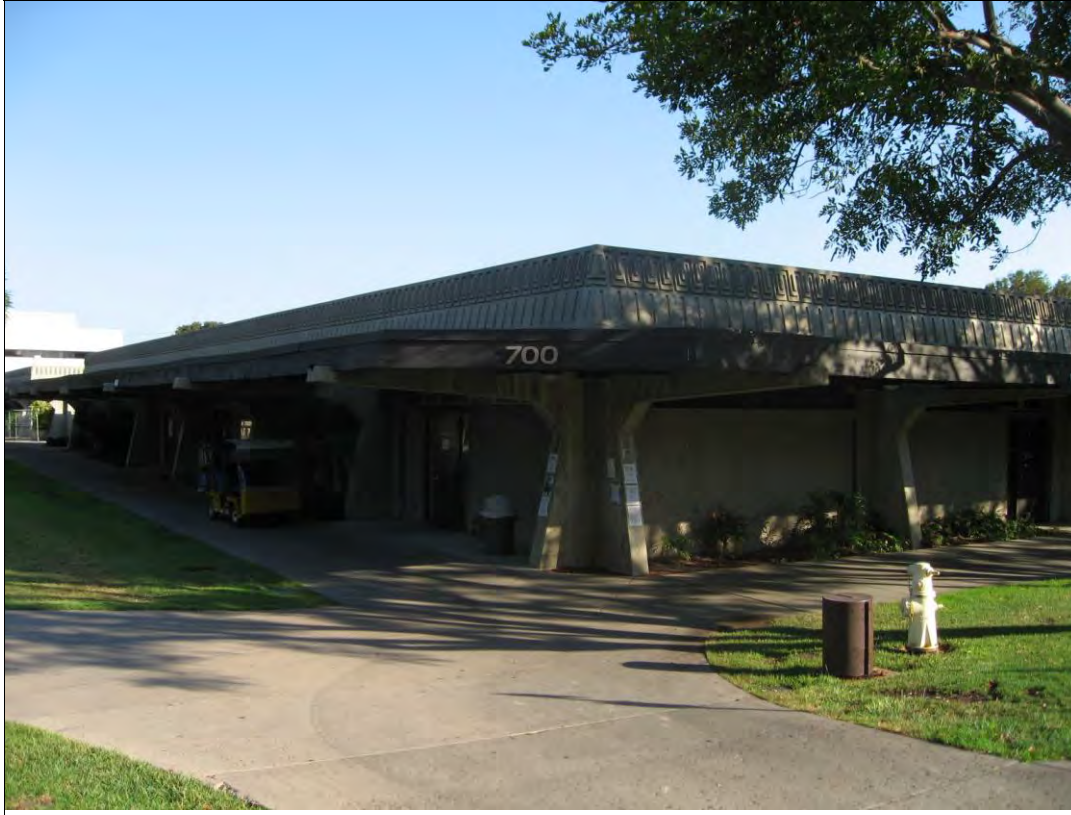
PRIMARY USE: Classroom

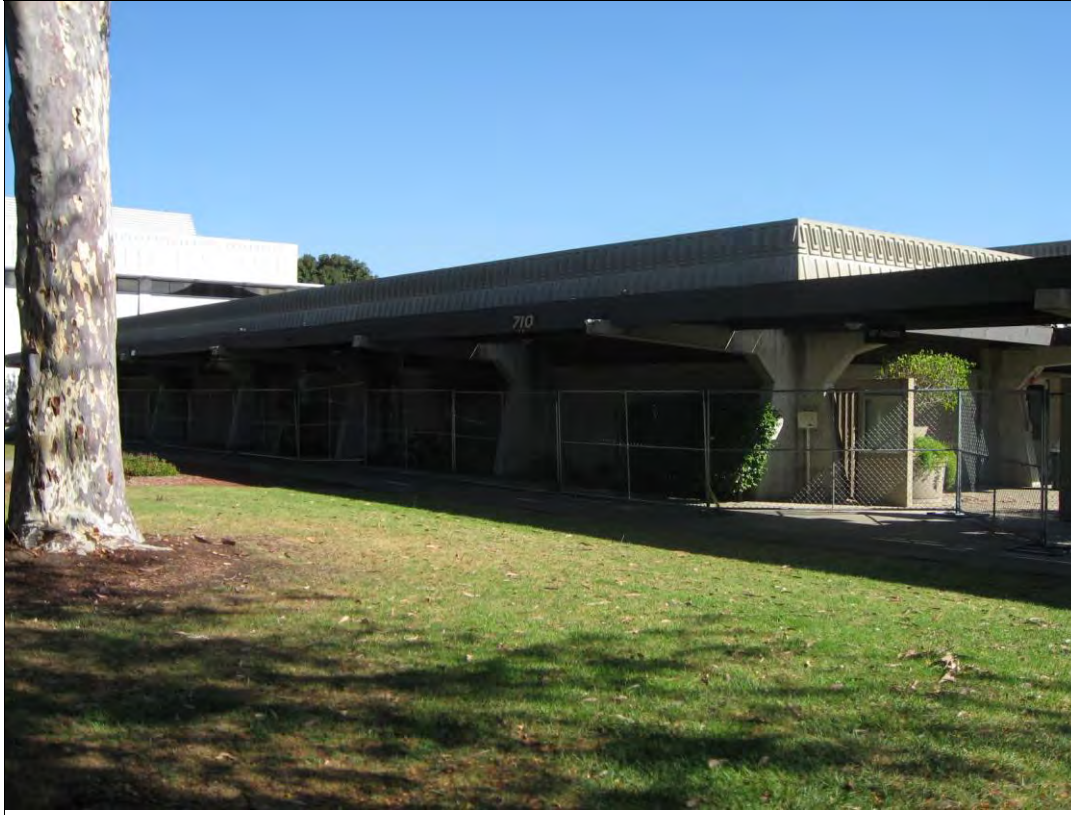
PRIMARY USE: Art Gallery

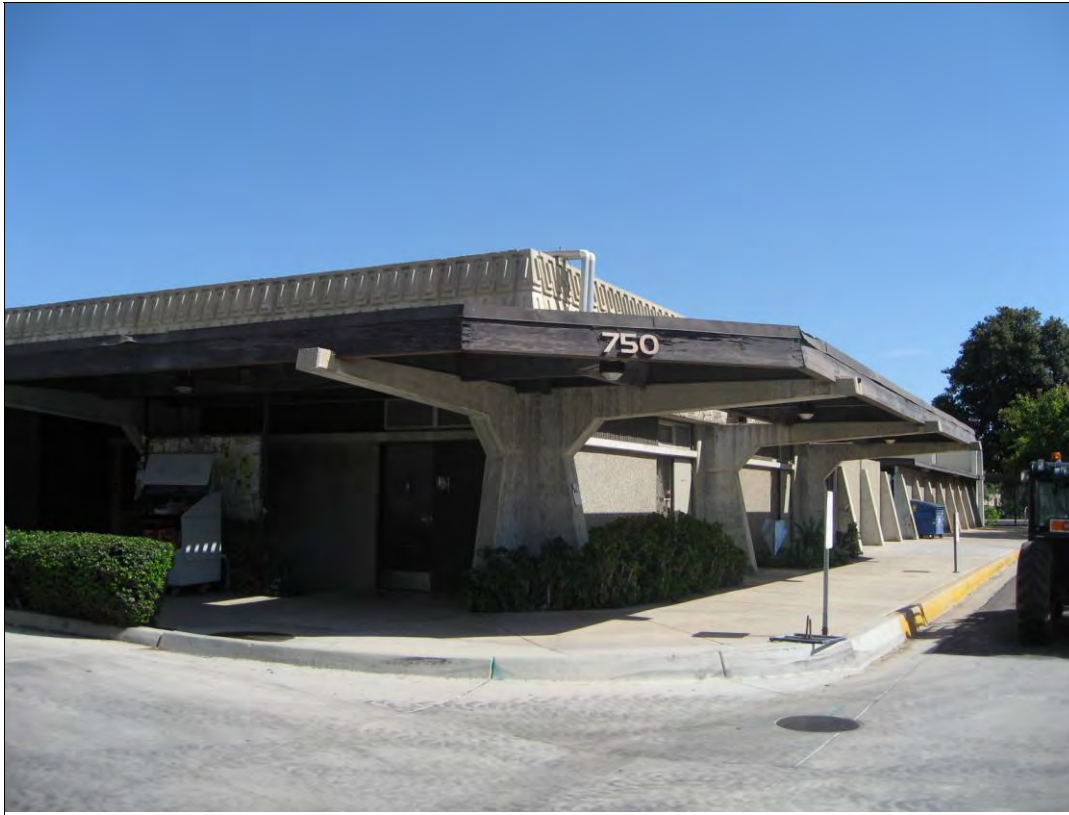
PRIMARY USE: Classroom

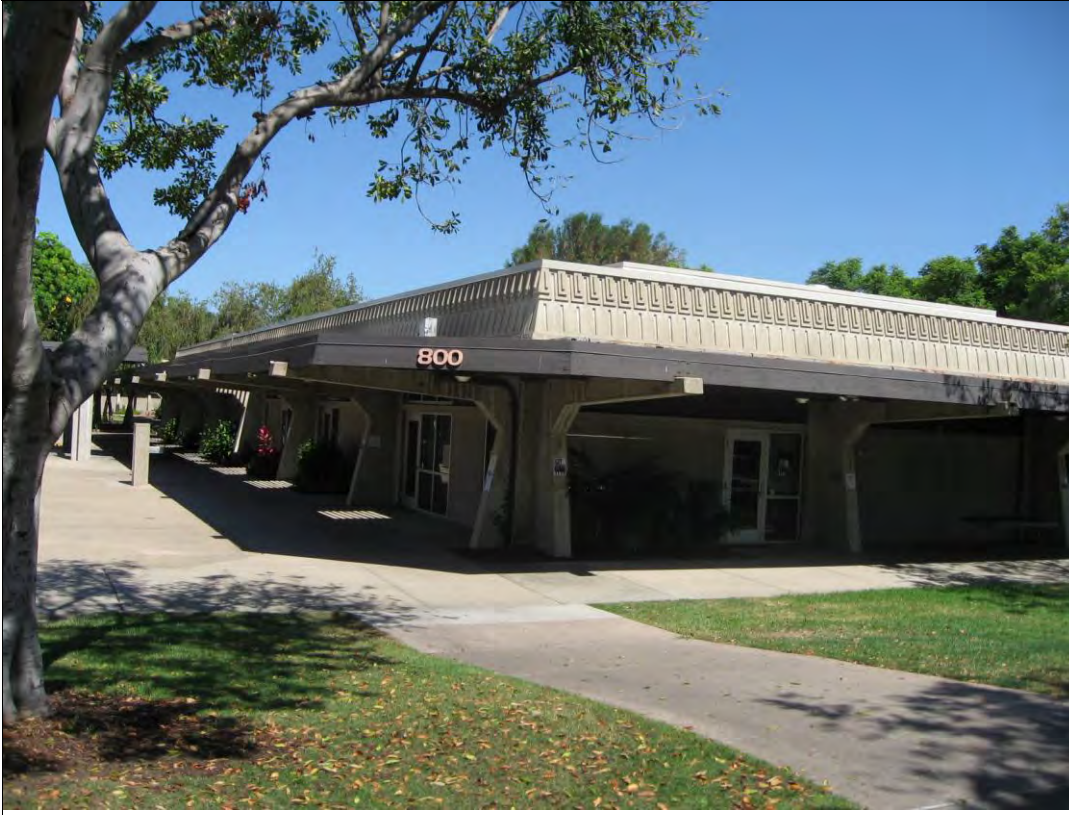
PRIMARY USE: Classroom/Studio

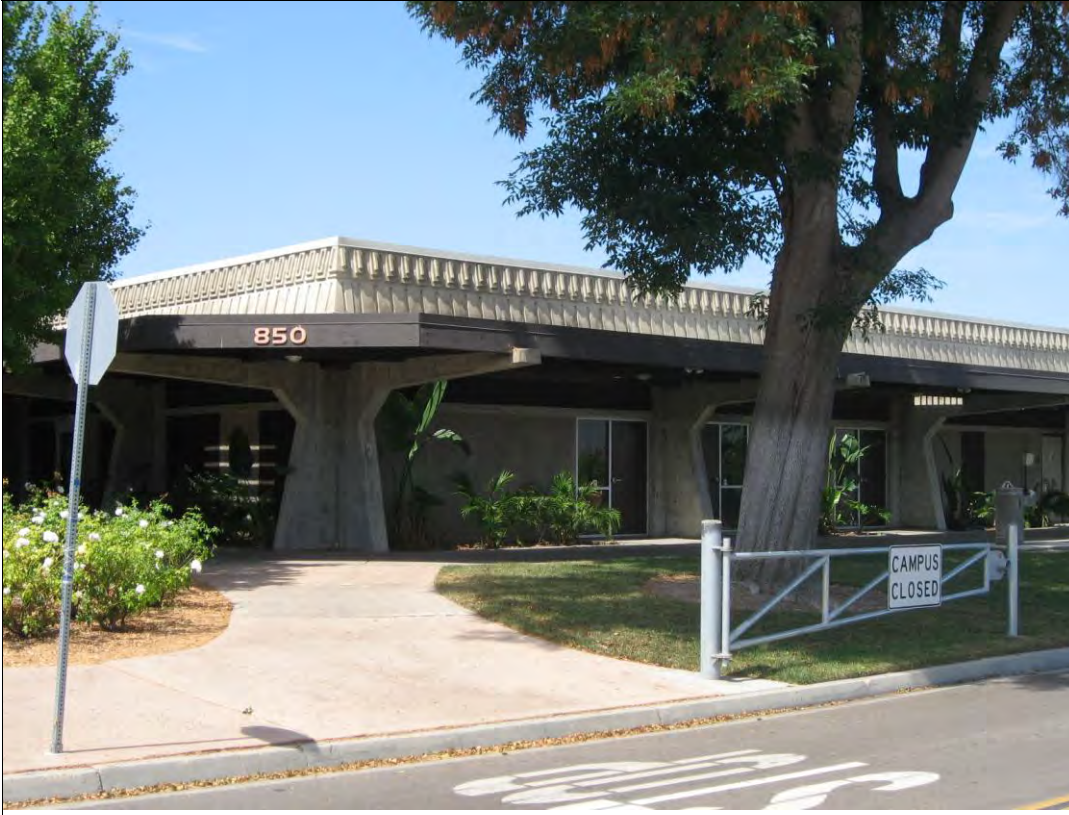
PRIMARY USE: Classroom/Studio

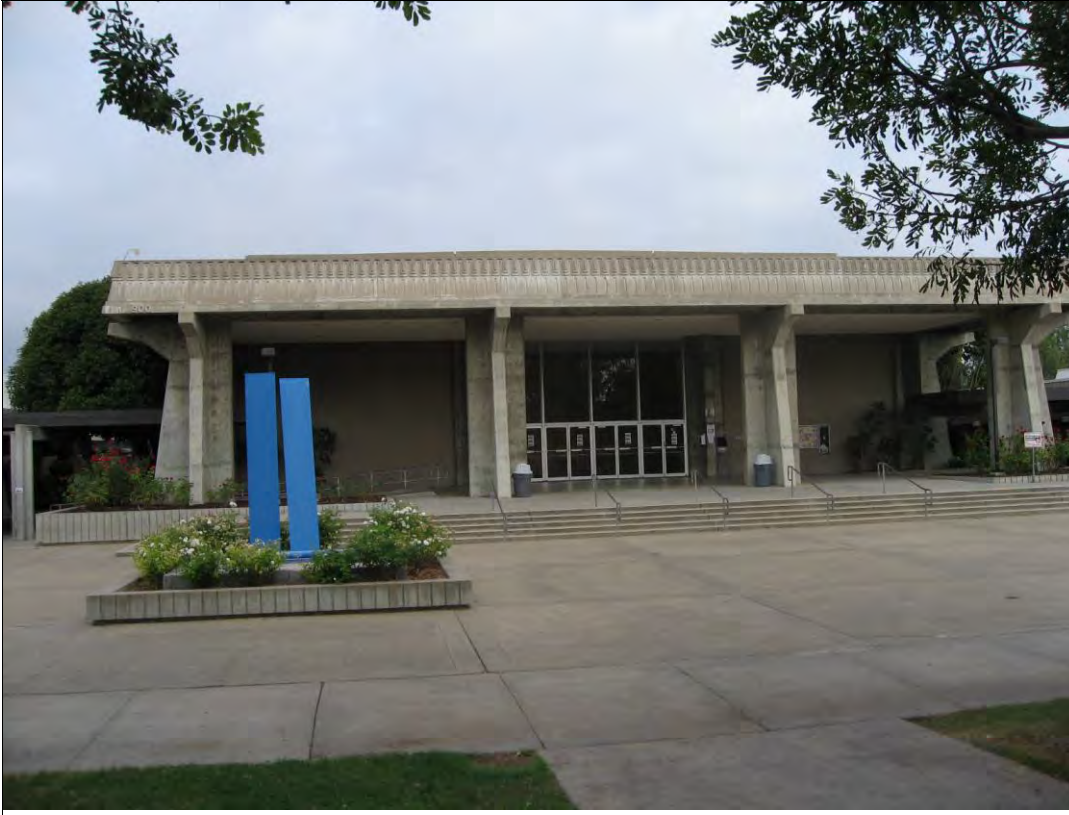
PRIMARY USE: Theater

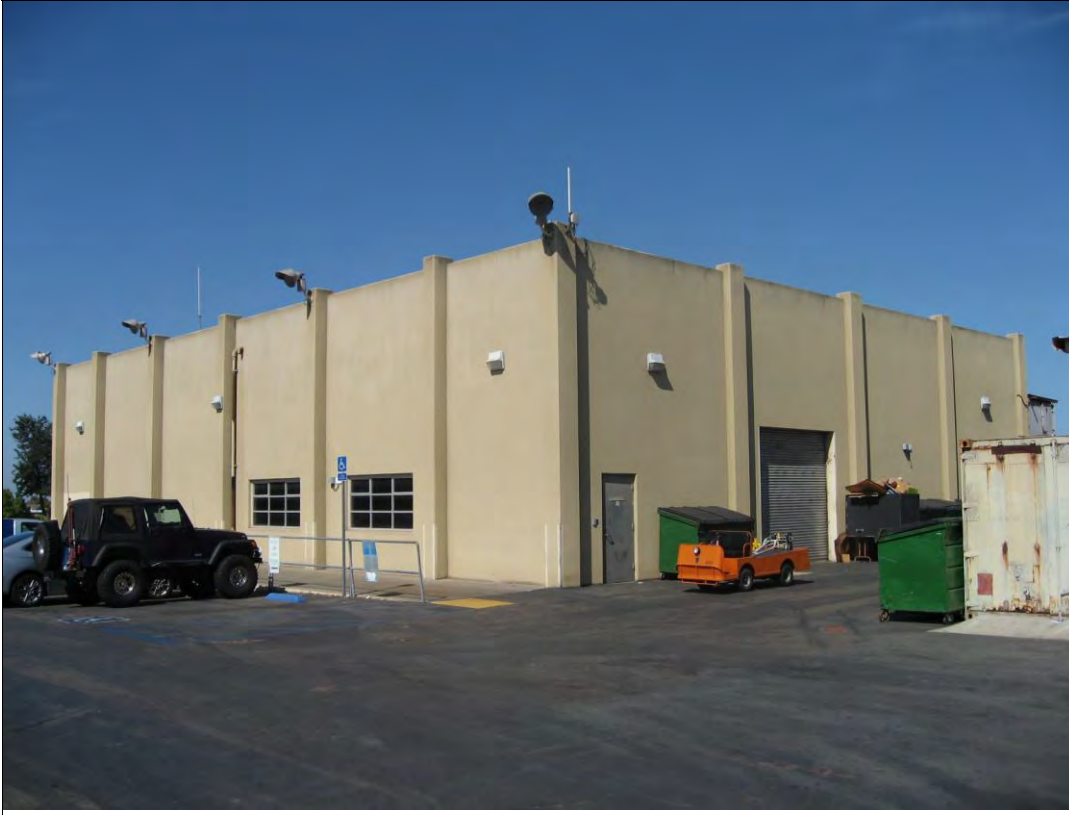
PRIMARY USE: Warehouse

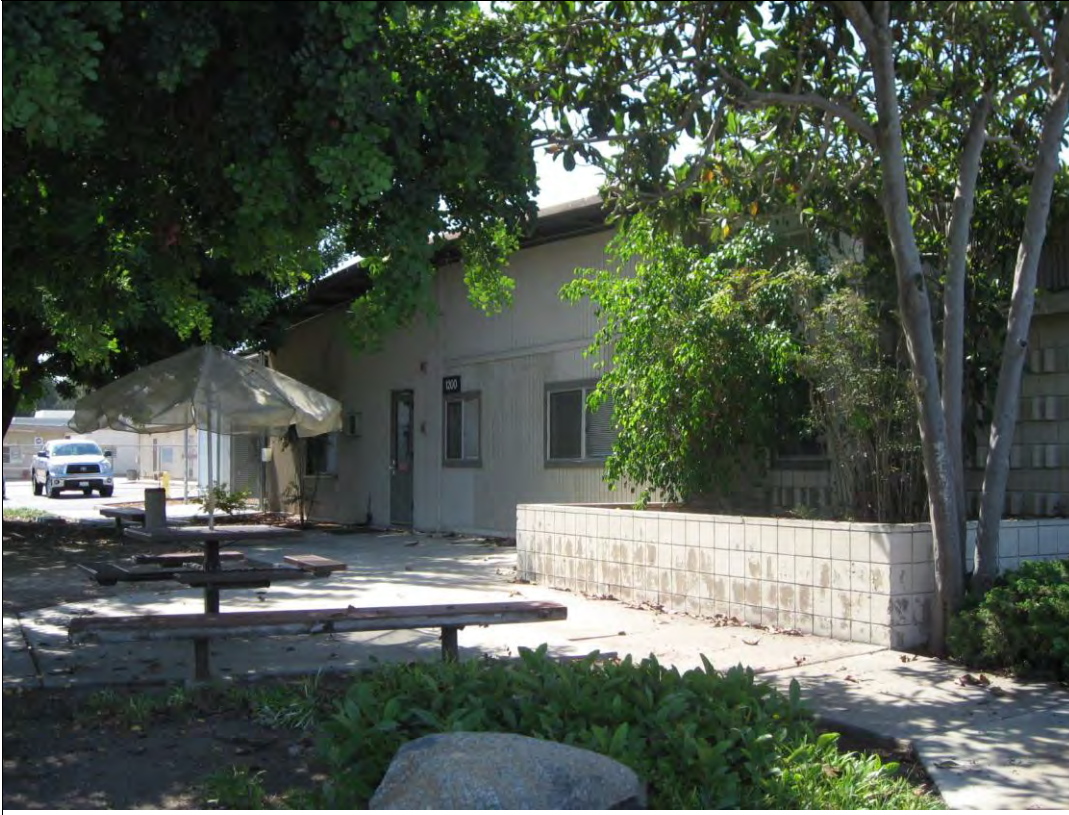
PRIMARY USE: Maintenance Support

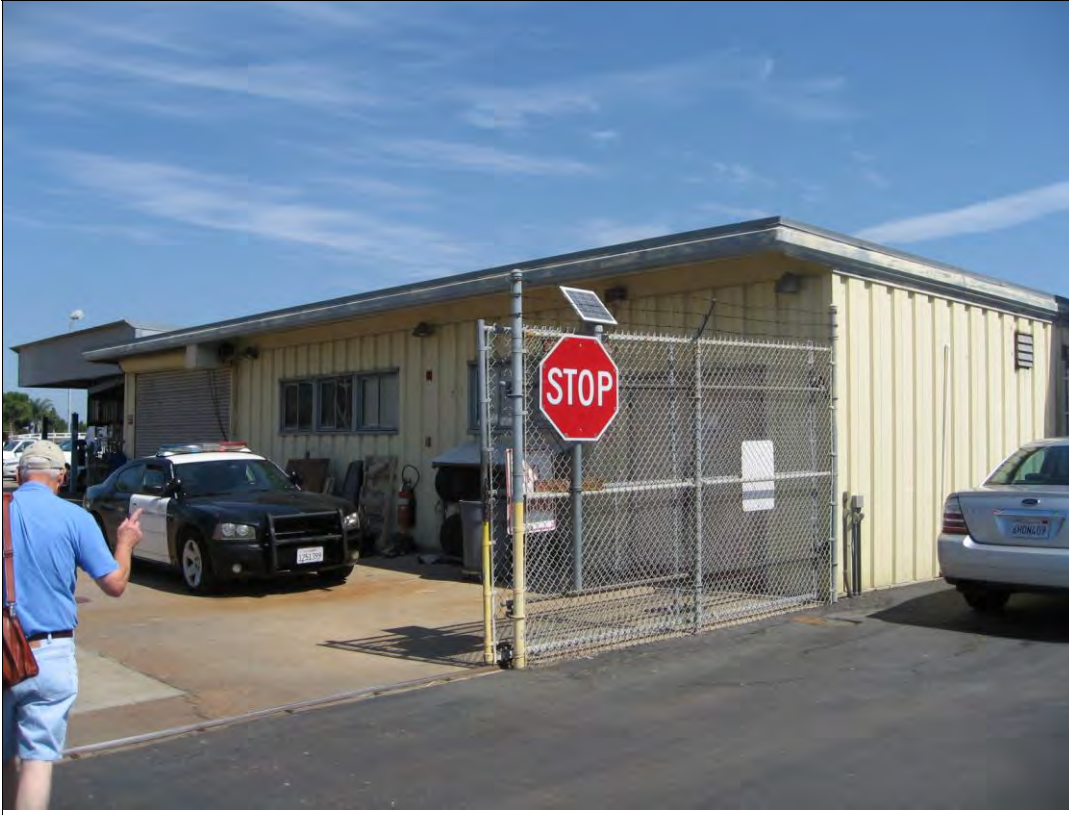
PRIMARY USE: Maintenance Support

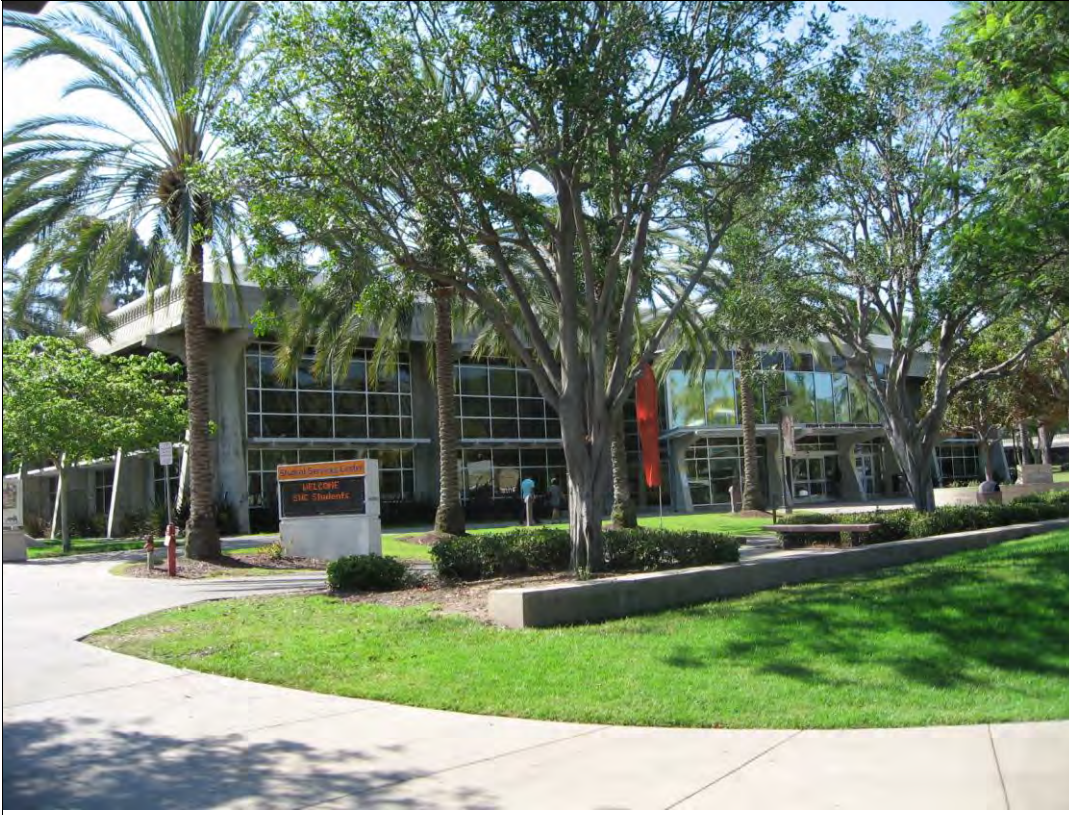
PRIMARY USE: Administration

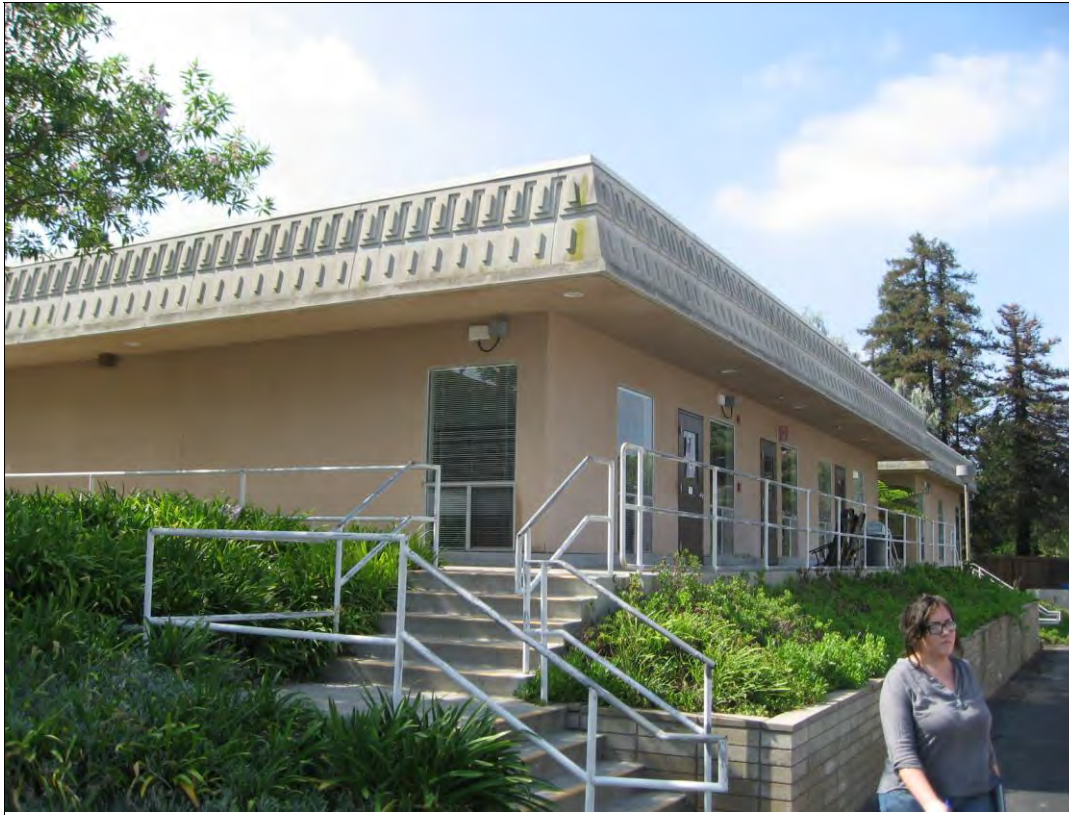
PRIMARY USE: Classroom

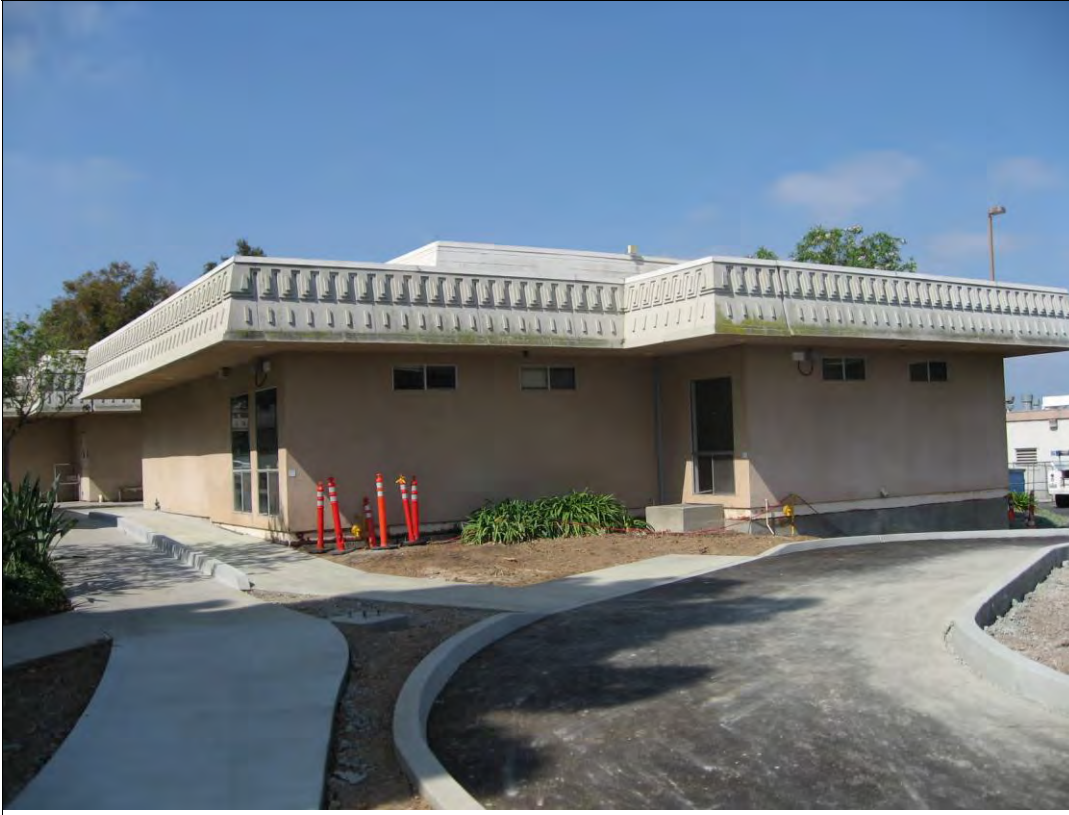
11 Deficiencies Were Identified

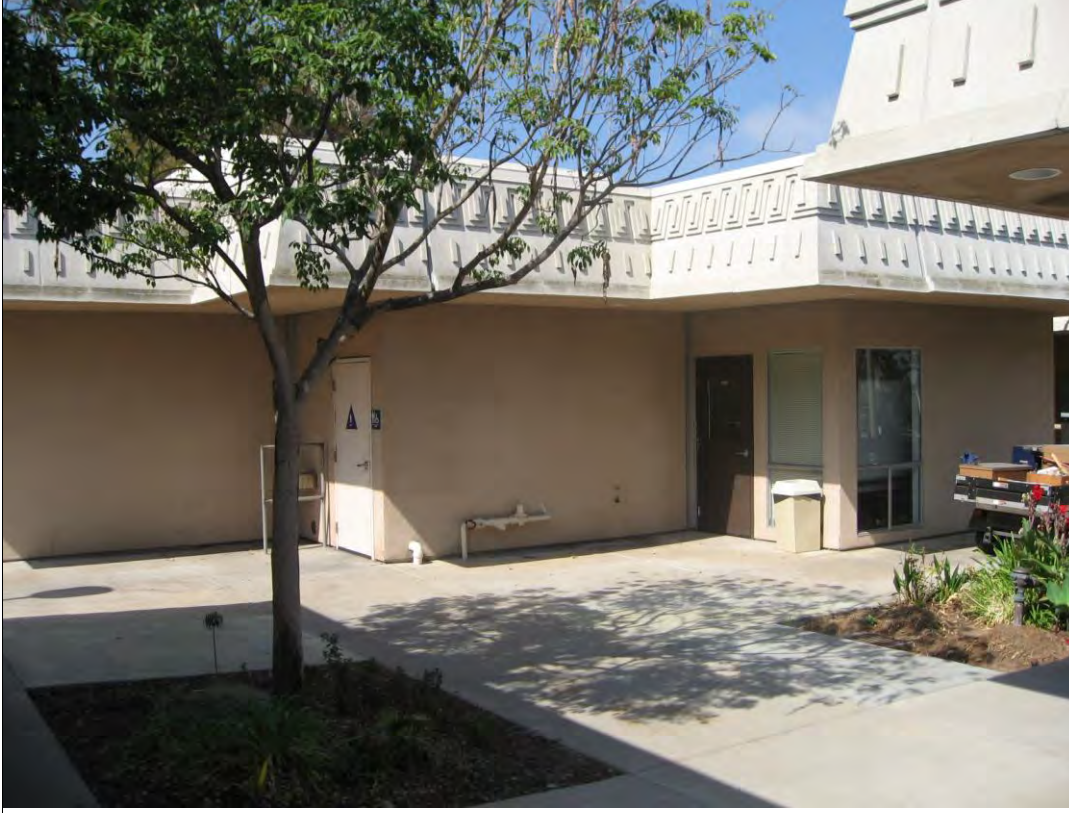
PRIMARY USE: Conference

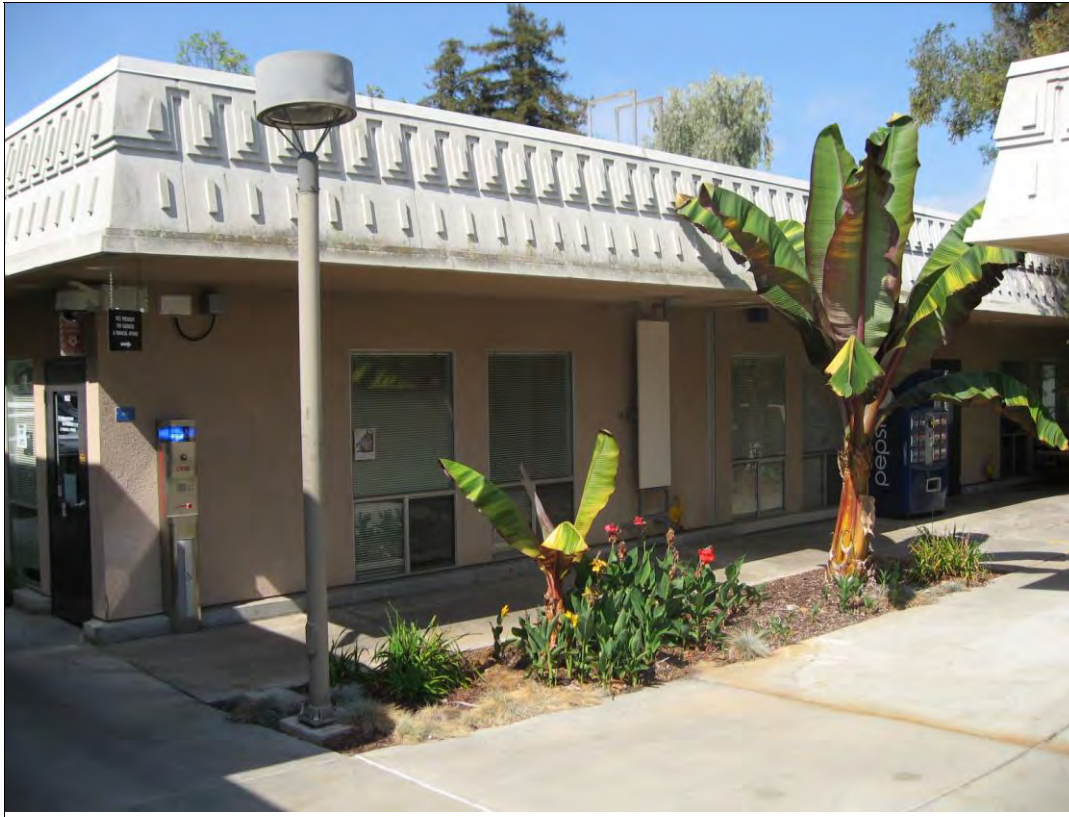
PRIMARY USE: Administration

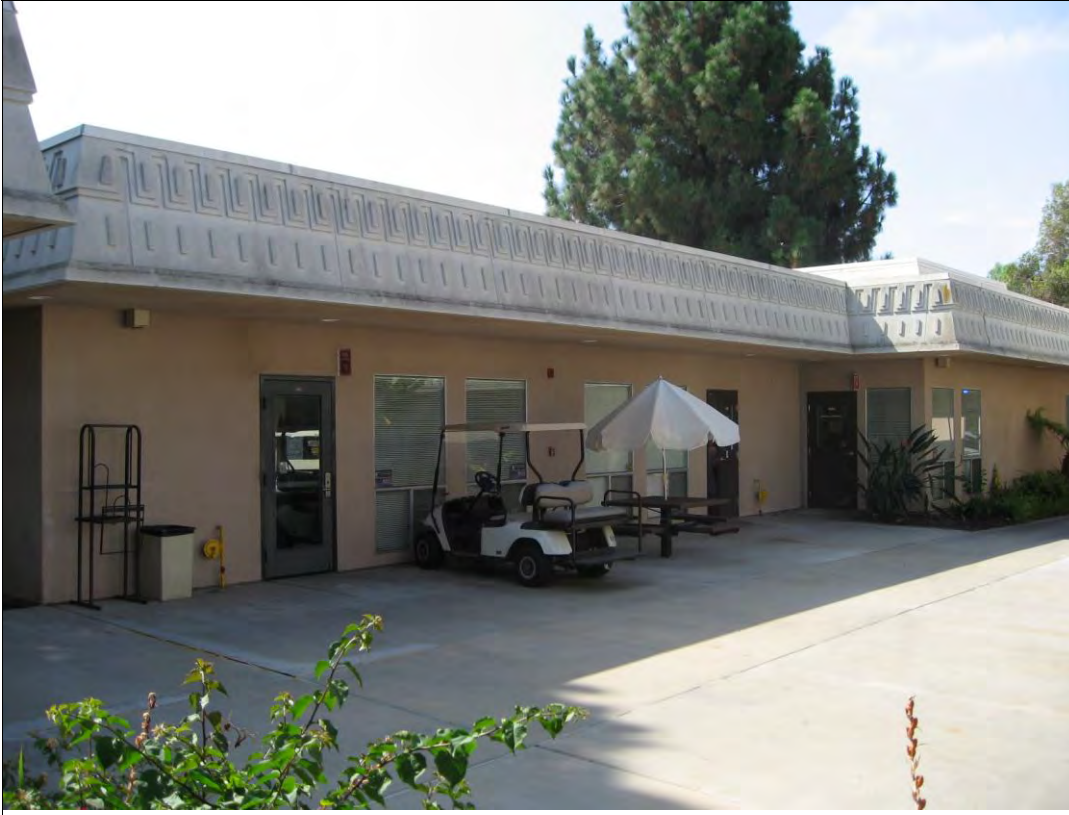
PRIMARY USE: Administration

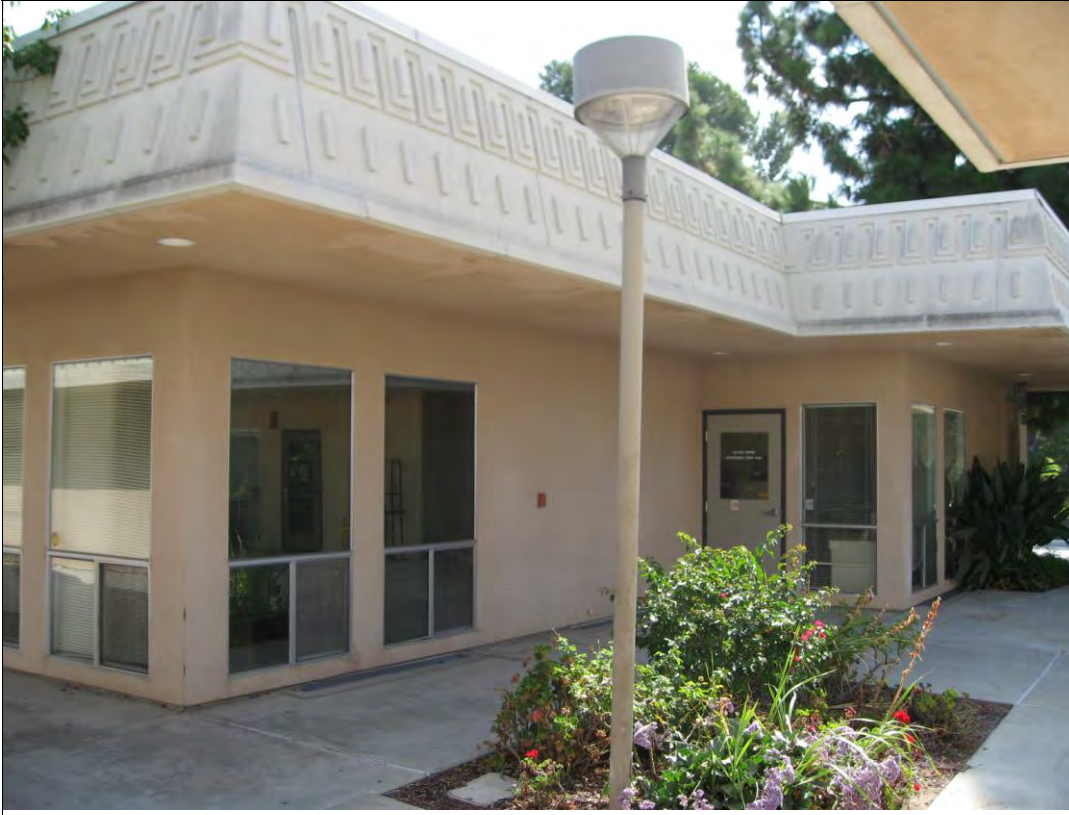
PRIMARY USE: Human Resources

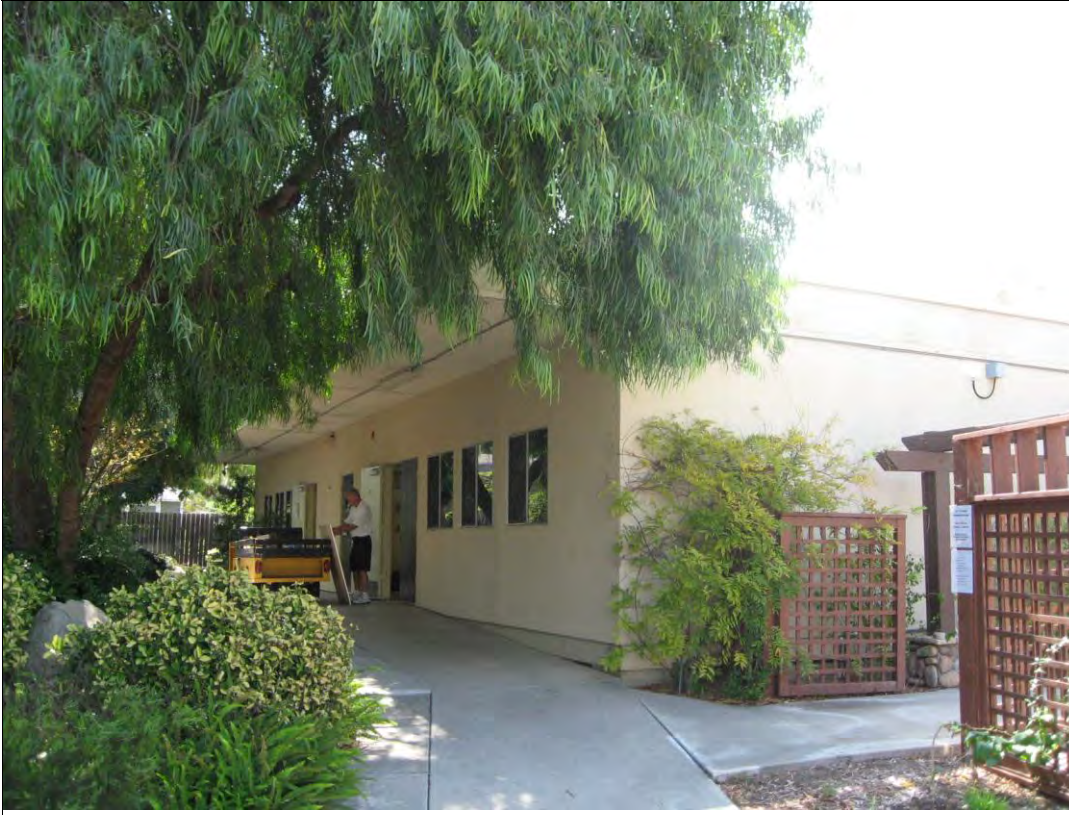
PRIMARY USE: Classroom
