2015 FACILITY CONDITION SURVEY

SOUTHWESTERN COLLEGE

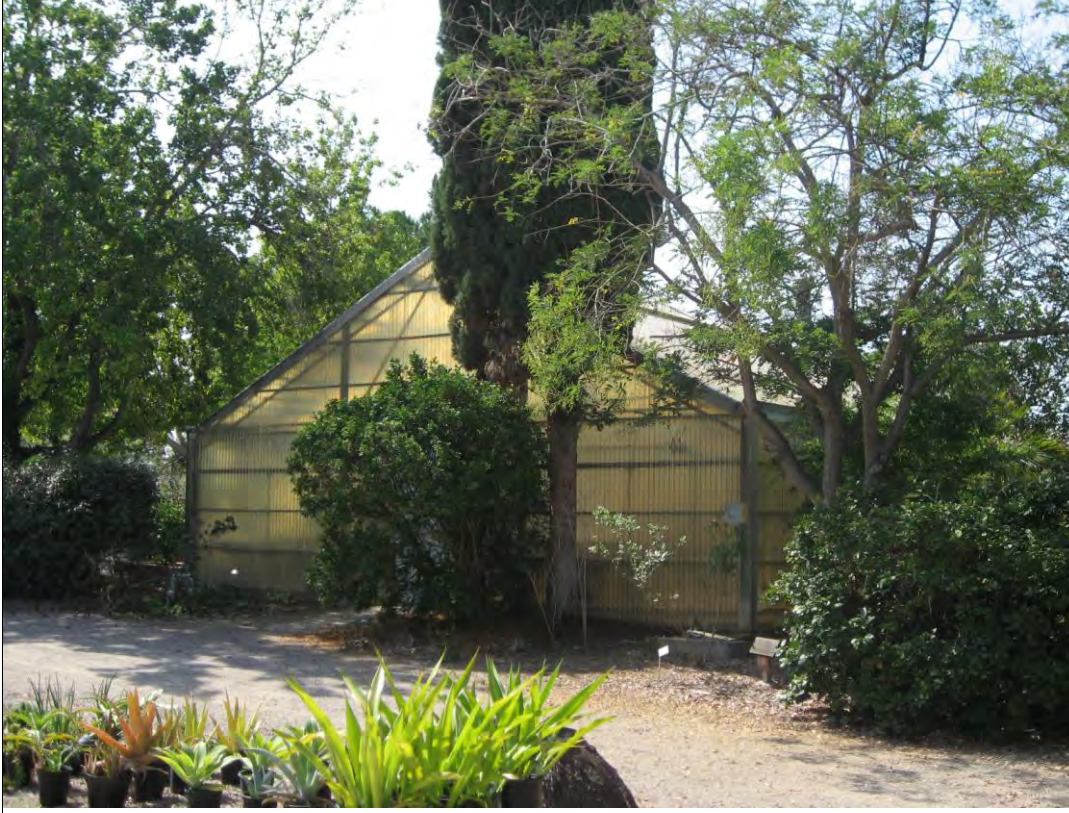
PRIMARY USE: Horticulture

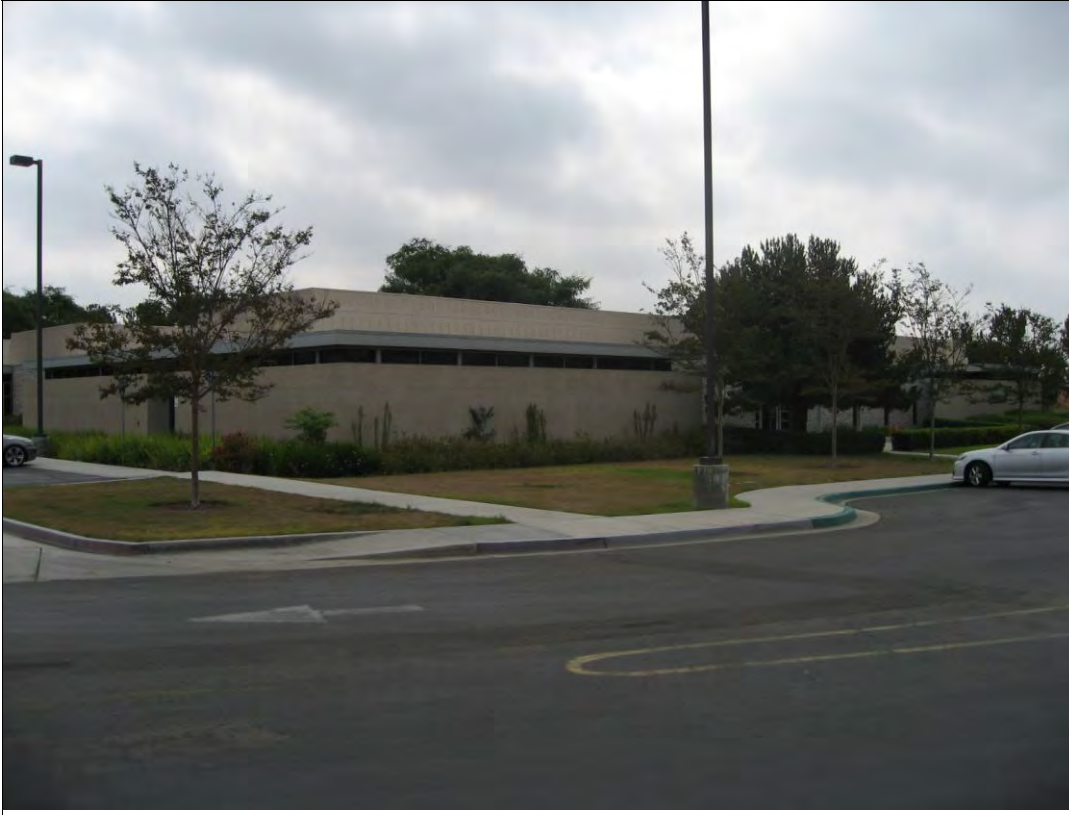
PRIMARY USE: Child Care/Classroom

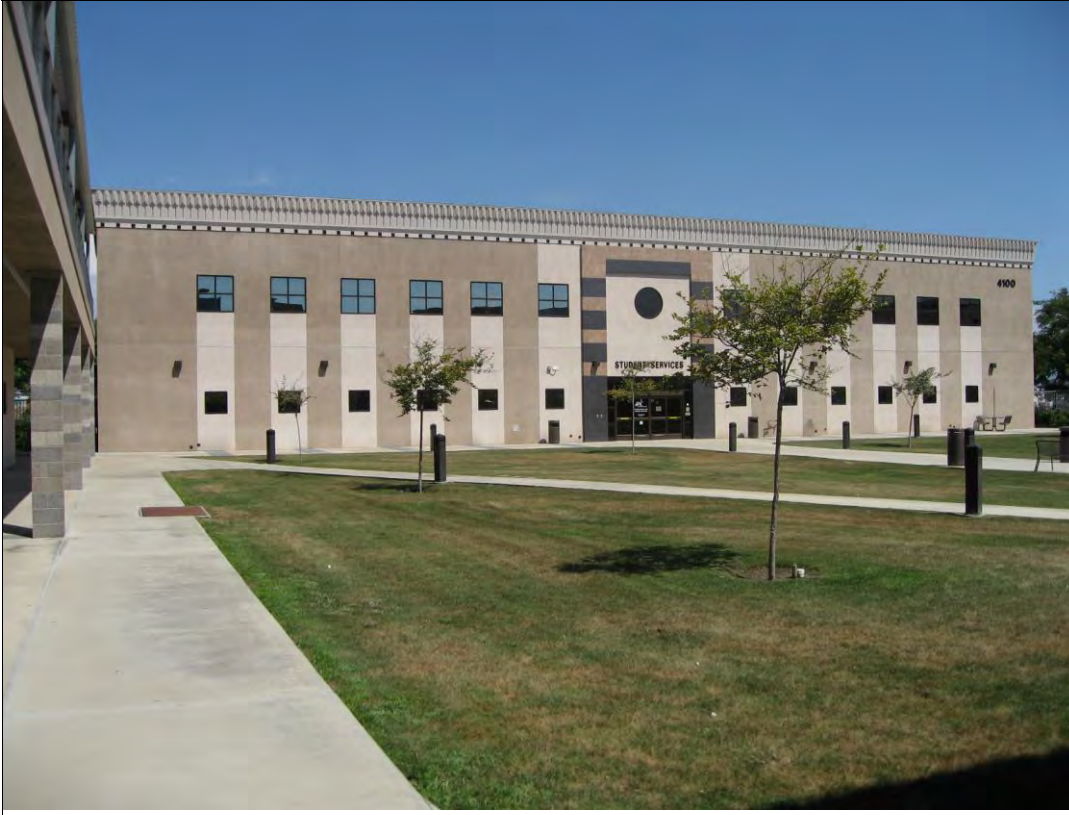
PRIMARY USE: Classroom/Lab

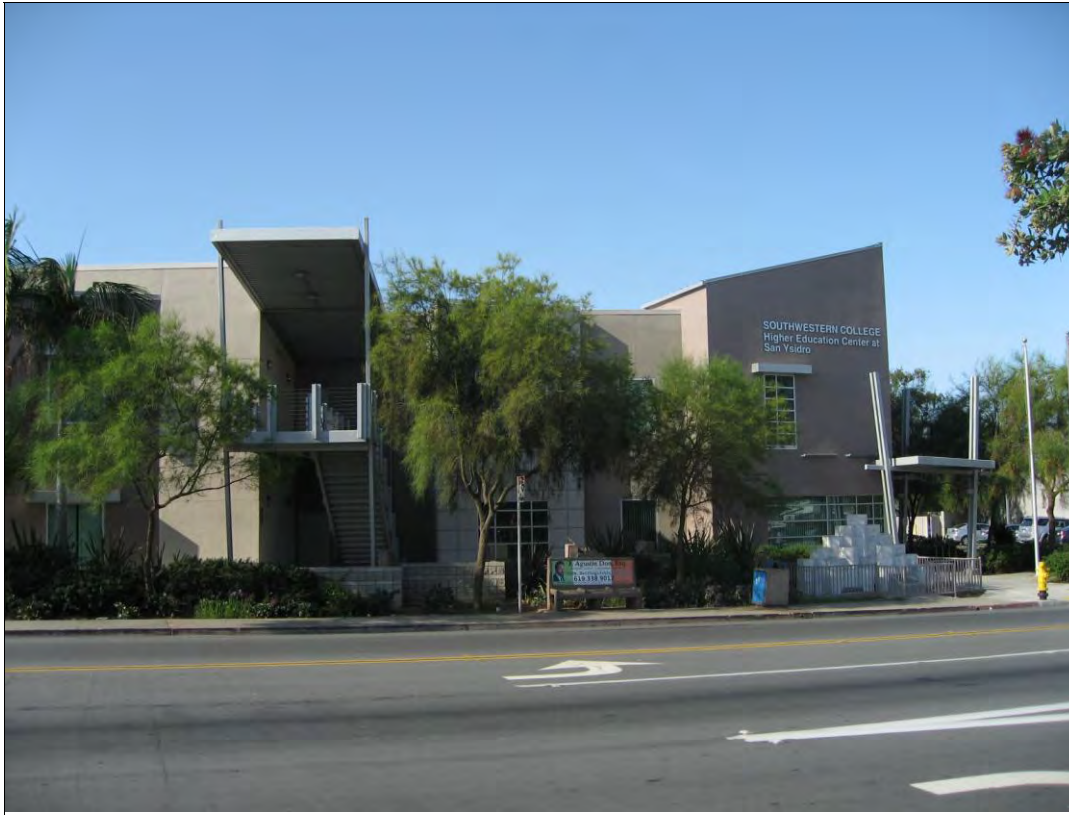
PRIMARY USE: Classroom/Lab

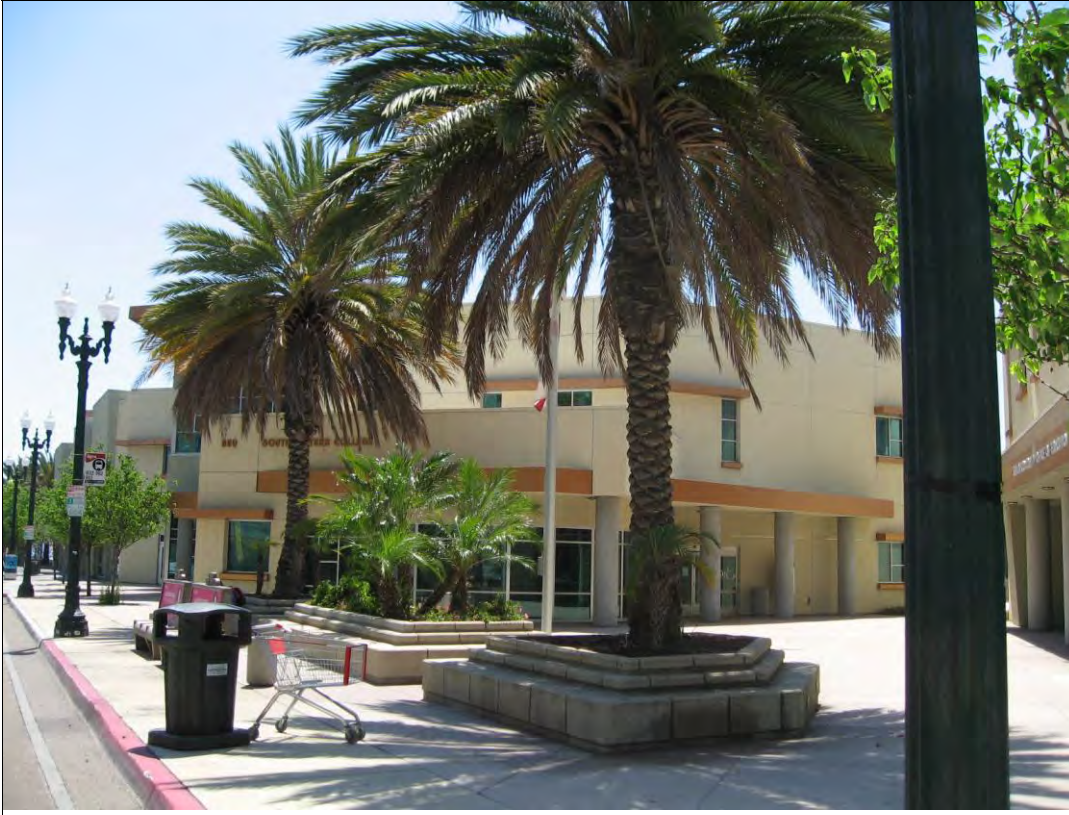
PRIMARY USE: Classroom/Lab

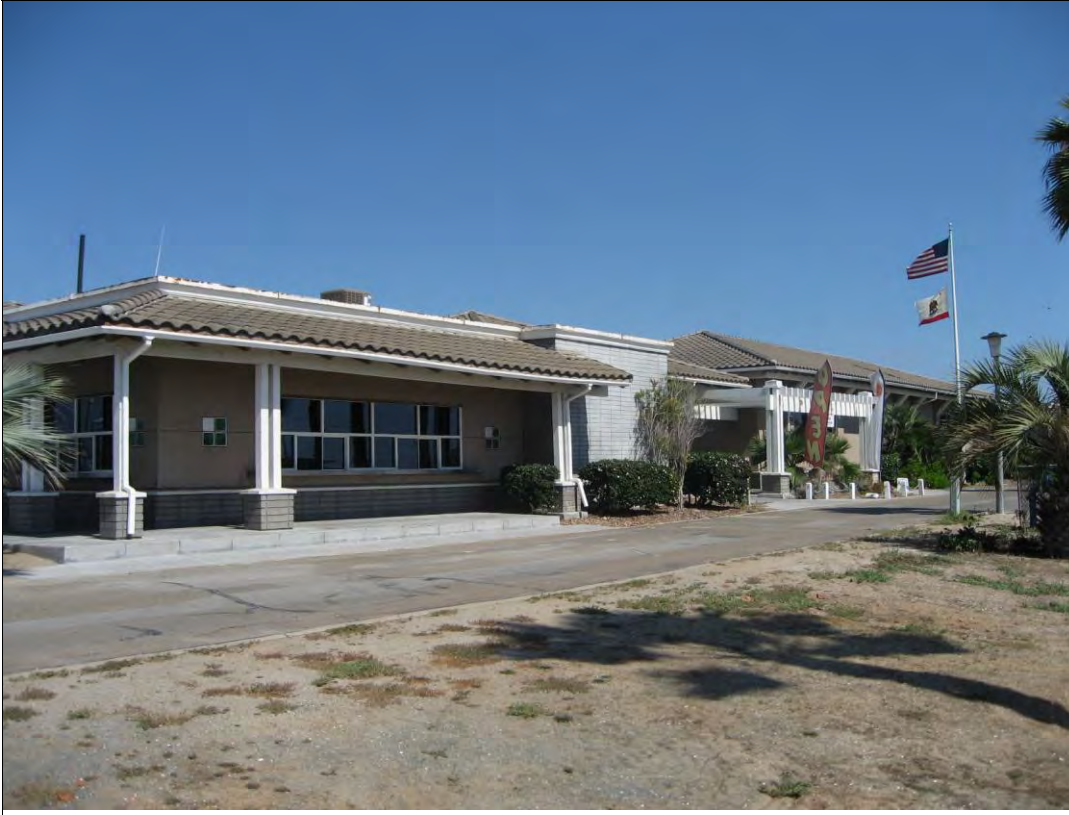
PRIMARY USE: Water Sport Instruction

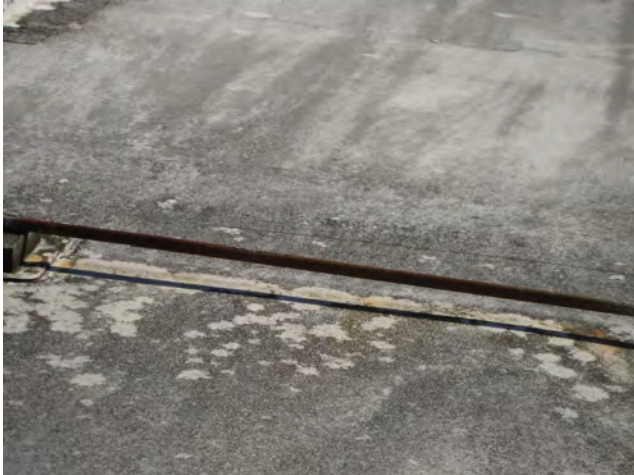
Bldg 103 - Badly rusted electrical conduit on roof

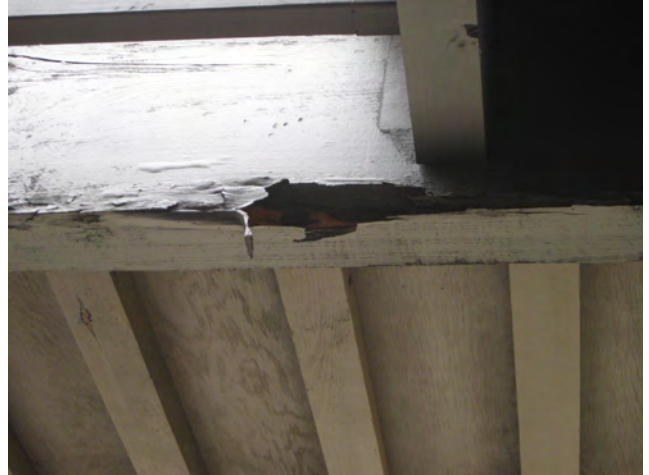
Bldg 220 - Deteriorating covered walkway roof support beam

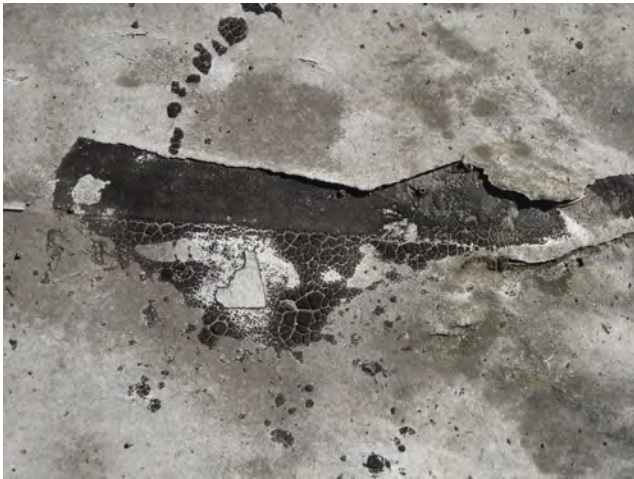
Bldg 315 - Deteriorating BUR

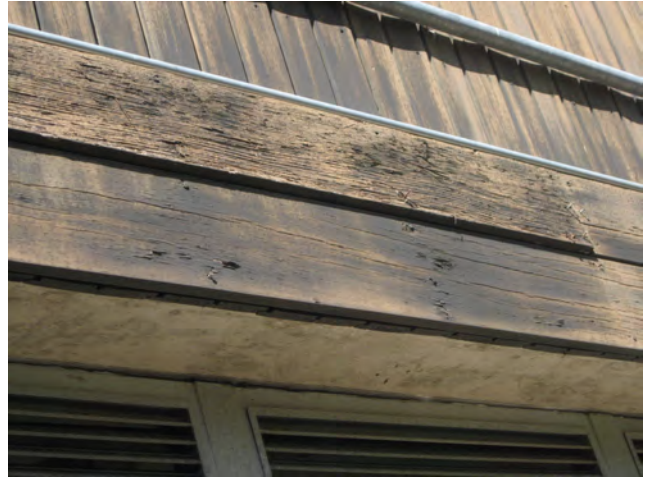
Bldg 315 - Badly deteriorated fascia/trim boards

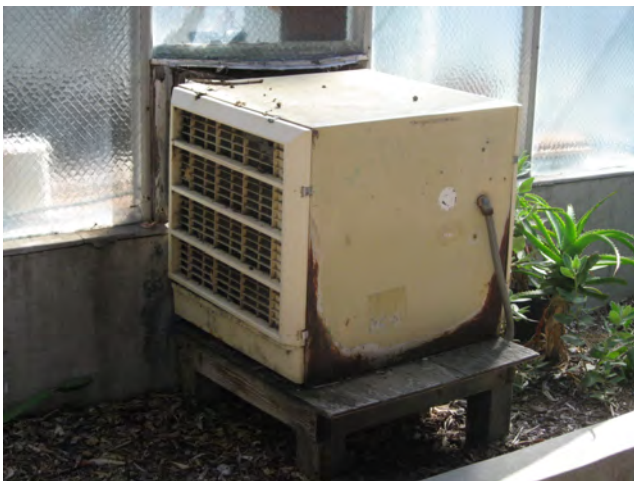
Bldg - 316 Deteriorated swamp cooler

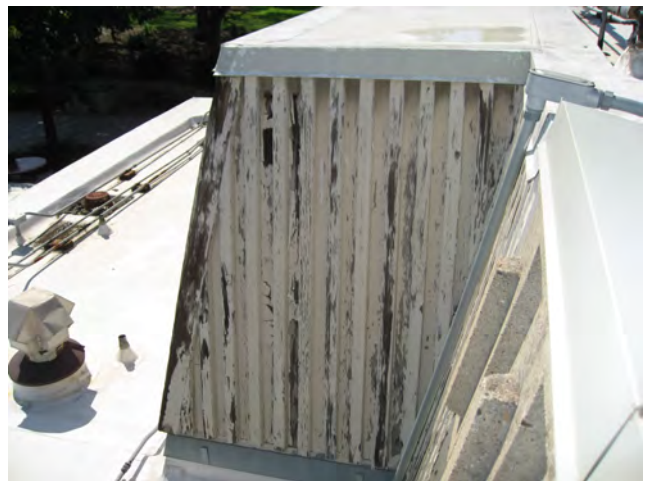
Bldg 340 - Deteriorated wood parapet

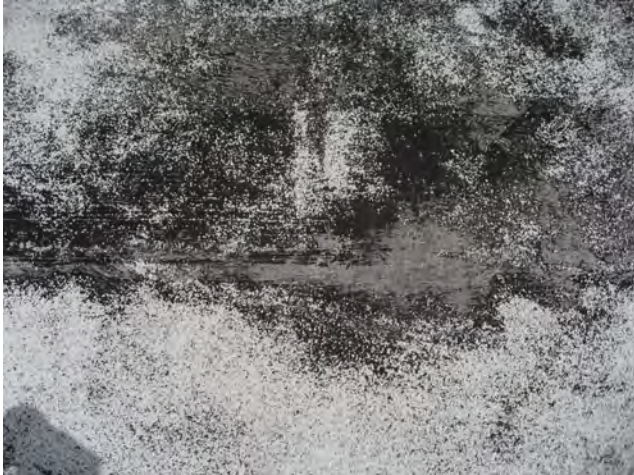
Bldg 381 - Deteriorated roof membrane

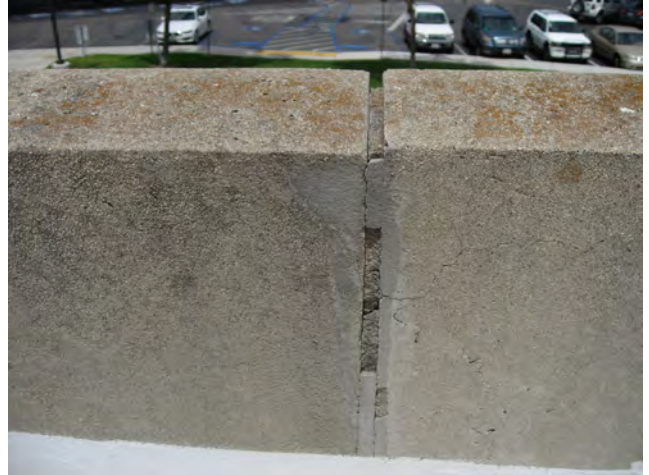
Bldg 381 - Deteriorating parapet wall joint mortar

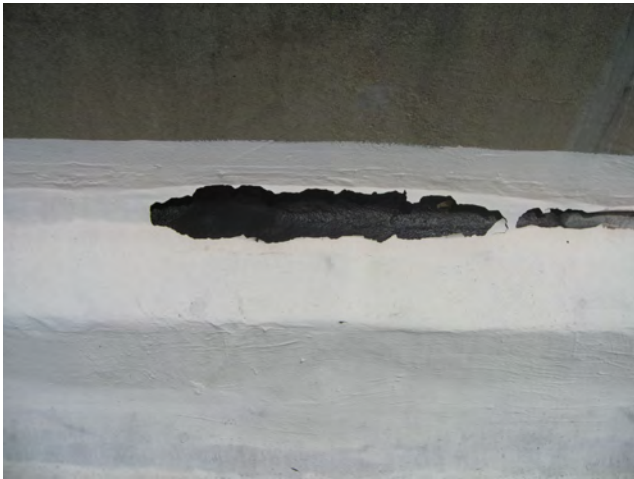
Bldg 381 - Deteriorating membrane flashing on parapet

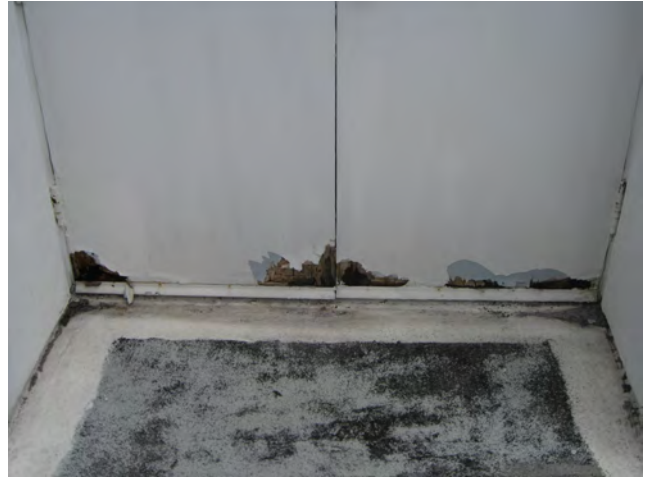
Bldg 381- Deteriorated wood doors on rooftop enclosure

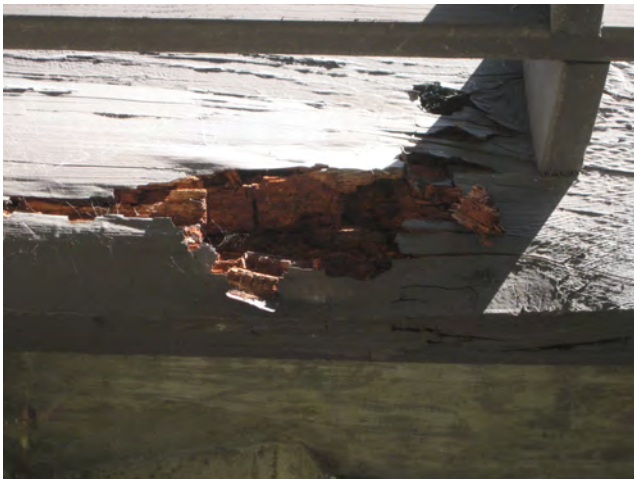
Bldg - 381 Rotted walkway roof support beam

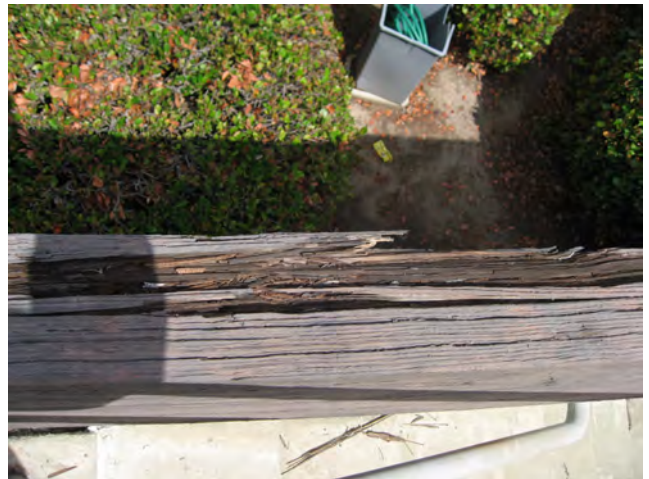
Bldg 381 - 2nd badly deteriorated walkway roof support beam

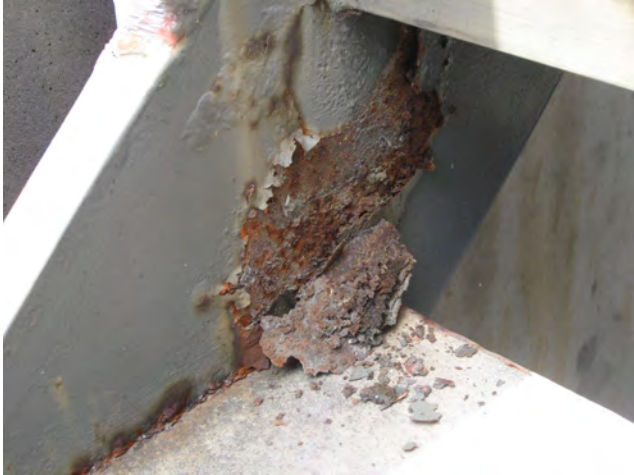
Bldg 381 - Rusting metal stringer on exterior stairway

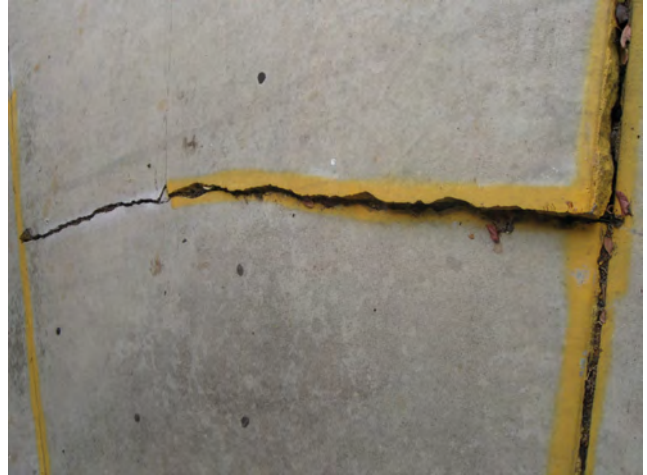
Bldg 381 - Badly cracked concrete patio area slab

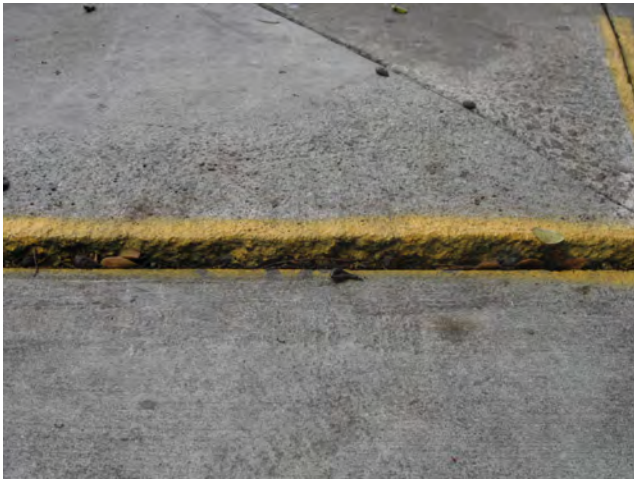
Bldg 381 - Dangerous lifting concrete walk slab

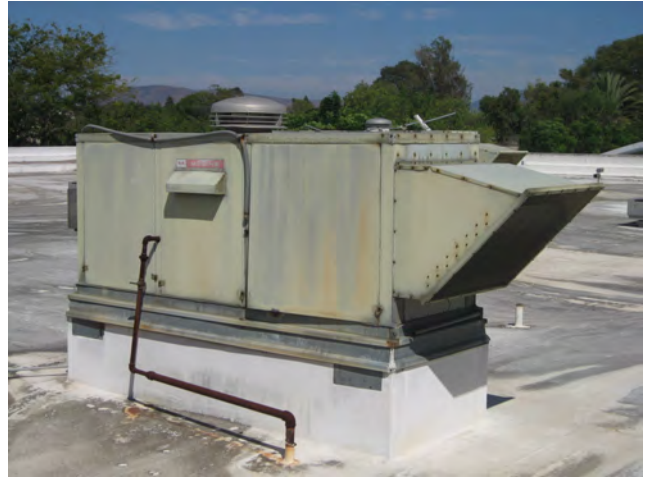
Bldg 420- Deteriorated packaged rooftop A/C units

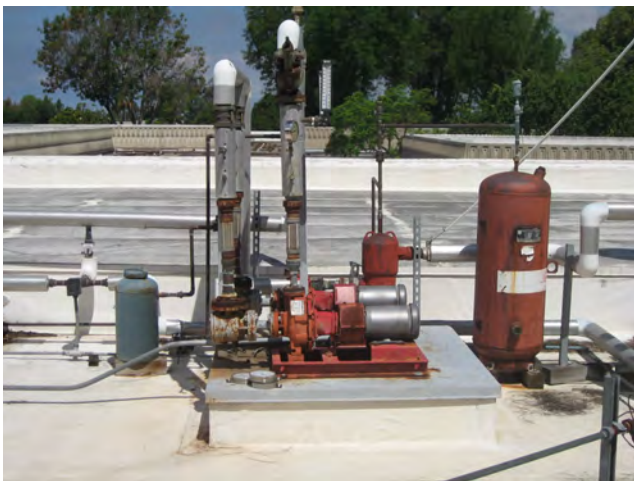
Bldg - 430 Deteriorated rooftop gas boiler and Circulating pumps

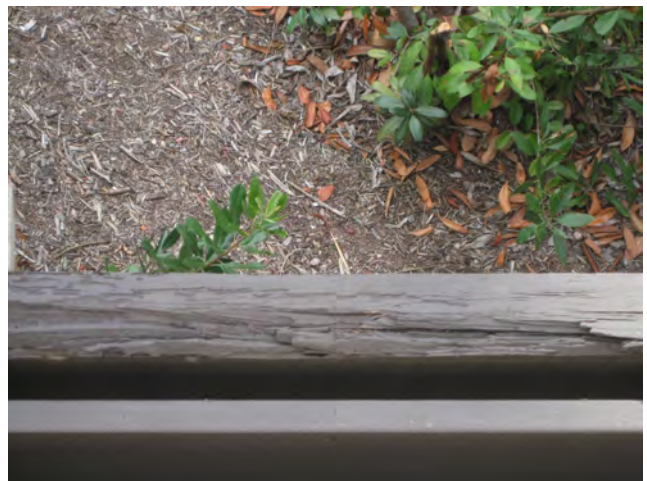
Bldg 430 - Deteriorating covered walkway roof support beam

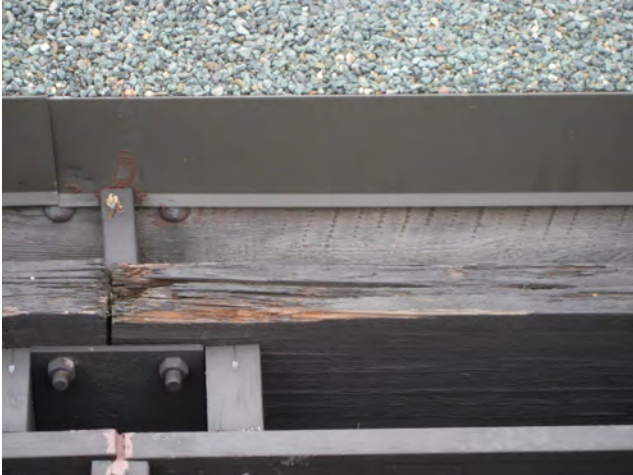
Bldg 560 - Deteriorating covered walkway wood support beam

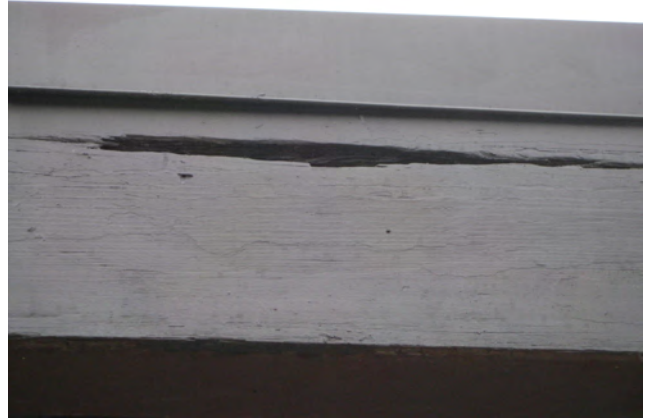
Bldg 560 - 2nd bad covered walkway wood support beam

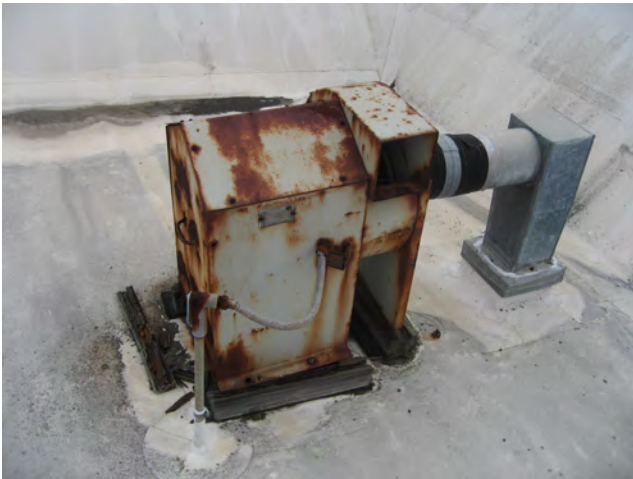
Bldg 590 - Badly deteriorated rooftop exhaust fan

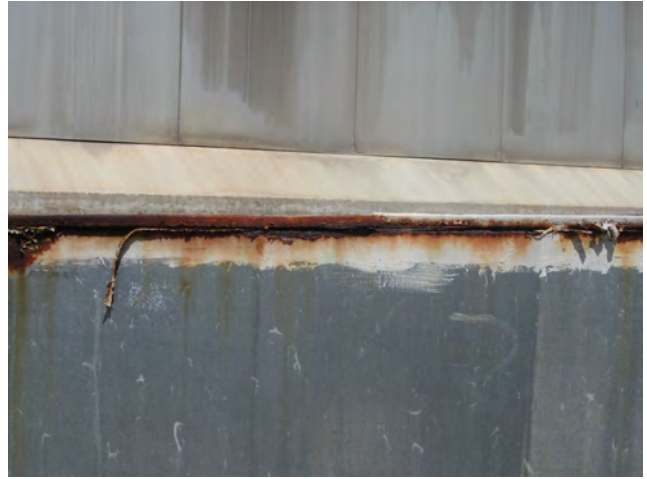
Bldg 600 – Badly rusting rooftop HVAC duct seams

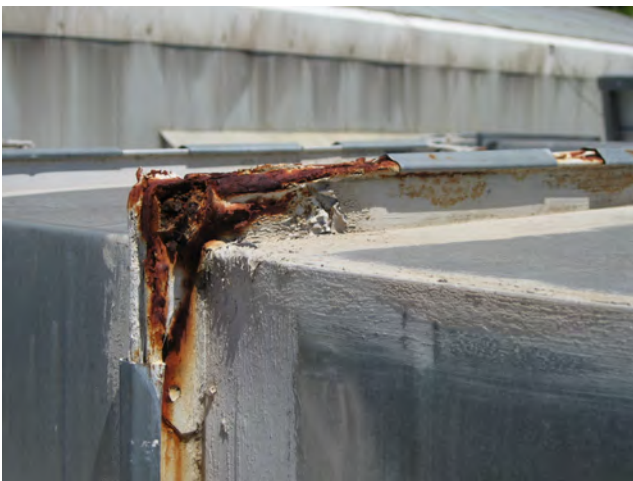
Bldg 600 - Badly rusting rooftop HVAC duct joints

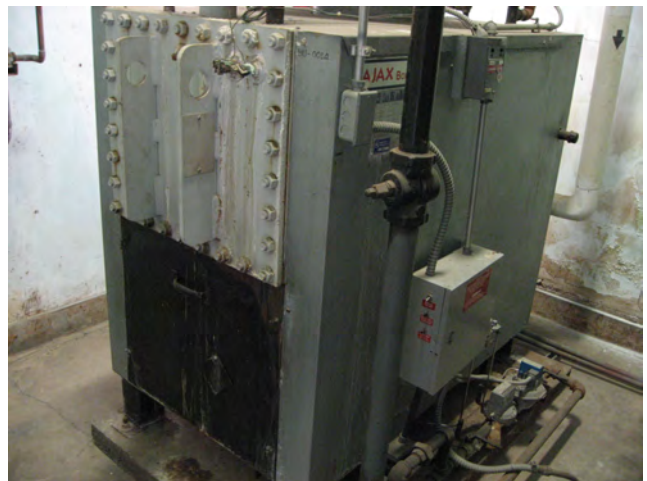
Bldg 610 - Deteriorating hot water boiler

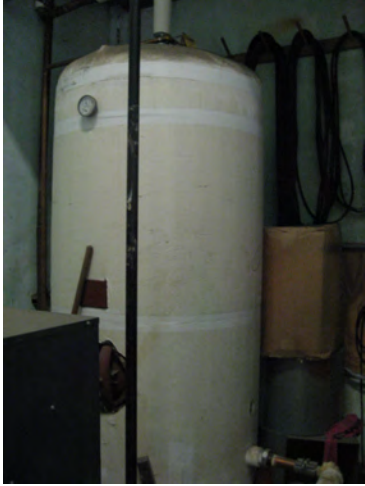
Bldg 610 - Deteriorating hot water storage tank

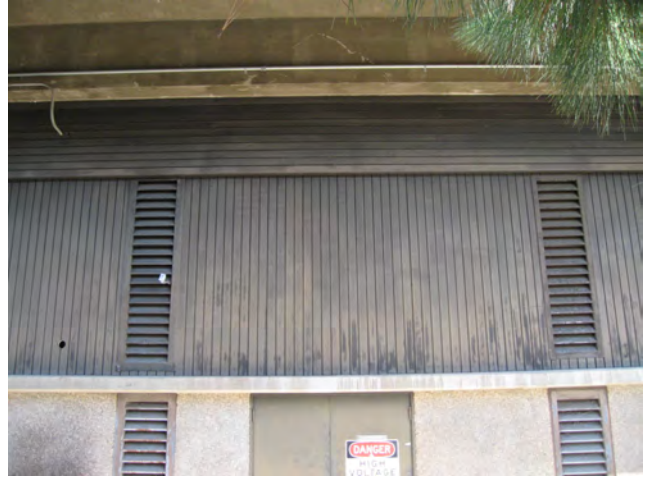
Bldg 610 - Weathered finish on exterior wood panels

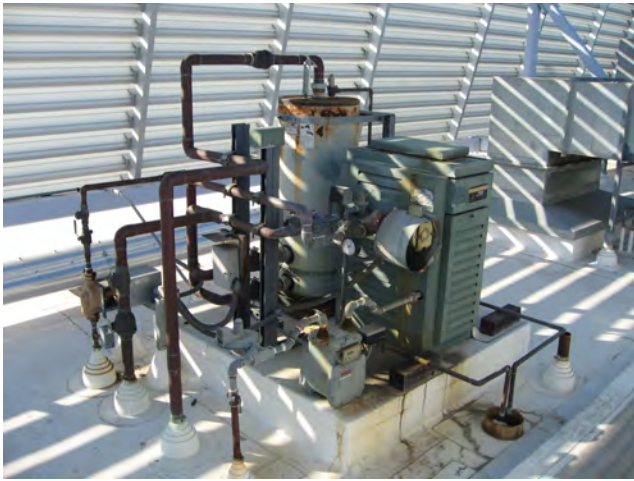
Bldg 620 - Badly deteriorated rooftop hot water heater

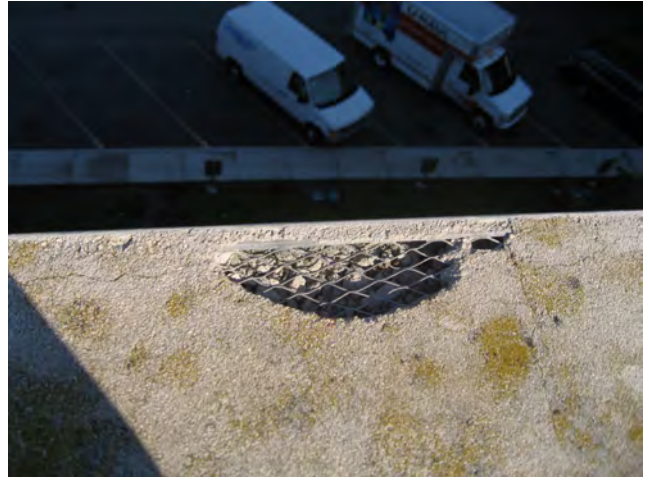
Bldg 620 - Damage on roof parapet top

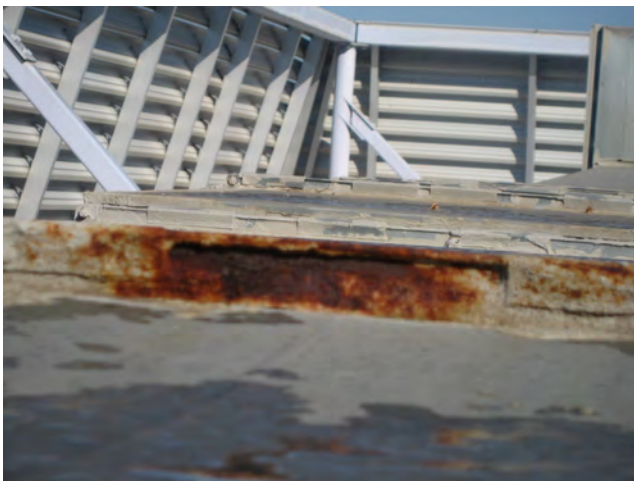
Bldg 620 - Badly rusting rooftop HVAC duct seams

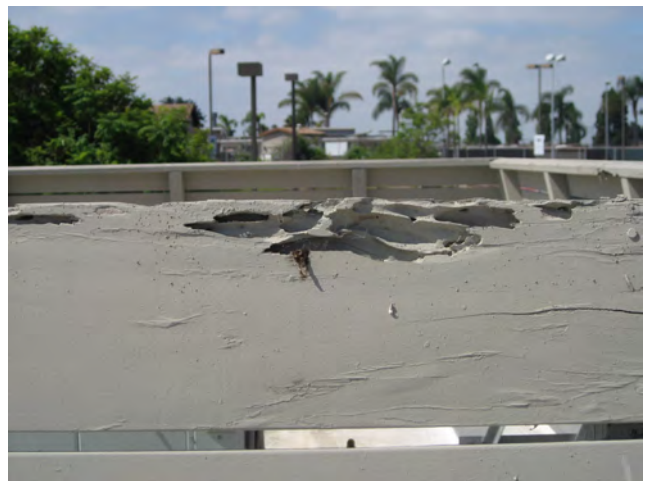
Bldg 630-660 - Typical deteriorating boards on Rooftop HVAC enclosures

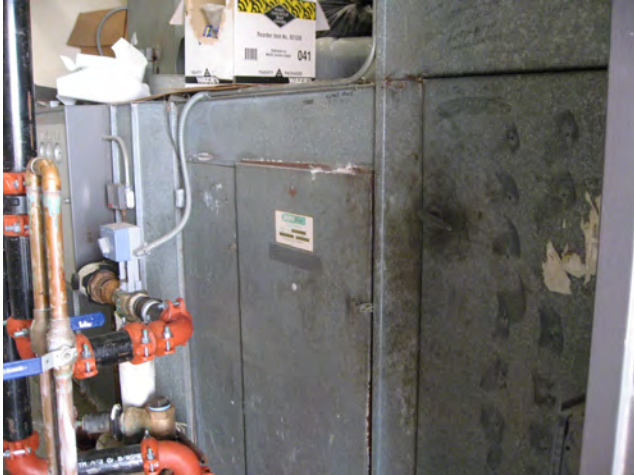
Bldg 710 - Deteriorating air handler

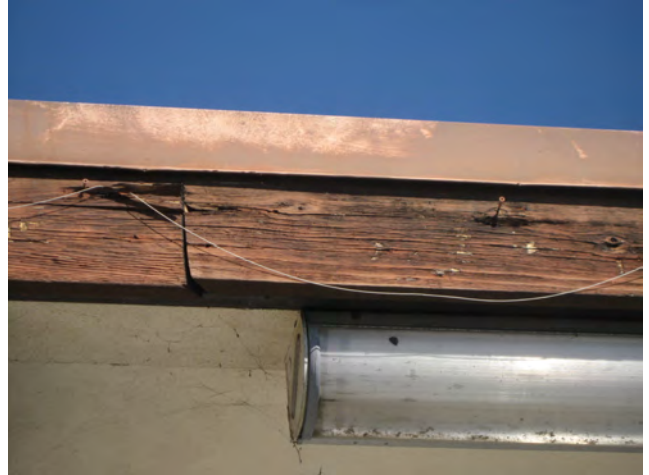
Bldg 750 - Badly deteriorated wood roof fascia

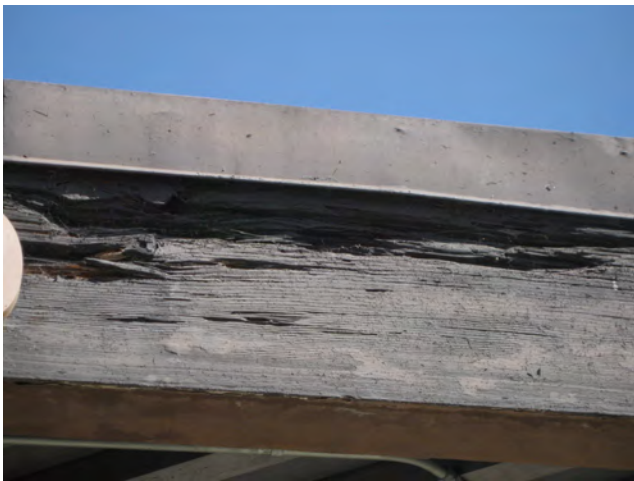
Bldg 750 - Badly deteriorated covered walkway
Roof beam

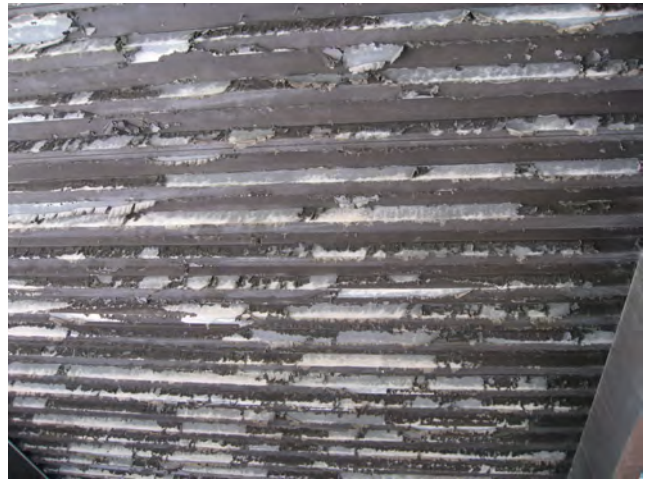
Bldg 900 – Badly peeling paint on underside of
canopies near front entrance

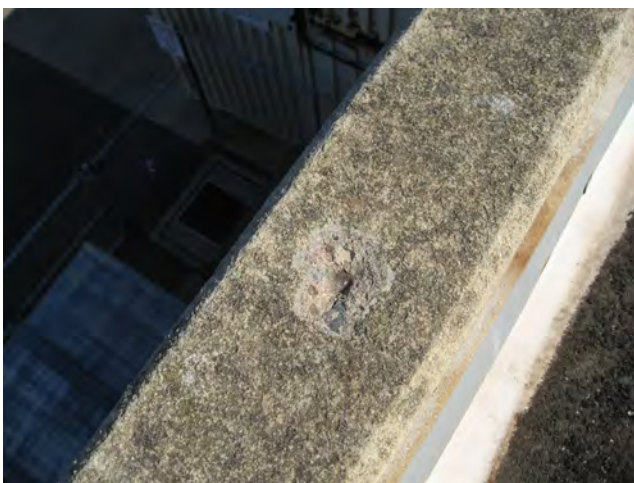
Bldg 1100 - Concrete spalling on roof parapet
Exposing rebar

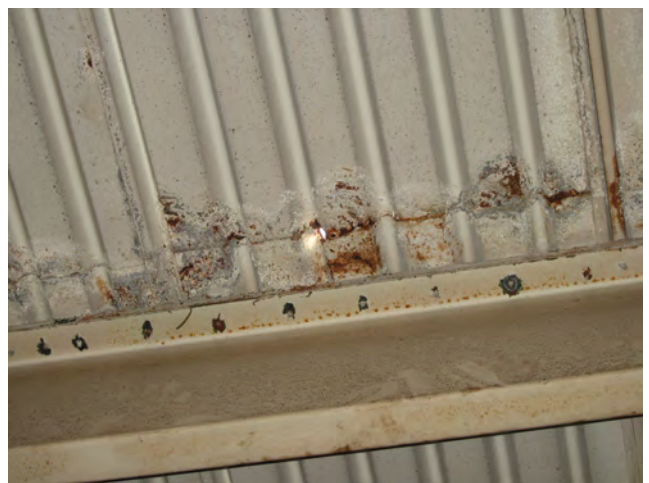
Bldg 1200 - Typical metal roof panel deterioration

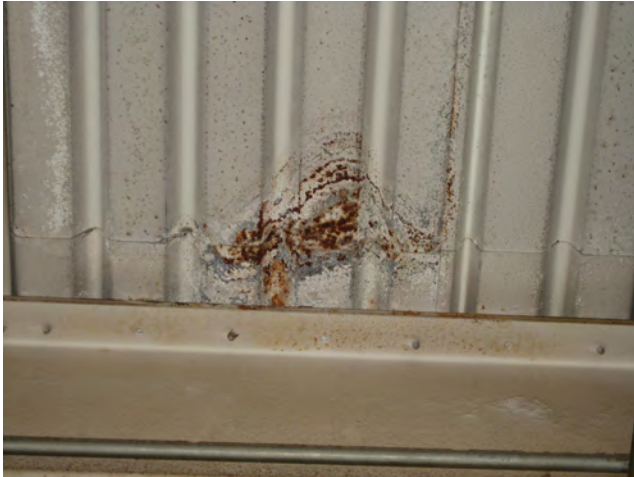
Bldg 1200 - Typical metal roof panel deterioration

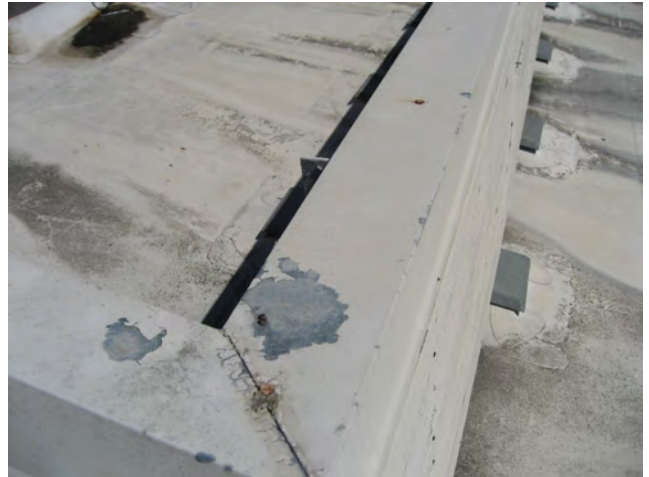
1600 Bldgs - Typical peeling paint on roof Parapet caps

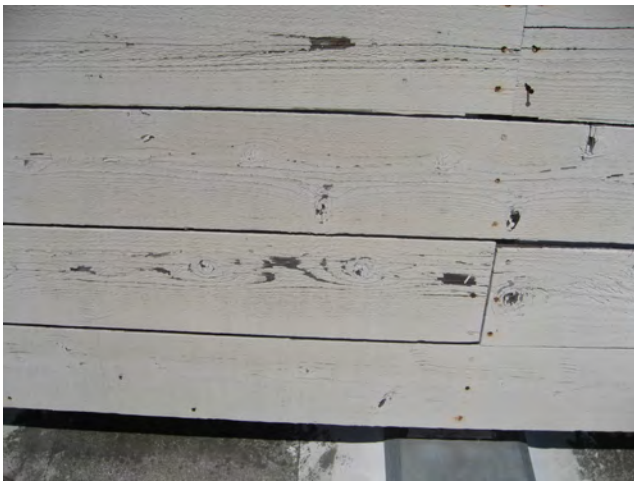
1600 Bldgs - Typical finish deterioration on rooftop HVAC enclosures

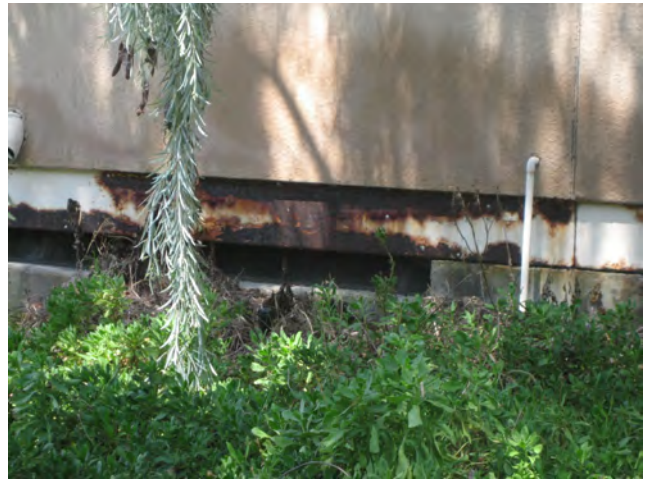
1600 Bldgs – Typical rusting on metal at base of buildings

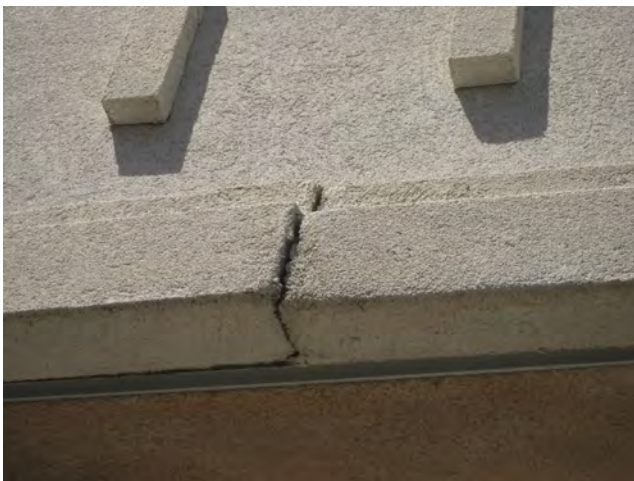
1600 Bldgs - Typical mortar deterioration at base Of roof parapets

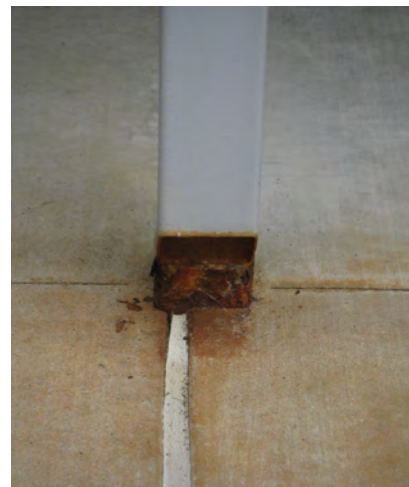
Bldg 2000 - Typical rusting of base of steel walkway Roof support columns

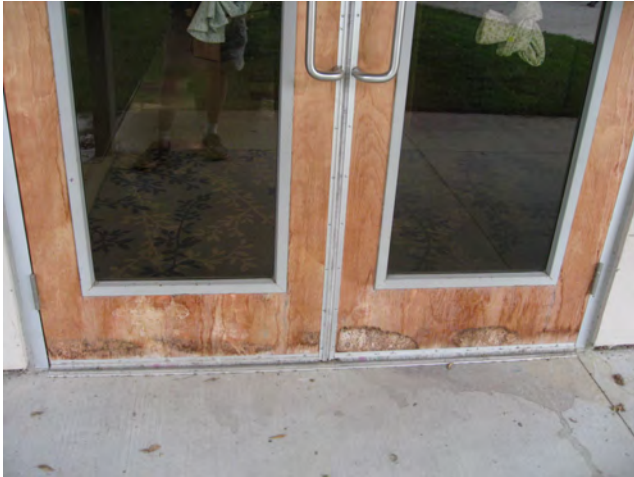
Bldg 2000 - Typical badly weathered exterior Door finish

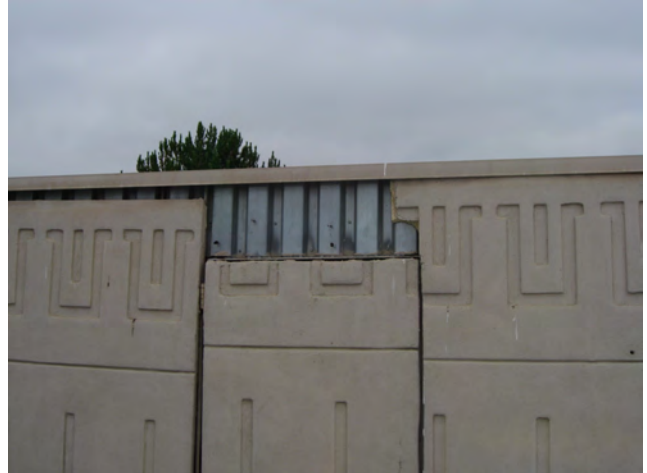
Bldg 2000 - Typical EIFS damage on rooftop HVAC enclosures

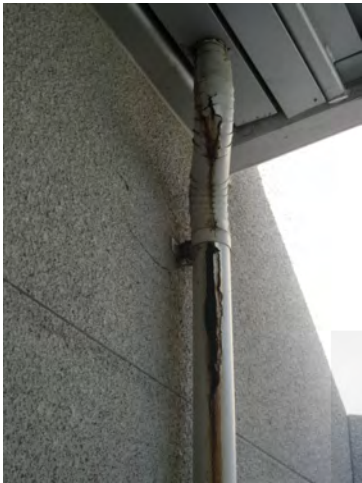
Bldg 5000 (San Ysidro) - Badly rusted/split steel downspout

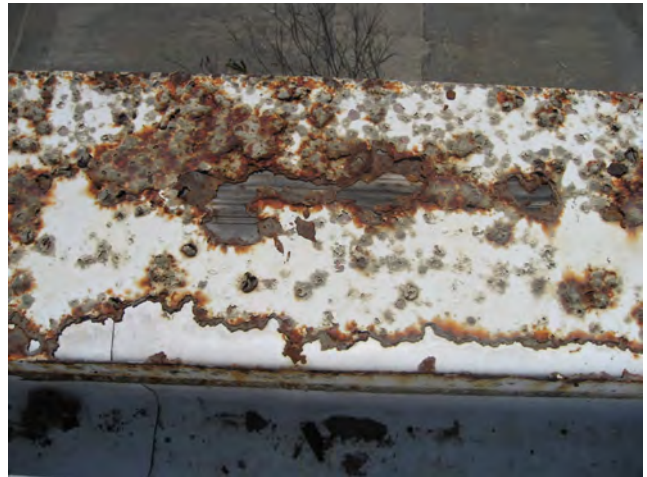
Bldg 9000 (Crown Cove) – Typical totally deteriorated metal parapet cap flashing

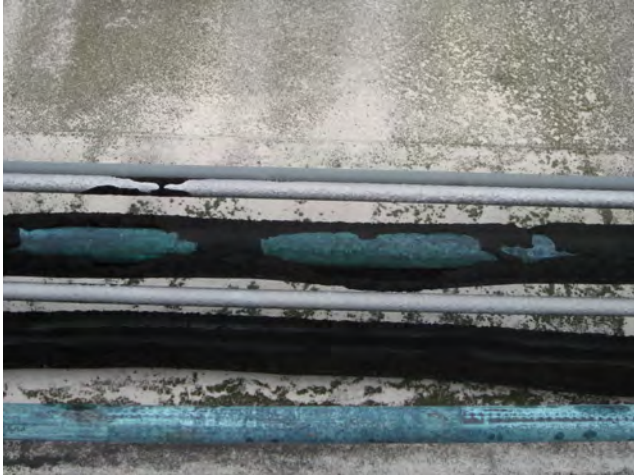
Typical deteriorated rooftop foam pipe insulation

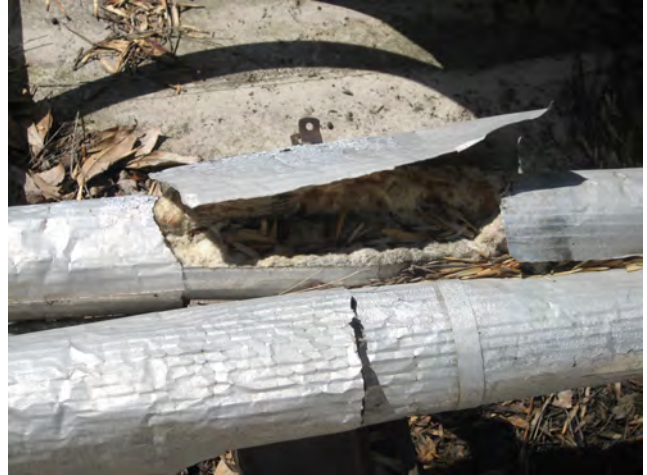
Typical deteriorated rooftop jacketed pipe insulation

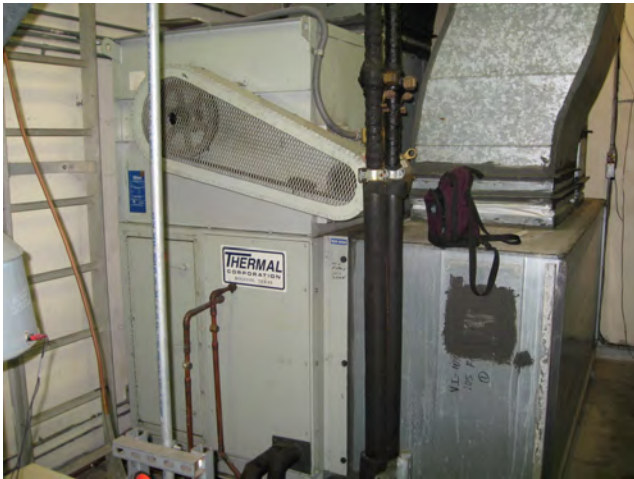
Typical air handler in mechanical room

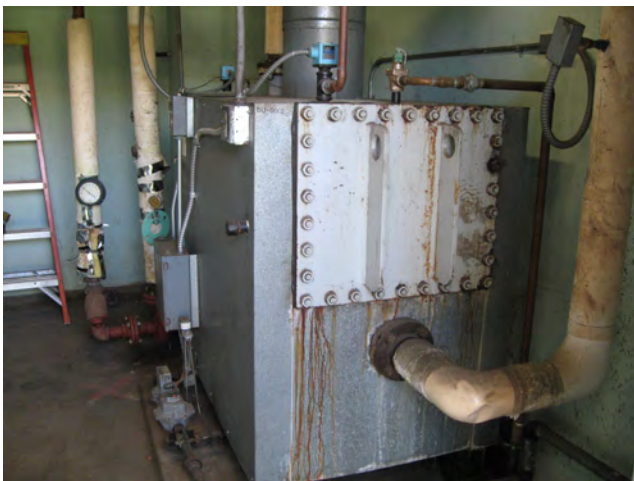
Typical aging/deteriorating boiler

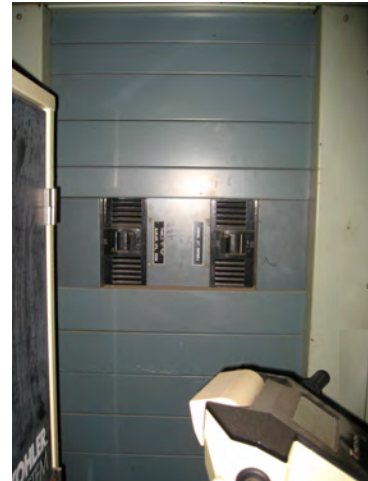
Typical old/obsolete electrical switchgear

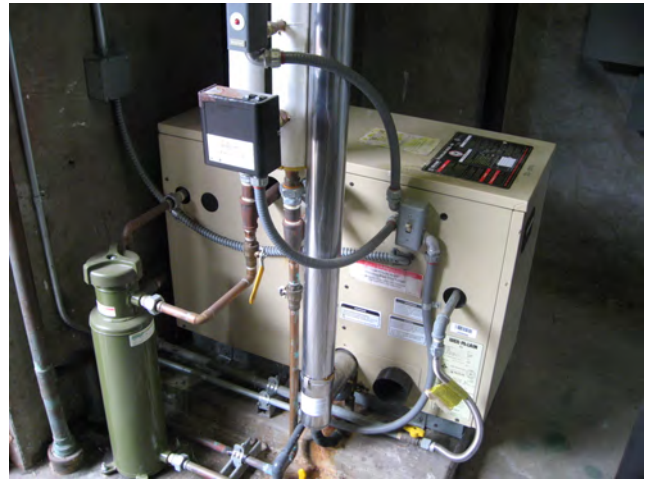
Typical deteriorating hot water boiler

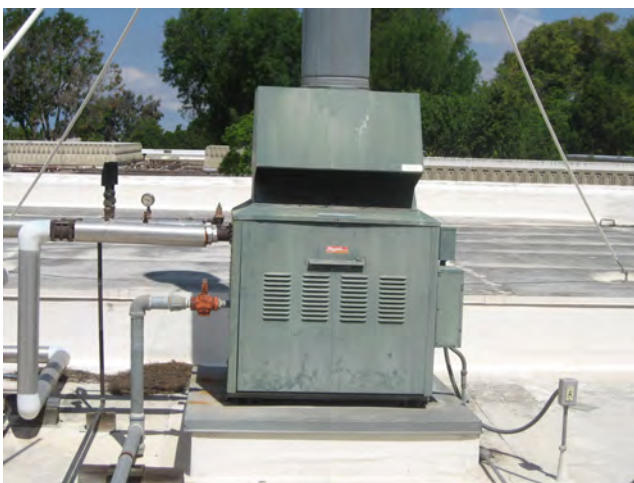
Typical deteriorating hot water boiler

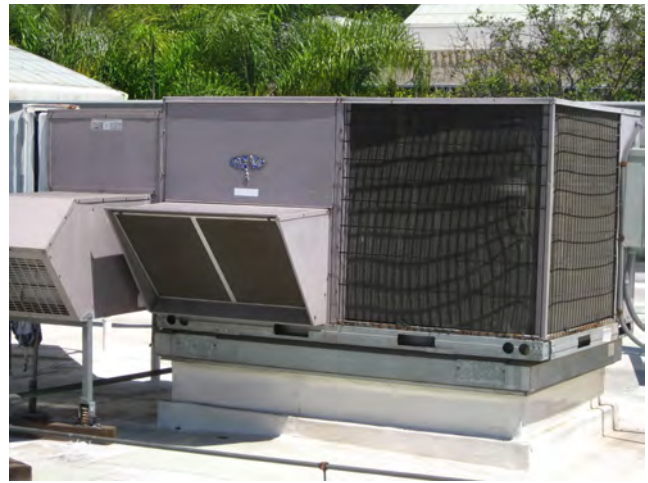
Typical older rooftop HVAC units w gaspaks

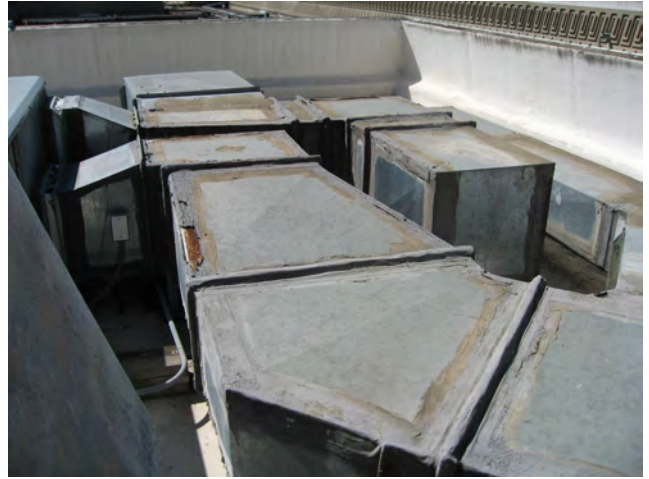
Typical deteriorating rooftop ductwork
Seam sealant

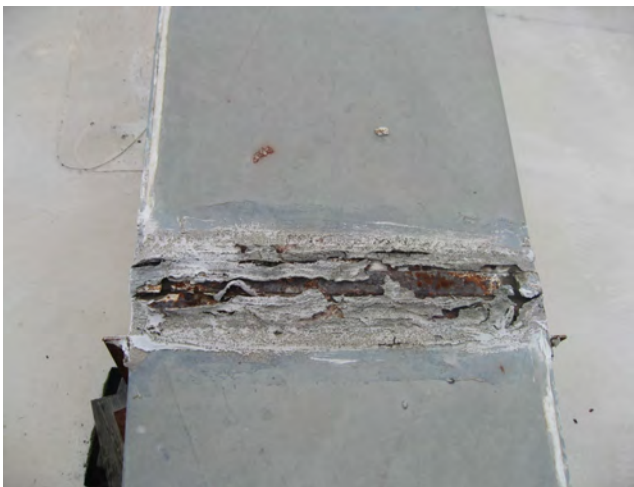
Typical deteriorating rooftop ductwork
seam sealant

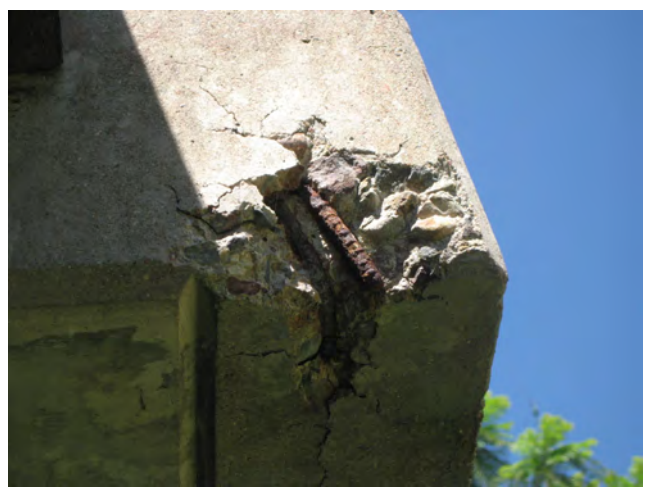
Typical concrete structural beam spalling
