2015 FACILITY CONDITION SURVEY

SOUTHWESTERN COLLEGE

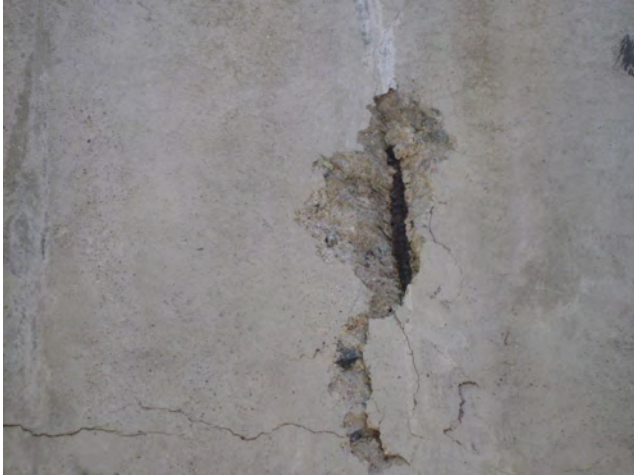
Typical concrete column spalling

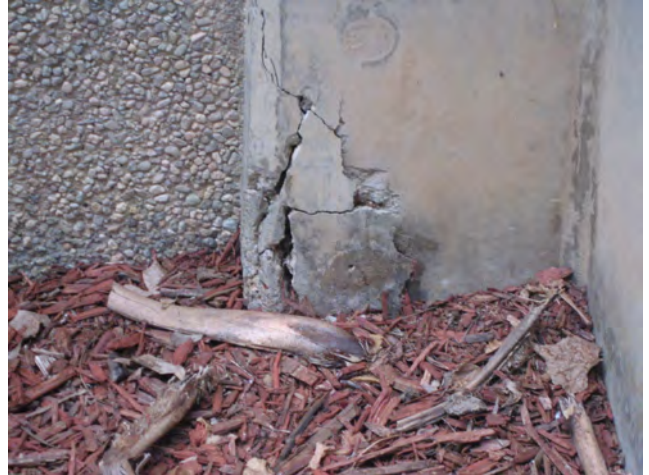
Typical concrete column spalling

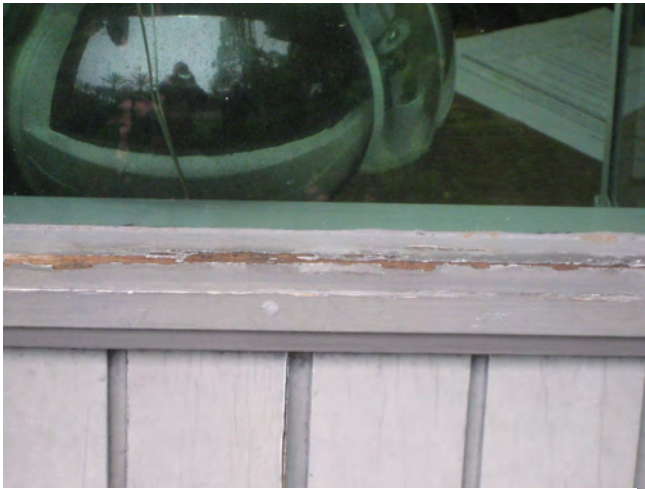
Typical exterior wood window frame finish deterioration

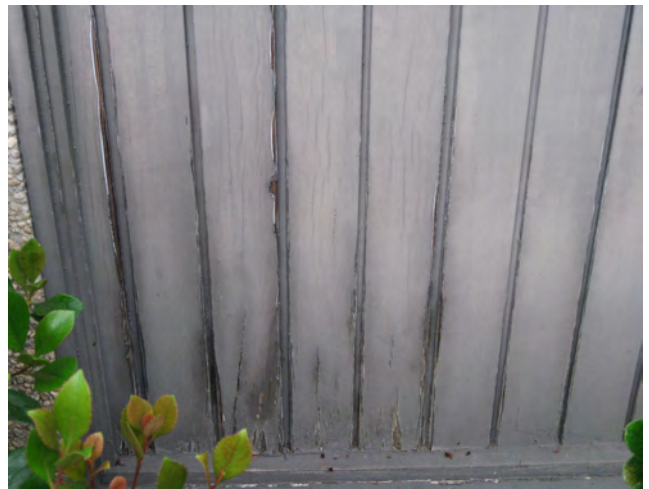
Typical exterior wood wall panel finish deterioration

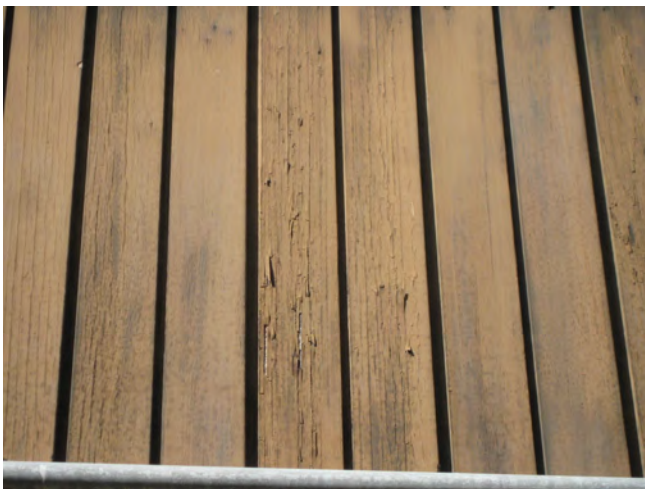
Typical exterior wood wall panel finish deterioration

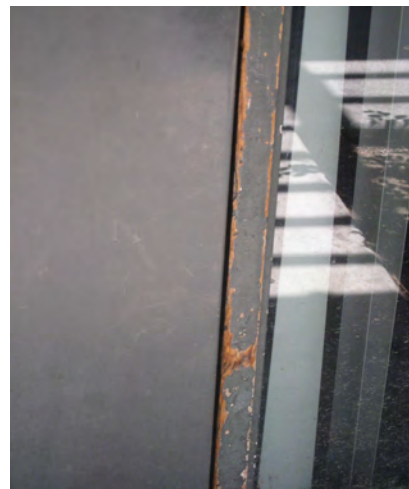
Typical exterior wood door frame finish deterioration

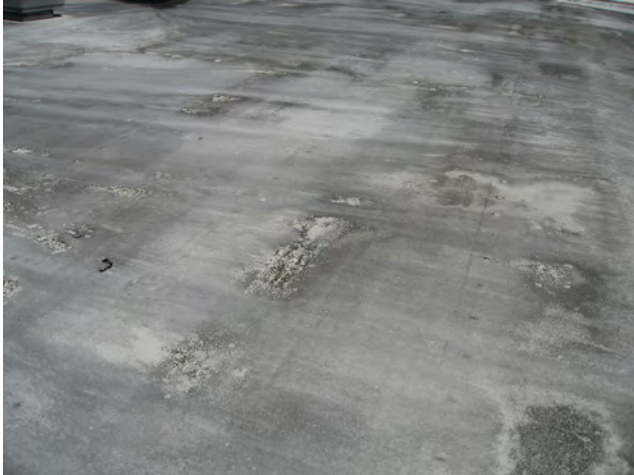
Typical dirty single-ply membrane surface

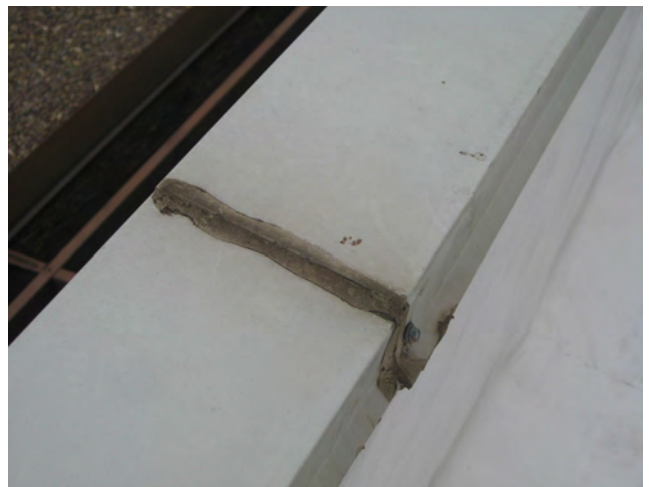
Typical deteriorating roof parapet cap joint sealant

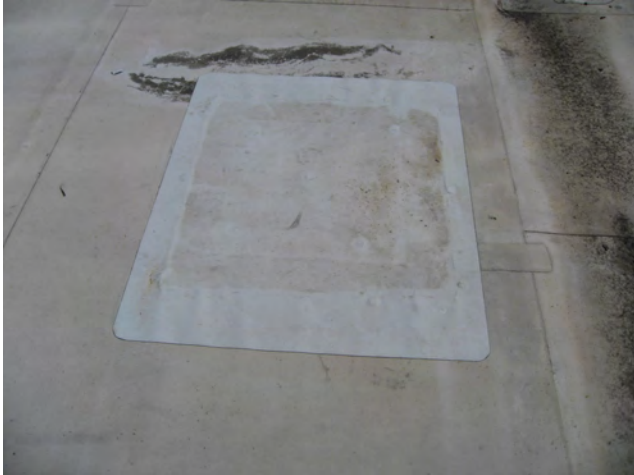
Typical roof patch on older single-ply membranes

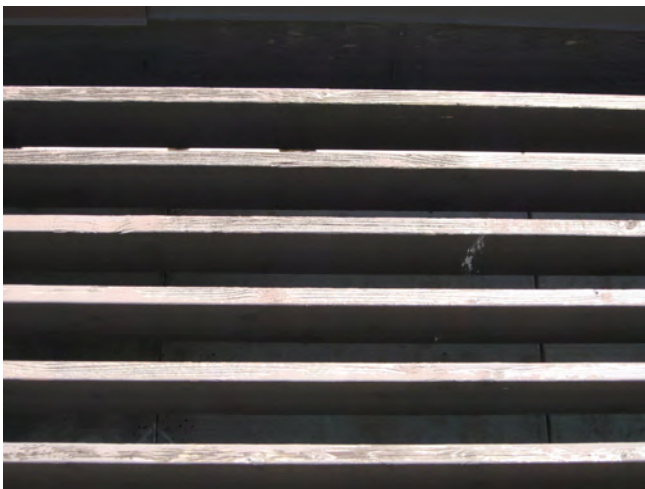
Typical deterioration on tops of sunscreen boards

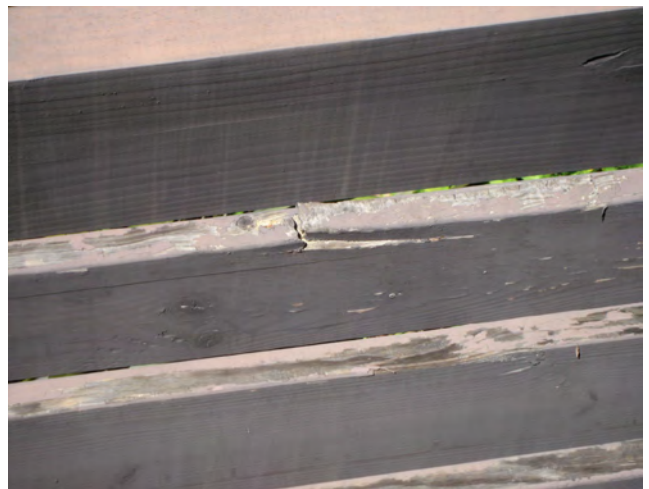
Typical deterioration on tops of sunscreen boards

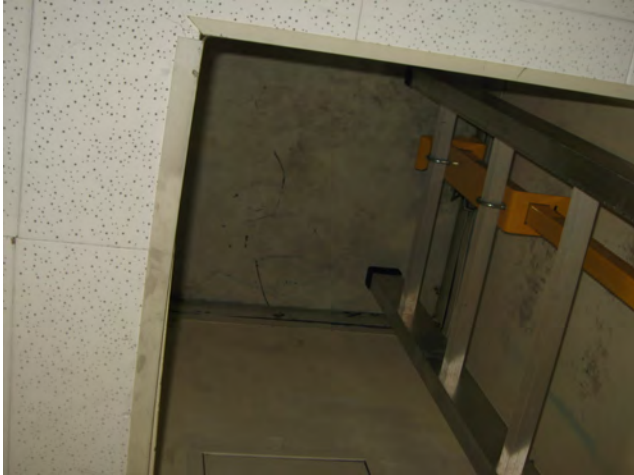
Typical failing roof hatch

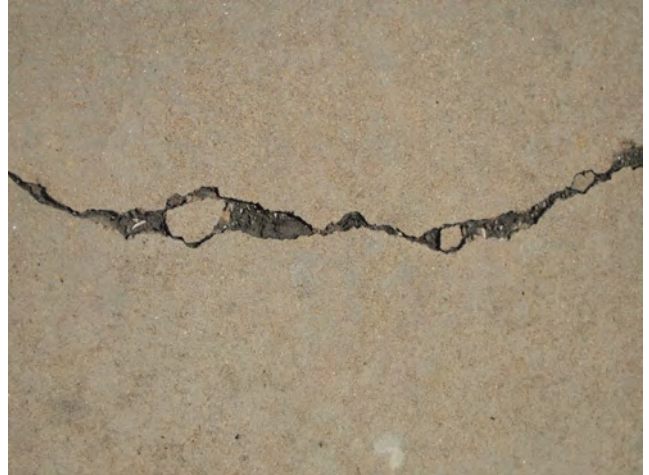
Typical concrete walkway cracks

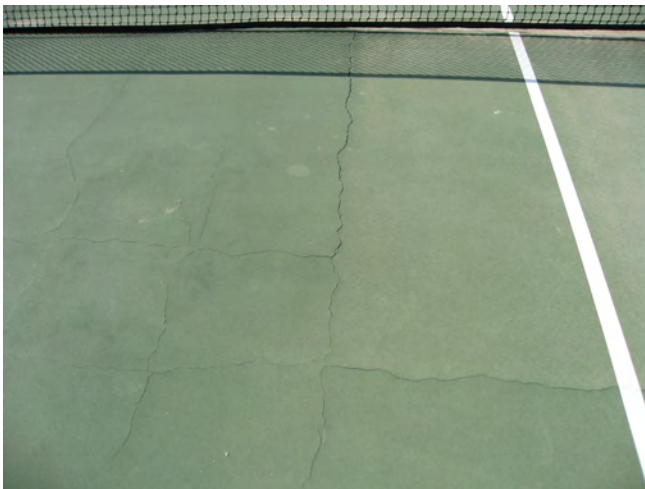
Typical tennis court surface cracks

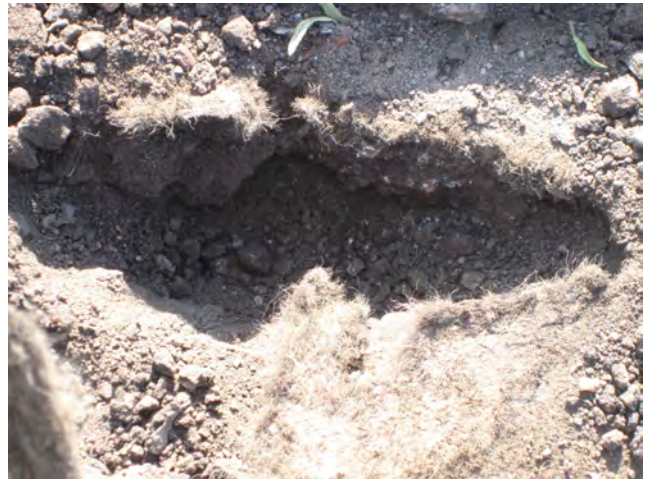
Parking lot paving deterioration-failure of old lift

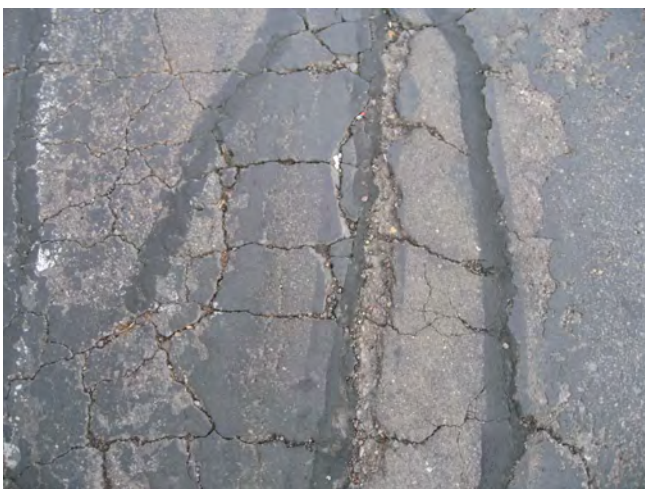
Typical parking lot paving alligating

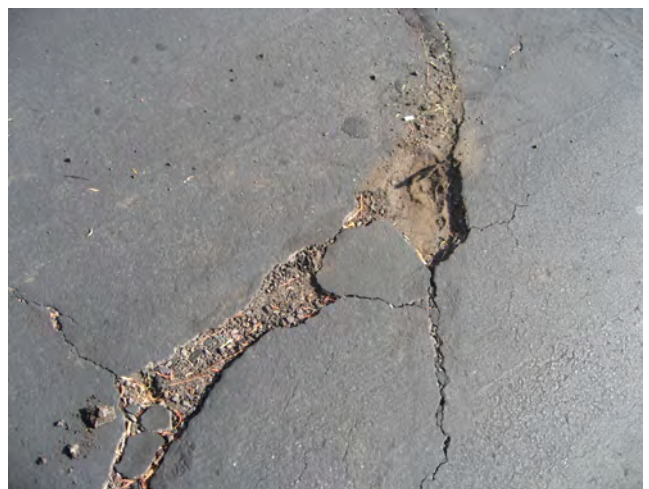
Typical failing parking lot paving wear layer

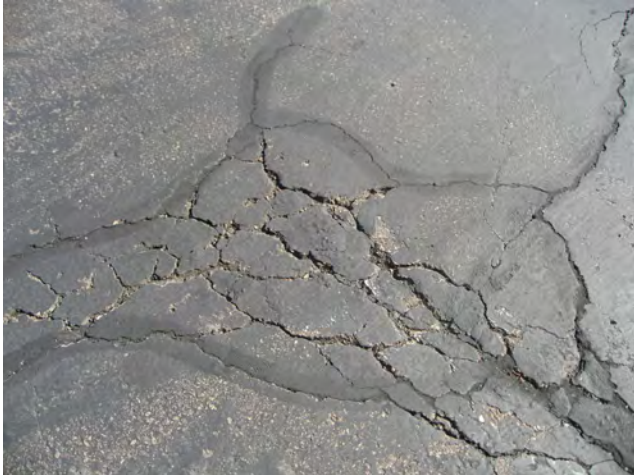
Typical larger area cracking in parking lot paving

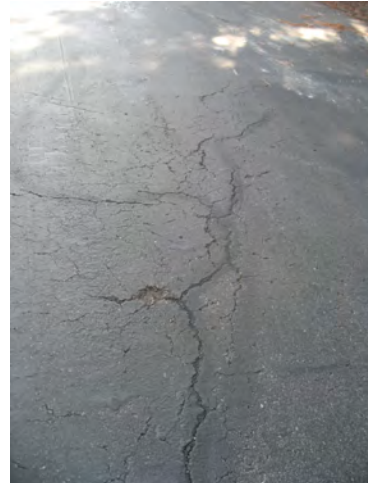
Typical smaller cracks in parking lot paving

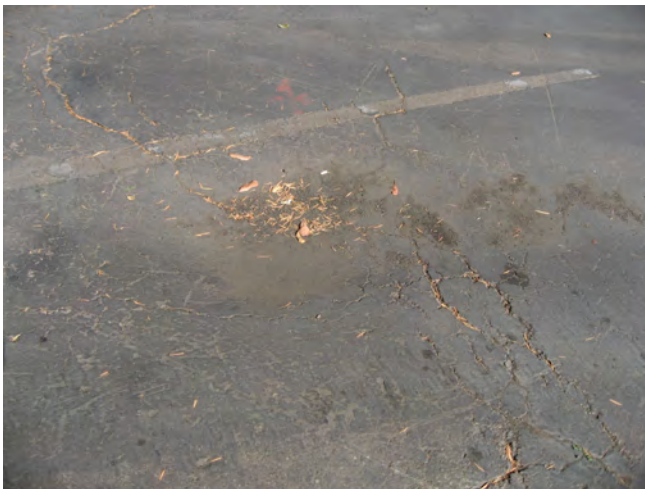
Typical parking lot paving surface crazing and hairline cracks

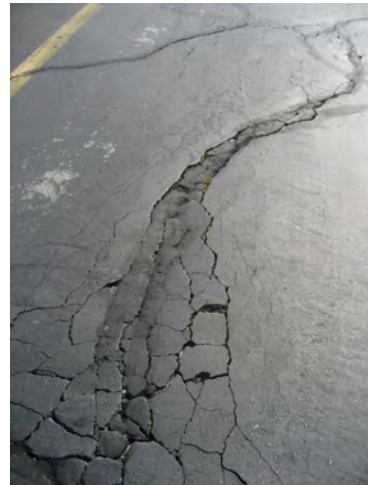
Parking lot paving slumping

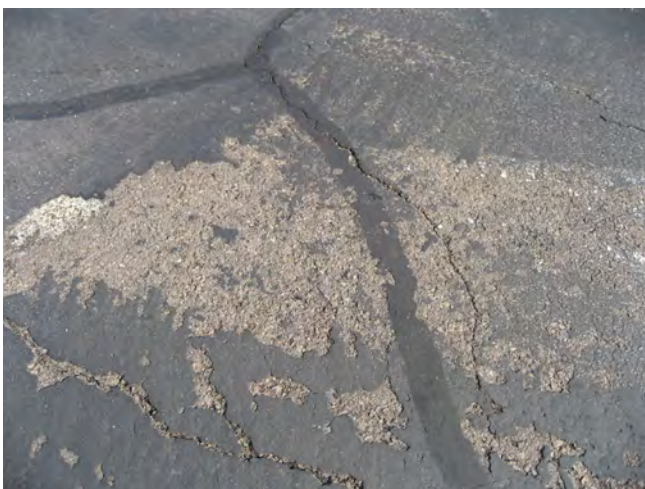
Typical parking lot paving surface wear

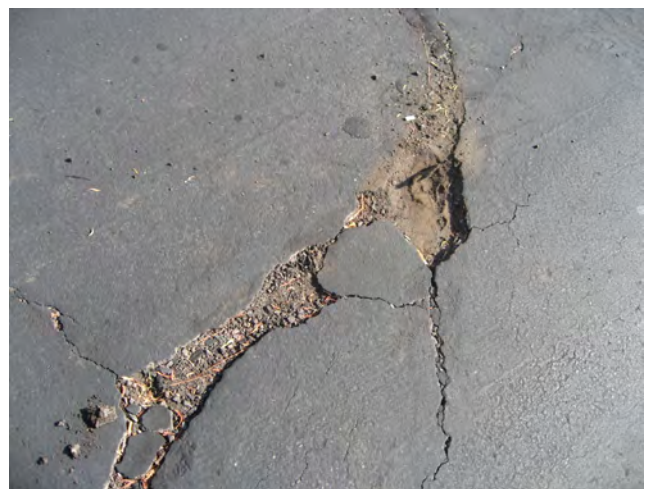
Typical failing parking lot paving wear layer
