RE: THREAT AND PHYSICAL SECURITY ASSESSMENT (TAPS) PHASE I

THREAT AND PHYSICAL SECURITY ASSESSMENT PHASE I

SOUTHWESTERN COMMUNITY COLLEGE DISTRICT

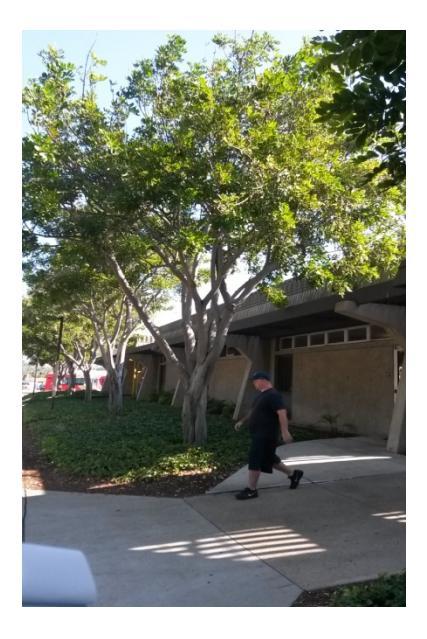
- 11. The trees near the front of the Police Department provide easy access to the building rooftop. This increases the possibility of unauthorized building access.
- 12. The Police Department is responsible for responding to District burglary alarm activations; however, the Facilities Department has oversight of the District burglary alarm system. Furthermore, the Civic Center Facilities Department has oversight of District key control.
- 13. The Police Department is located in a converted office building which is not a hardened location. This presents numerous safety and security related issues for Police Department personnel.

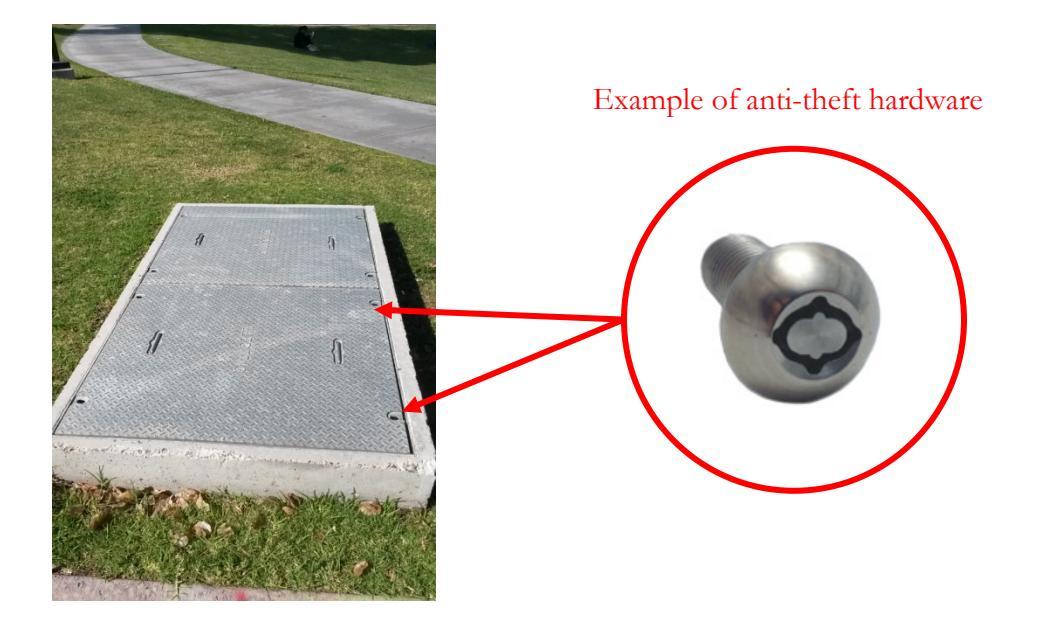
1. Unsecured utility enclosures and utility vaults were observed at each campus throughout the District. Utility enclosures and vaults typically contain high value materials such as copper, brass, aluminum and electrical components. For this reason, utility enclosures and vaults are frequently targeted for theft. Utility enclosure and vault thefts frequently leave the site without power, water or other critical infrastructure for extended periods of time and they are typically high cost repairs. In some cases, these type of thefts result in substantial secondary losses such as short circuited equipment, flooding, etc.

1. Utility enclosures should be secured with a lock or anti-theft hardware. Utility vaults should be secured with special anti-theft hardware similar to the example pictured below. Consideration should be given to alarming high value enclosures, vaults or rooms.

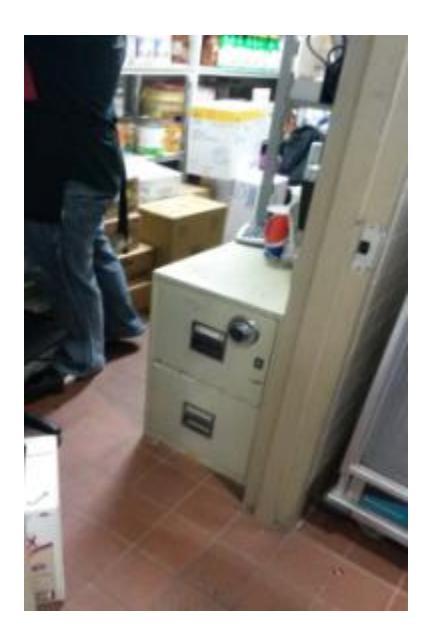
- 1. The Time Out Café closes out their registers two times a day and transports that money to the Cashier's Office without a police escort.
- 2. Up to \$6,000 is stored in a locked file cabinet in the Café office overnight. There is no intrusion alarm system or video surveillance coverage of the Café office. The Café is not equipped with a safe that can be used for money storage.

1. It is recommended that staff utilize a police escort when transporting Time Out Café money to the Cashier's Office.

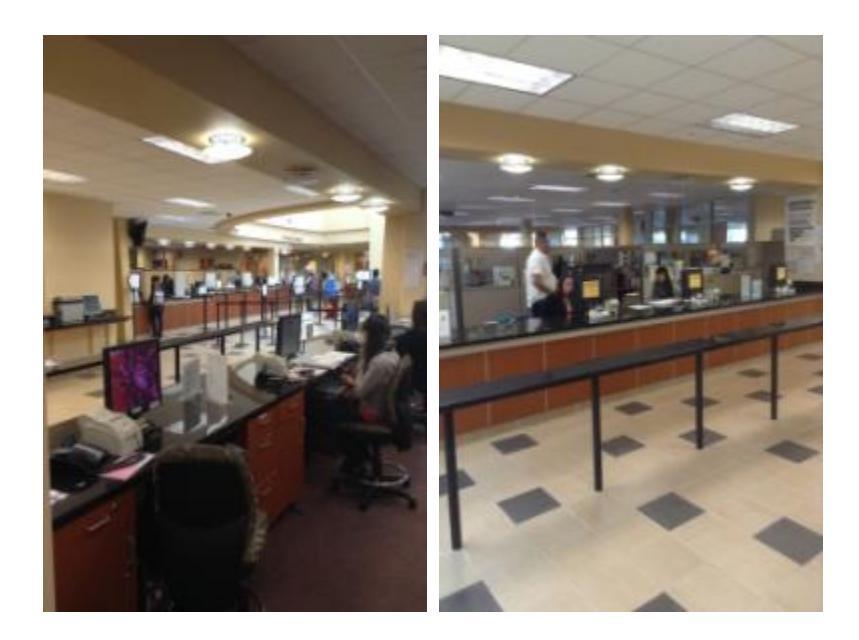
1. The low public cash transaction counter is not equipped with any type of barrier to prevent someone from easily jumping or reaching over it.

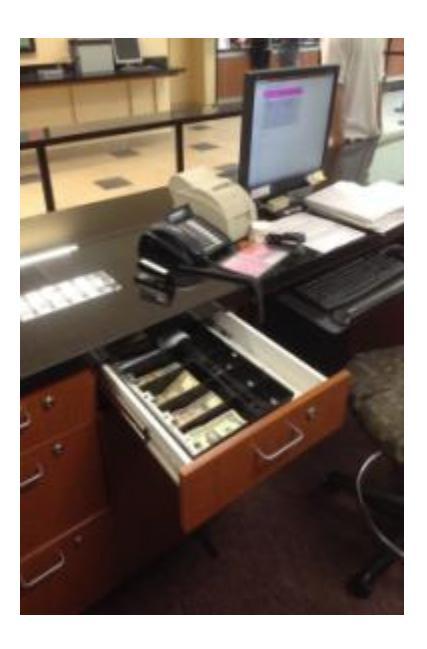
2. During the assessment, it was noted that the cash drawers at the low public cash transaction counter were left unlocked while unattended. The unlocked drawers contained cash. I was informed that there have been prior thefts from this area.

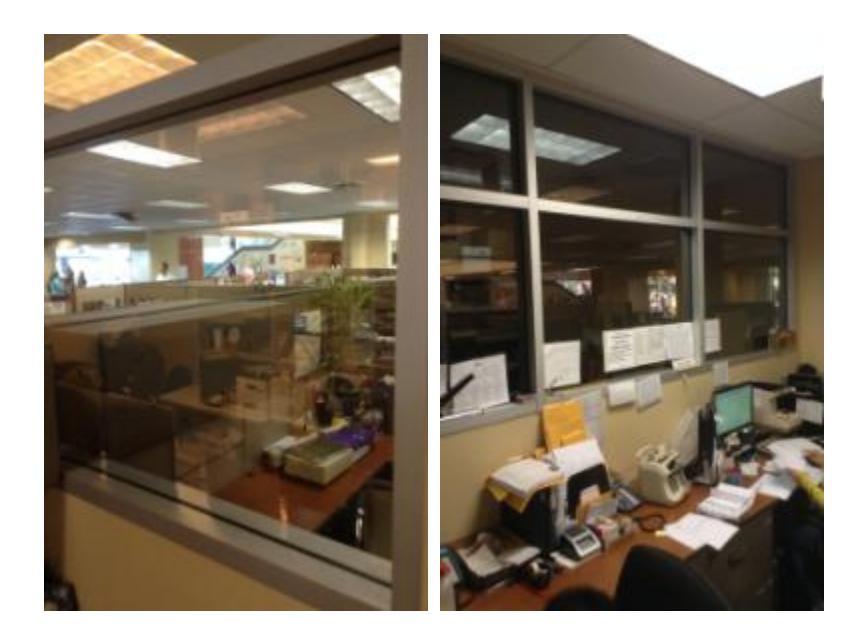
- 6. The video surveillance system in the money counting room (102E) is a stand-alone system. It does not sit on the SWCCD internal platform.
- 7. The money counting room (102E) is equipped with large windows that provide a plain view of the room's interior.

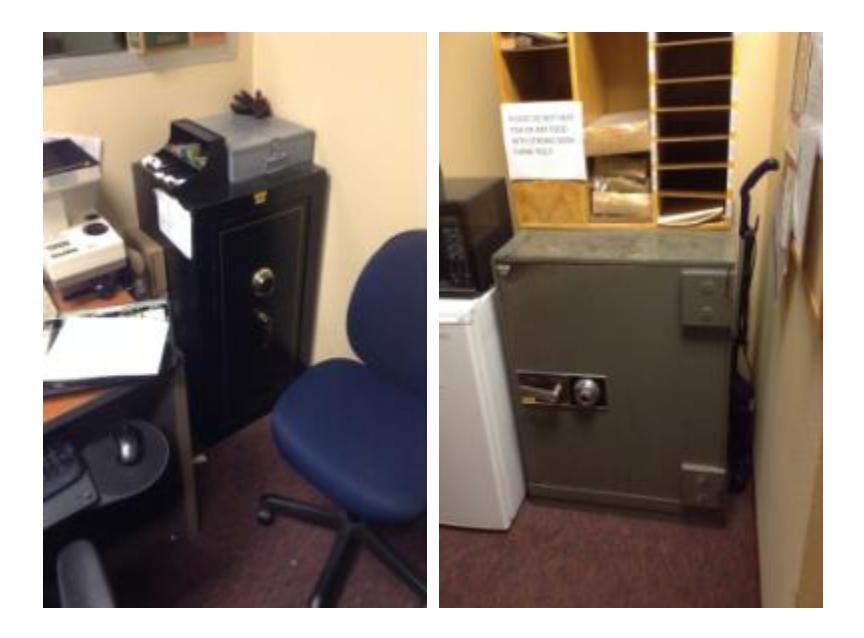
8. The small safe in the money counting room is used for storage of parking fee money only. The small safe is not secured in a manner that discourages easy movement. The main safe outside the money counting room contains up to \$30,000 between third party courier pickups. The main safe is not secured in a manner that discourages easy movement.

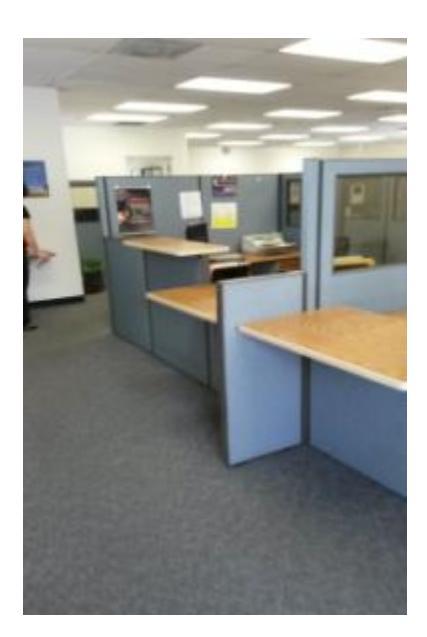
1. The Human Resources Office is not equipped with an adequate physical barrier between the front lobby area and the staff work area. This increases the possibility of potential workplace violence incidents. The staff work area also contains sensitive or confidential information and should not be easily accessible to unauthorized persons.

1. It is recommended that a continuous physical barrier be added to this area. The barrier should separate the front lobby area from the staff work area. The barrier should restrict free movement into the staff work area. Examples of physical barriers are high counter tops and customer service windows.

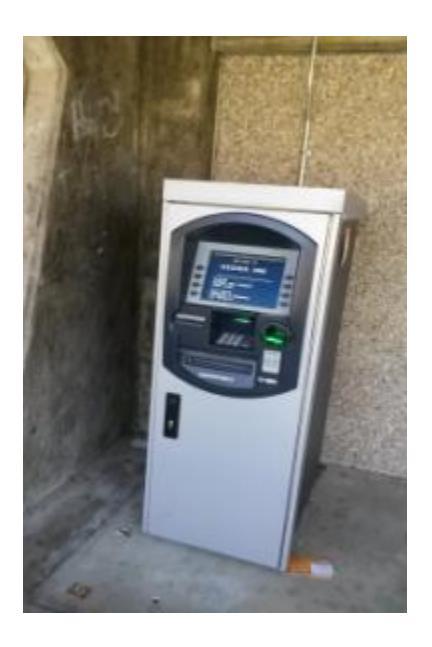
1. The ATM machine located outside the bookstore is not equipped with an internal camera or any external video surveillance coverage. This presents an elevated risk of theft, robbery or violent confrontation, especially during off hours.

1. It is recommended that the ATM machine located outside the bookstore be provided with a camera or external video surveillance coverage to reduce the risk of theft, robbery or violent confrontation.

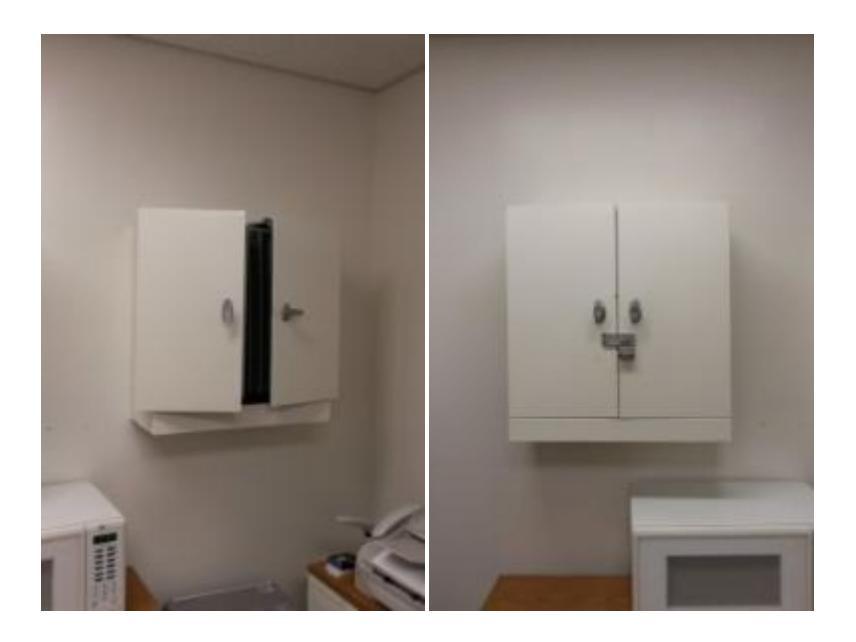
1. SWCCD master keys are stored in the Facilities Office in two wall mounted key lockboxes. The boxes only provide minimal security for the keys. This presents an elevated risk of theft or unauthorized access.

1. It is recommended that all SWCCD master keys be stored in a safe to provide additional security and reduce the risk of theft or unauthorized access. The District should consider transferring control of the master keys to the Campus Police Department and relocating key storage to the Police Department building.

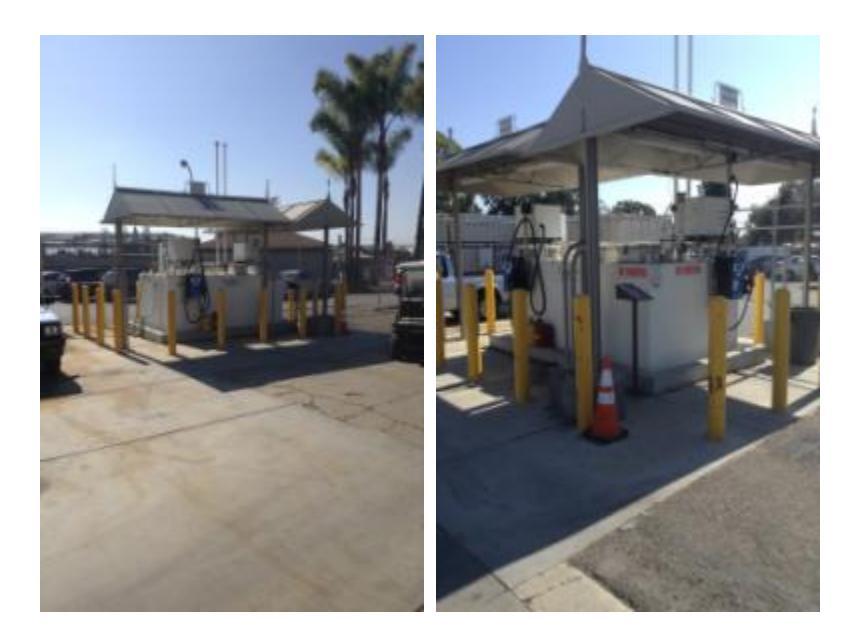
- 1. Rolling recycle bins and trash cans are being stored near the exterior walls of campus buildings. This presents an elevated potential for arson fires, especially when the bins contain combustible material.
- 2. The fuel storage tank is not provided with video surveillance coverage or motion alarm coverage. The fuel storage tank is susceptible to theft or acts of terrorism.

- 1. Rolling recycle bins, trash cans and dumpsters should be secured away from site buildings in a manner that prevents them from being moved. Emptying recycle bins and trash cans daily will help reduce the potential for arson fires.
- 2. Consideration should be given to providing video surveillance coverage and motion alarm coverage of the fuel storage tank. This can reduce the possibility of theft or acts of terrorism. Installation of a card lock type fueling system would increase security and reduce the possibility of fuel theft from this location.

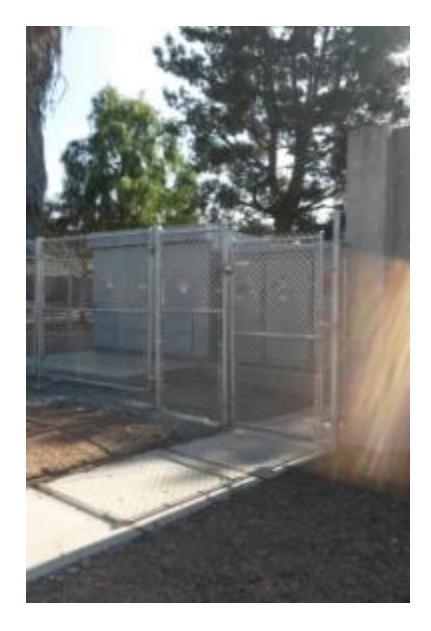
1. The chain link fence surrounding the switch gear cabinets provides plain view of the equipment from outside the yard. Switching gear is part of the site infrastructure and is susceptible to theft or acts of terrorism.

1. Consideration should be given to providing a visual barrier around the chain link fence and equipment yard. This could reduce the possibility of equipment theft or acts of terrorism.

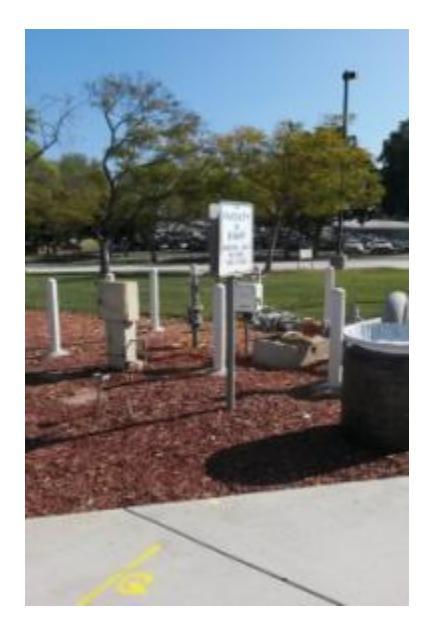
1. The gas main adjacent to the staff parking lot is not provided with any type of barrier to prevent tampering or acts of terrorism.

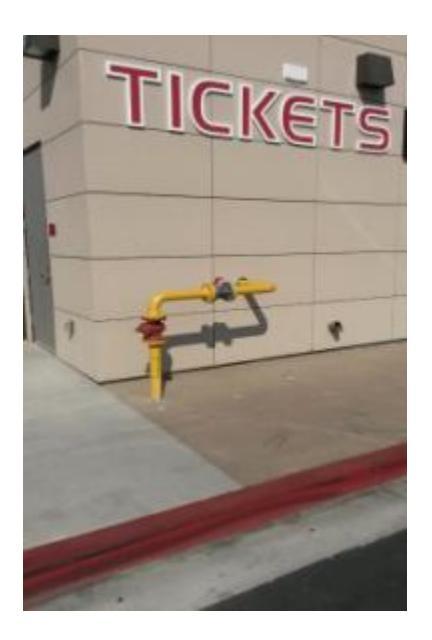
1. The gas main adjacent to Building 1282 is not provided with any type of barrier to prevent vehicle strikes, tampering or acts of terrorism.

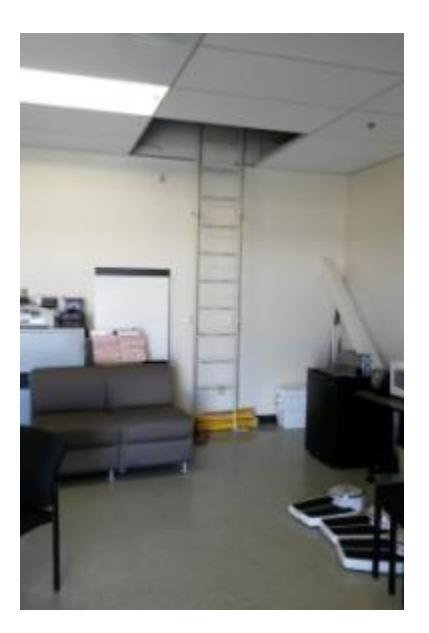
1. It was noted that the hatch leading from the access ladder in the Academy Storage Room to the roof was not equipped with a lock. Roof hatches are vulnerable to forced entry when they are not equipped with a lock or some type of device that prevents the latch from being manipulated

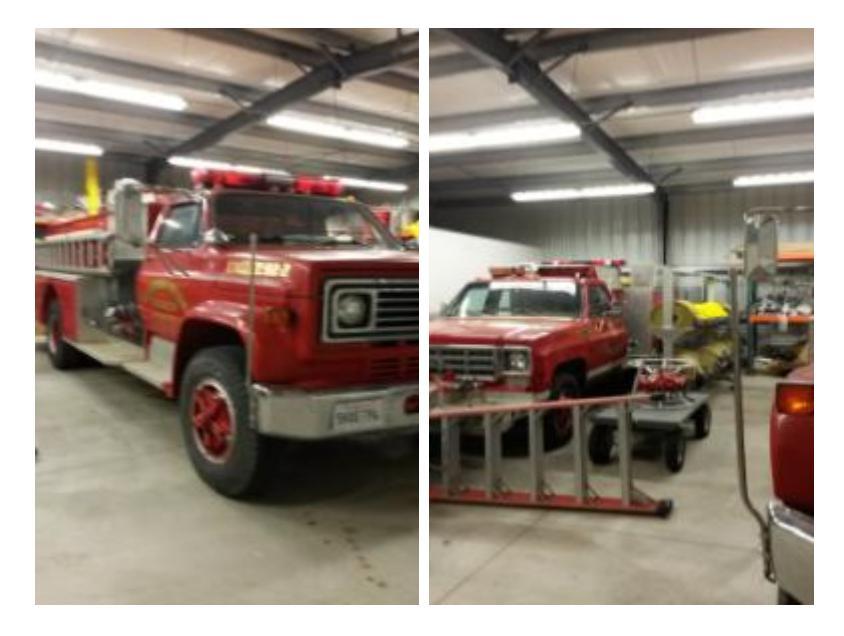
1. The Maintenance Warehouse is being used to store Fire Academy supplies including vehicles and equipment. It is considered a high value room. The warehouse is not equipped with an intrusion alarm system. This presents an elevated risk of unauthorized entry to this area.

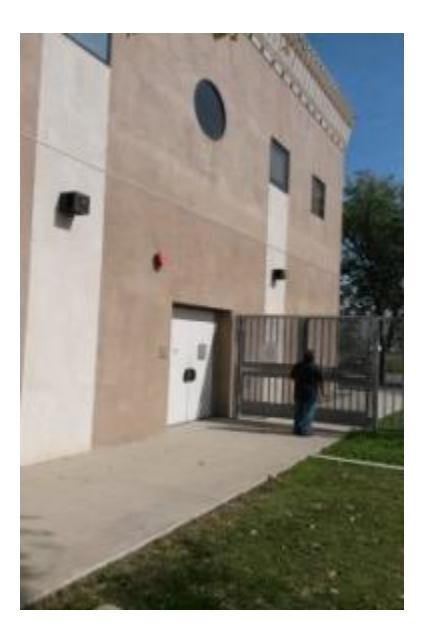
1. Site staff advised me that the lighting around the walkway on the south side of the Administration Building is inadequate at night. It was noted that there is a limited number of light fixtures installed in this area.

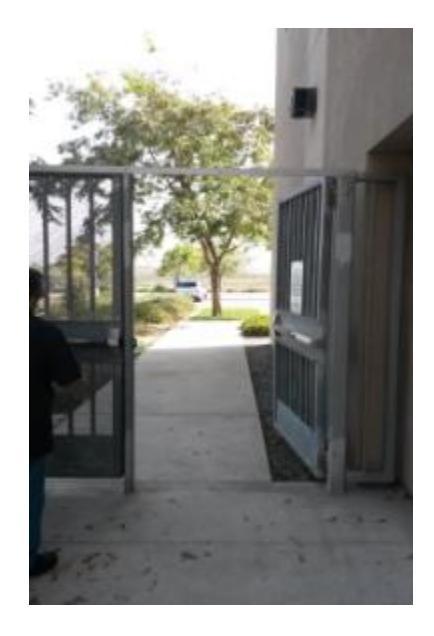
1. It was noted that several perimeter gates were standing open during the assessment. The gates are equipped with panic exit hardware but they are not equipped with self-closing hardware. This decreases the effectiveness of the site perimeter and increases the possibility of unauthorized access.
